Uxbridge, Massachusetts
Evaluation Report
Project Number: 7533
June 2021

BRIDGE / CULVERT MANAGEMENT PLAN

Prepared by: BETA GROUP, INC.
Prepared for: Town of Uxbridge

June 2021

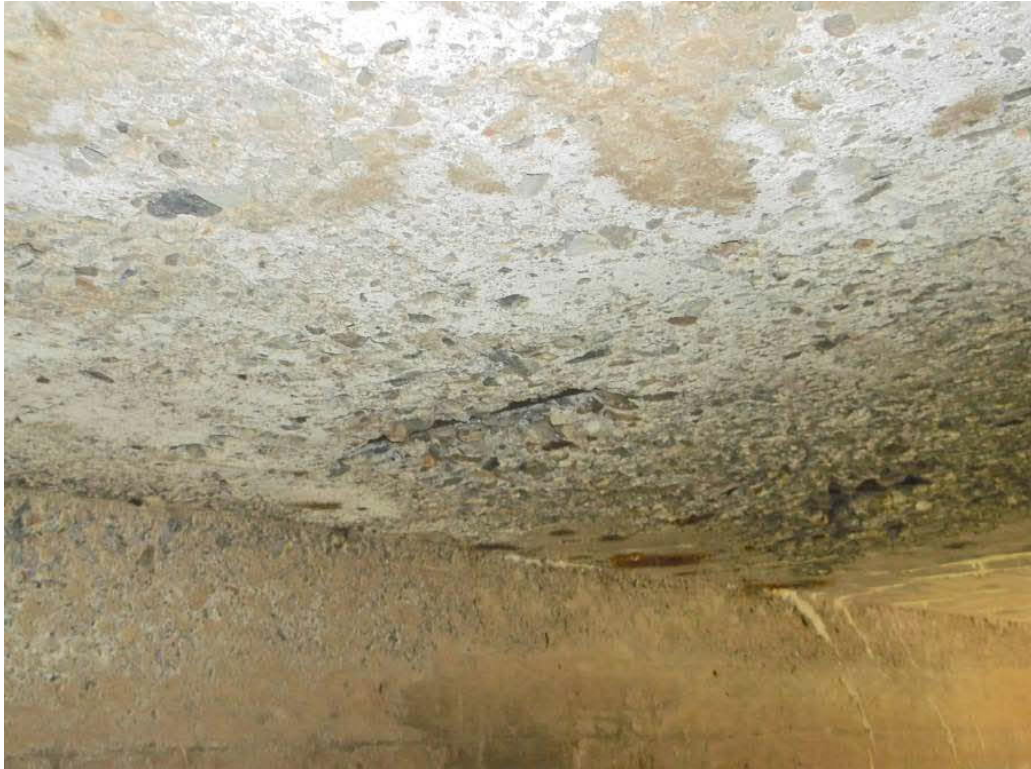
Photo 3: Span #1 center, poor consolidation.

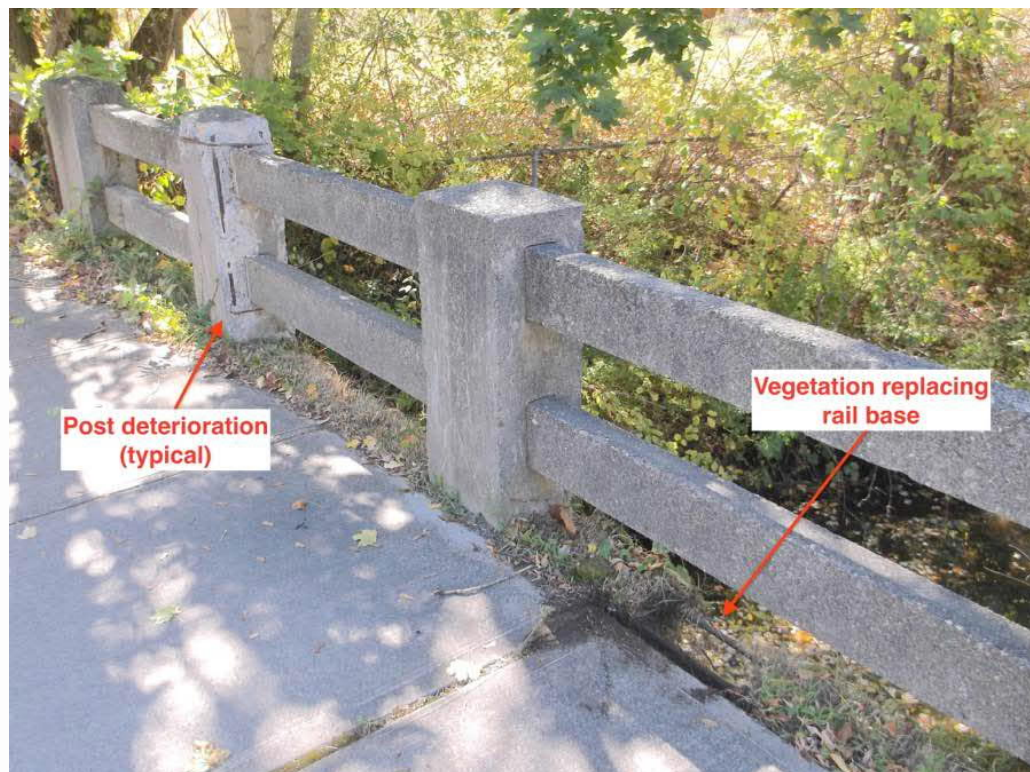
Photo 9: West rail, typical headwall (rail base) and post deterioration.

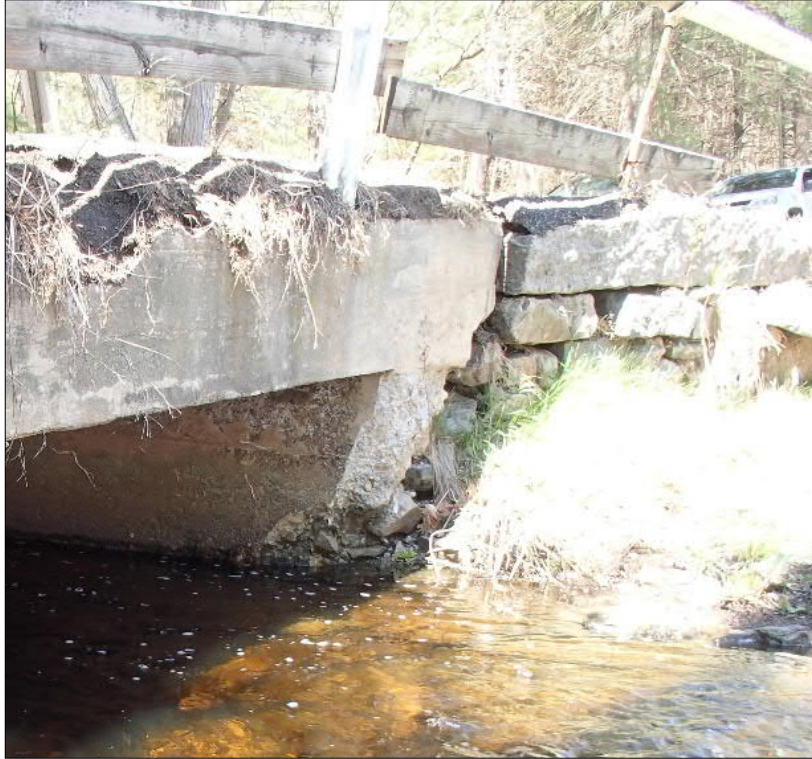
Photo 11 Looking Northwest: Spalling at Northeast Abutment Corner

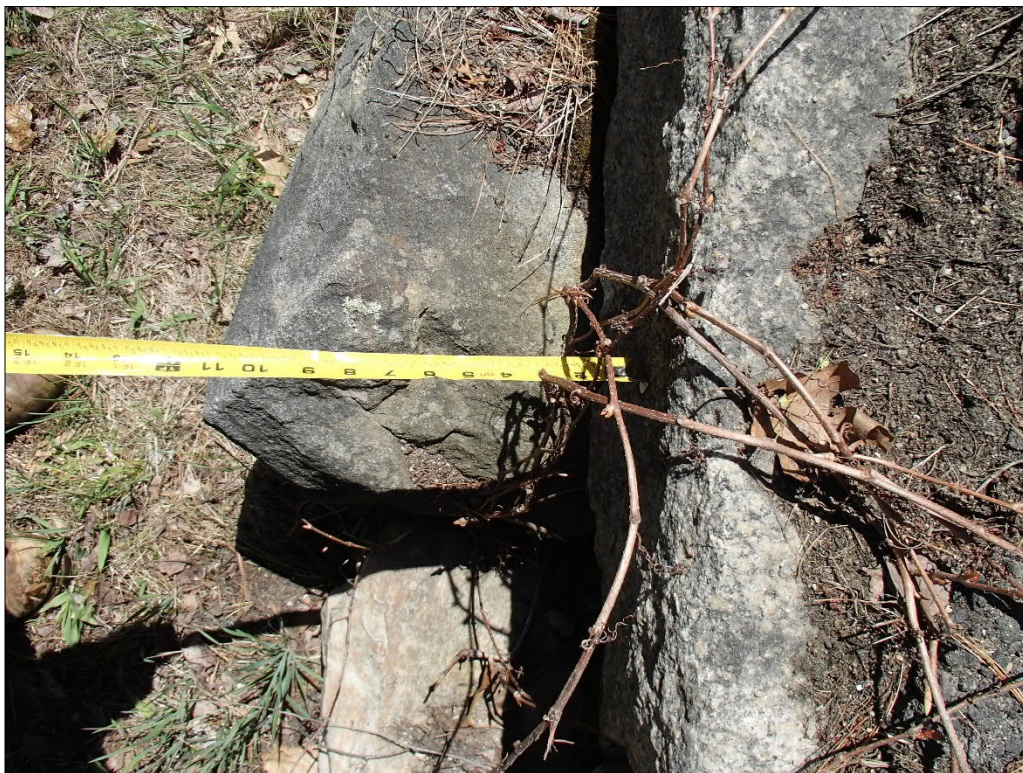
Photo 12 Lateral Displacement of Northeast Wingwall

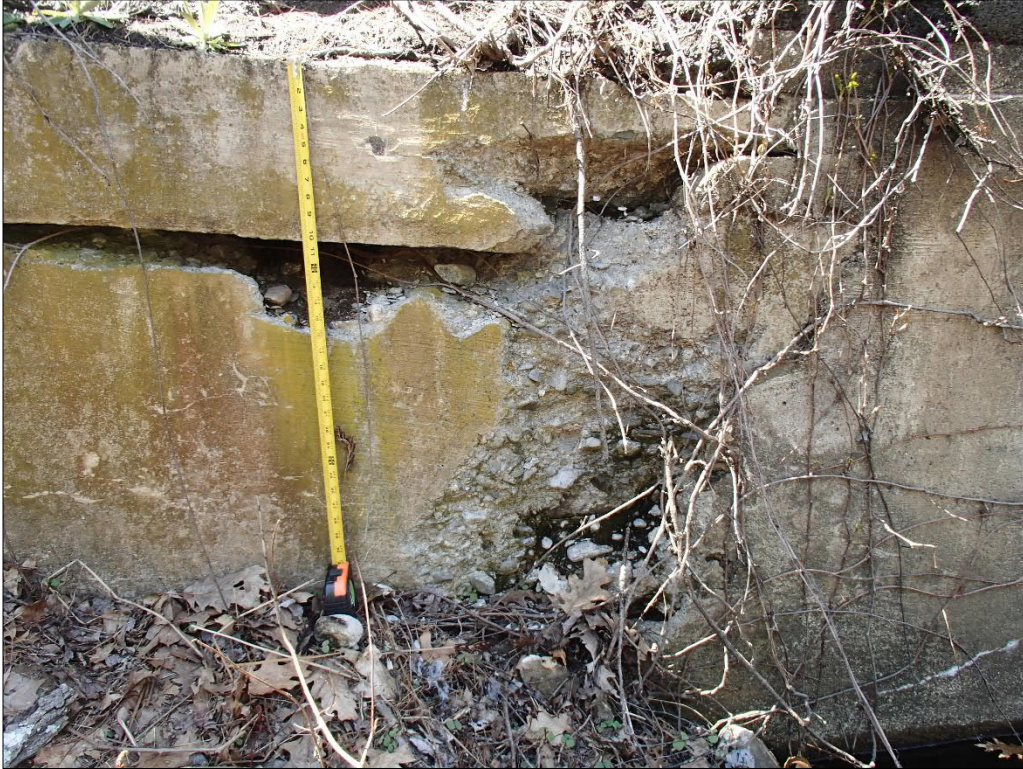
Photo 13 Looking East: Cracking and Spalling of Southeast Wingwall

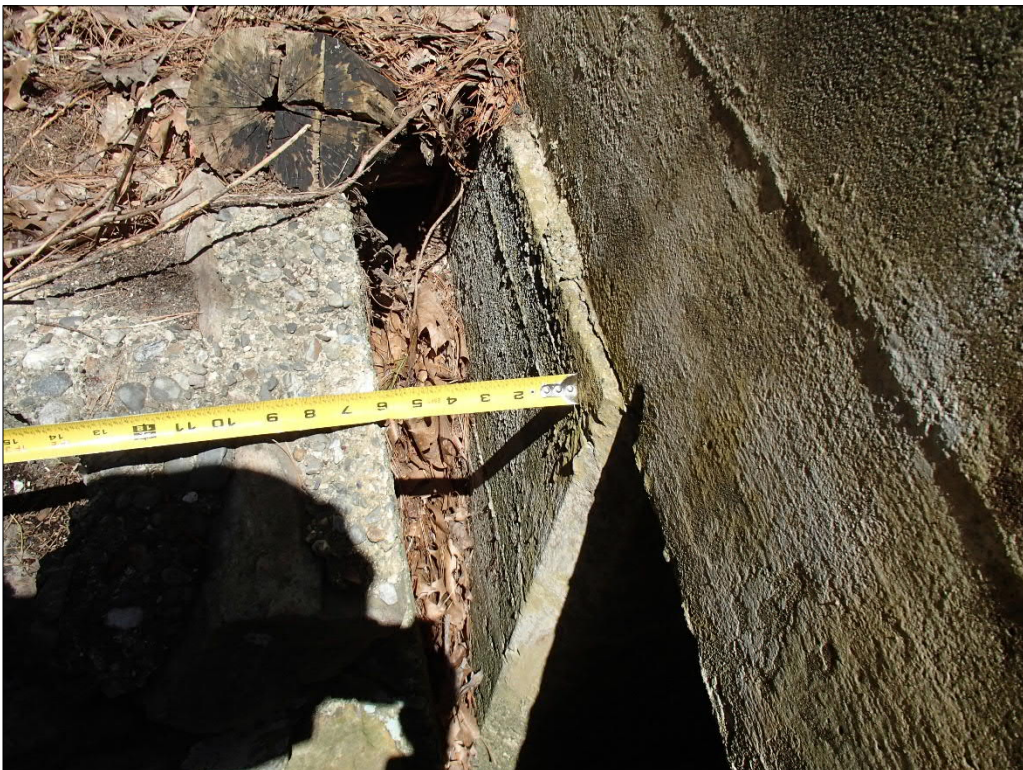
Photo 14 Looking North: Separation of Northwest Training Wall and Culvert

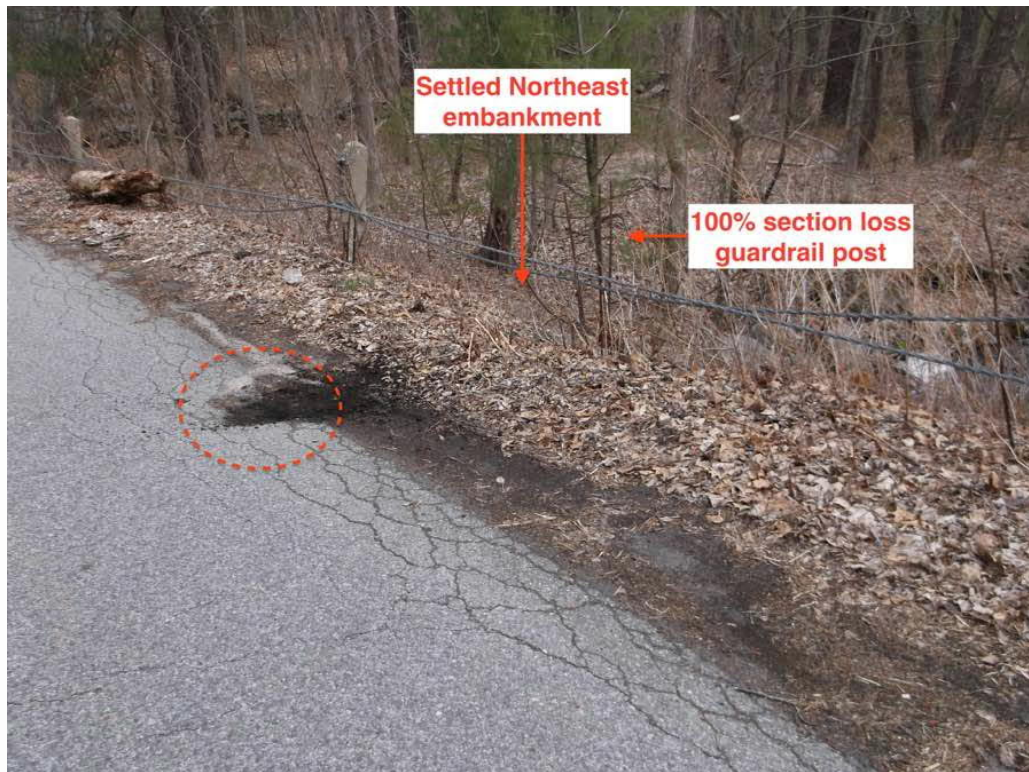
Photo 5: Wearing surface and North approach pavement, looking Northeast. Settlement in Northbound lane is circled. East rail post with 100% concrete section loss indicated (only rebar remaining).

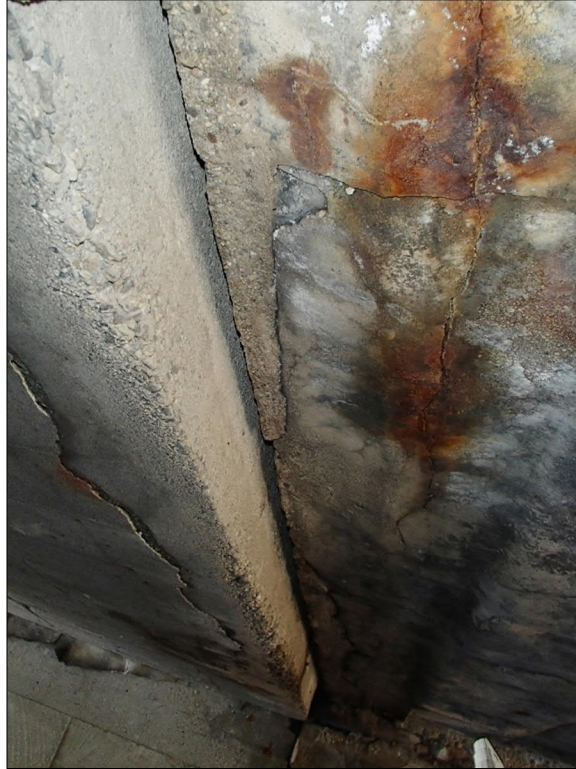
Photo 7 Looking West: Culvert Roof Interface – Shows Cracks w/ Rust Stains & Efflo.

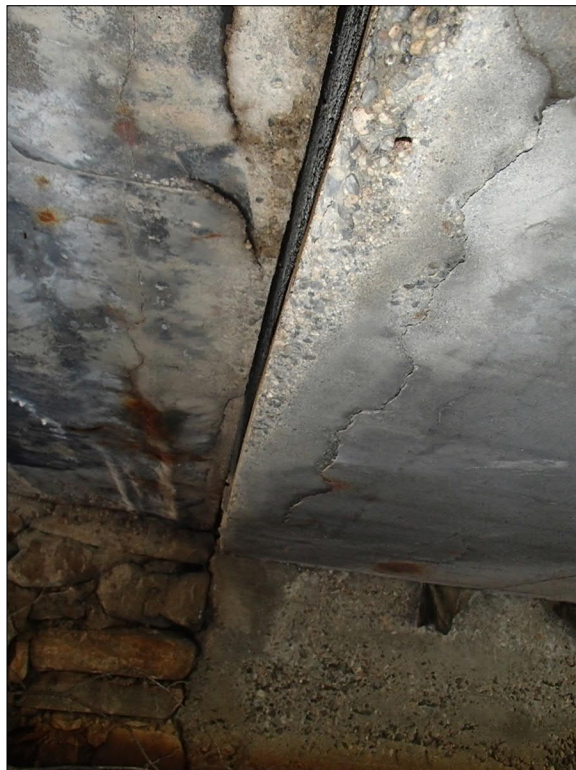
Photo 8 Looking East: Culvert Roof Interface – Shows Cracks w/ Rust Stains & Efflo.

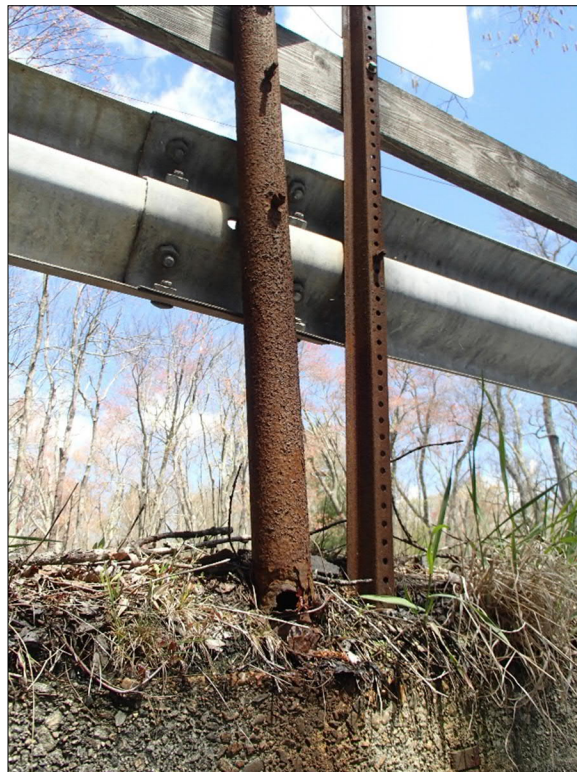
Photo 22 Looking North: Rust at South Railing

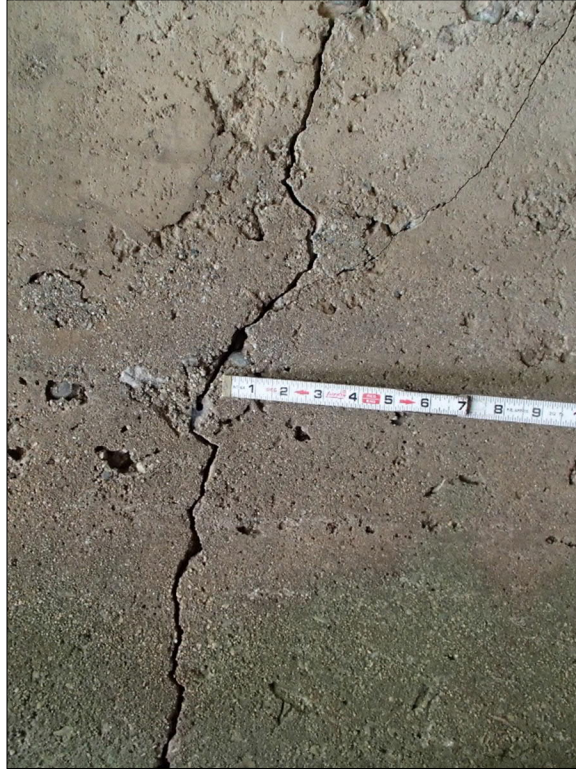
Photo 9 Looking North: Crack near West End of North Abutment

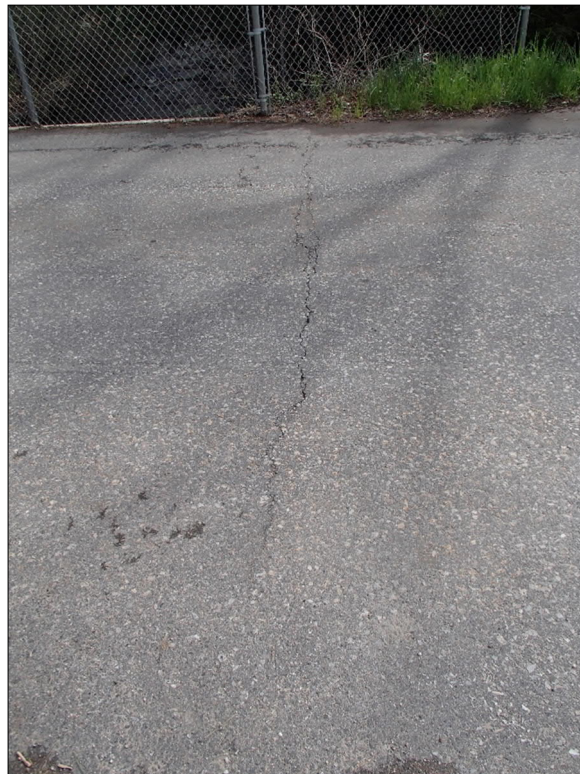
Photo 14 Looking East: Crack at South Approach

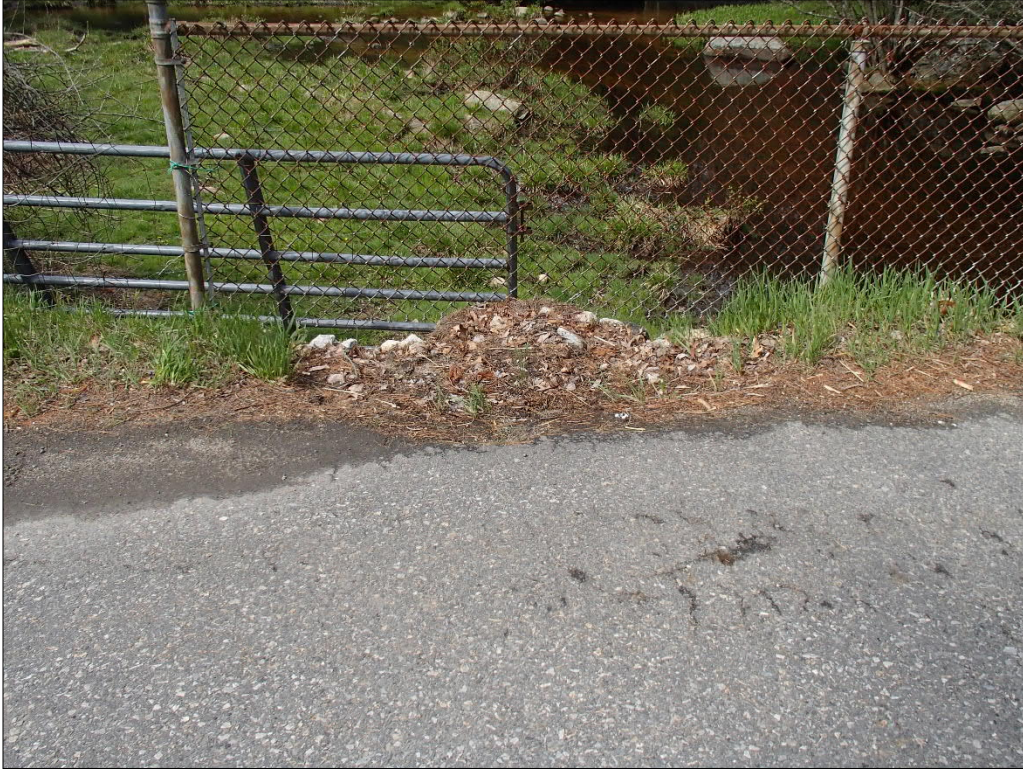
Photo 15 Looking West: Settling at South Approach

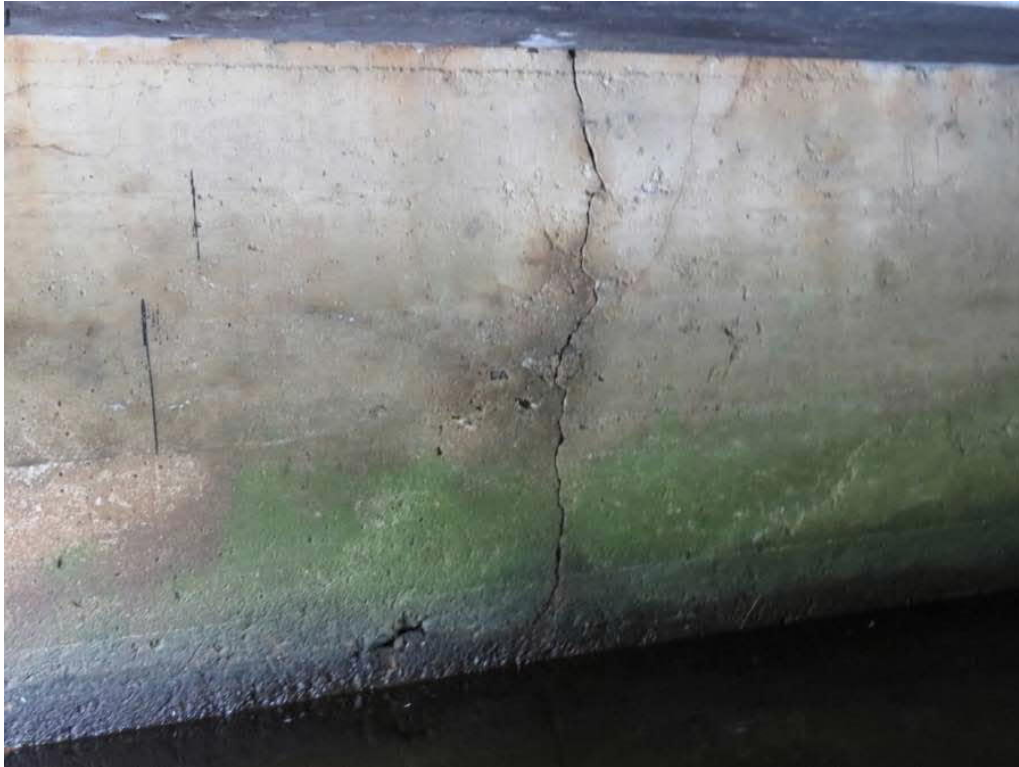
Photo 7: North breastwall settlement crack, 6' in from West end.

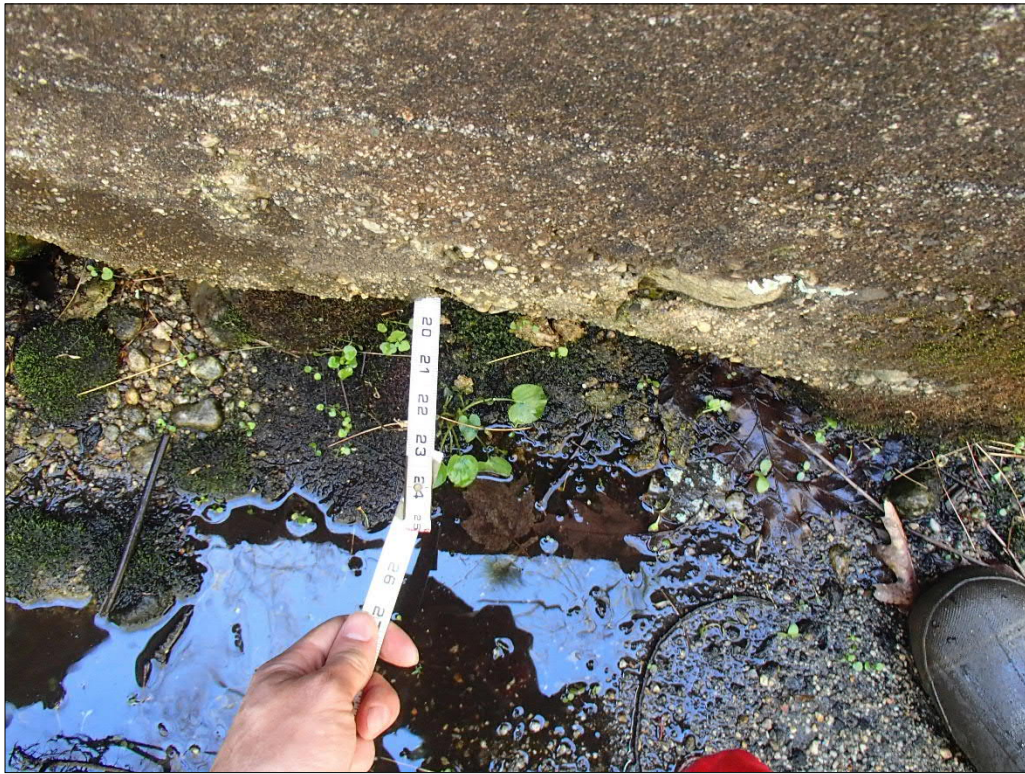
Photo 7 Looking South: Southwest Wingwall Void

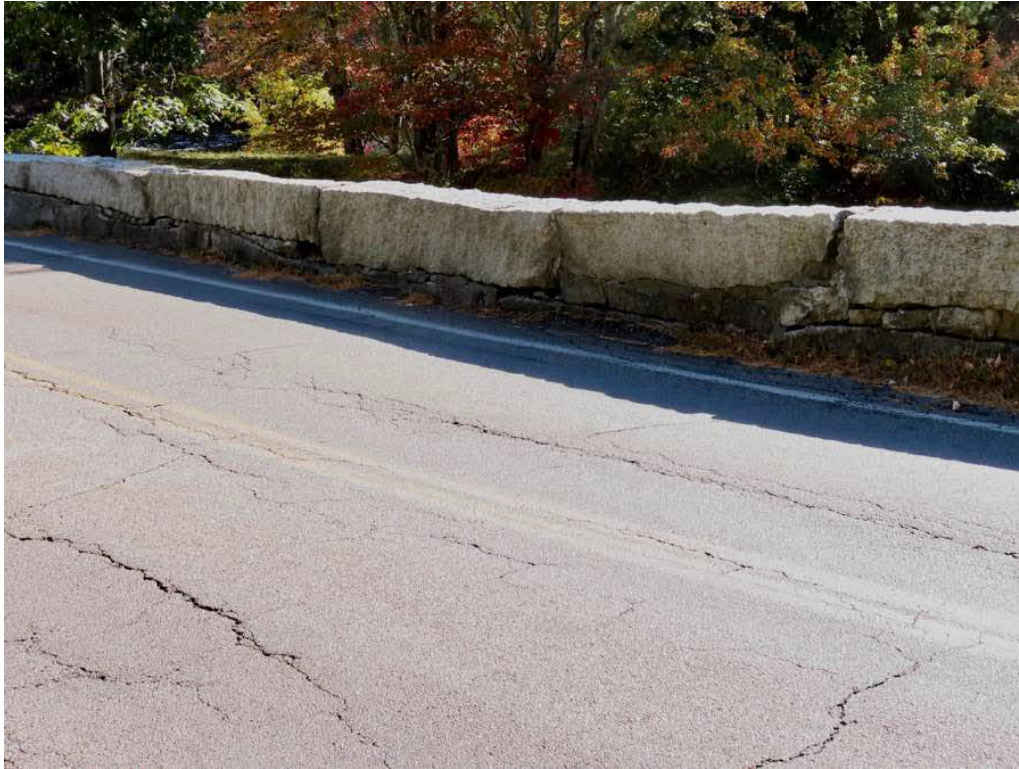
Photo 1: Cracking to the wearing surface.

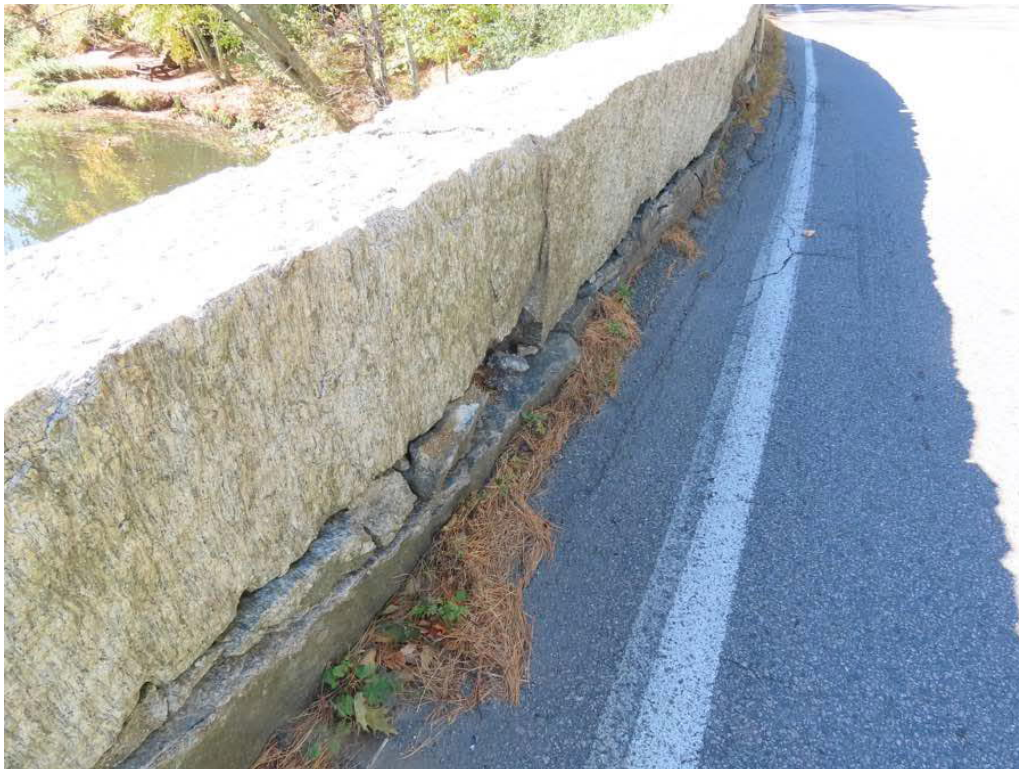
Photo 2: Minor misalignment of the parapet stones. South parapet.

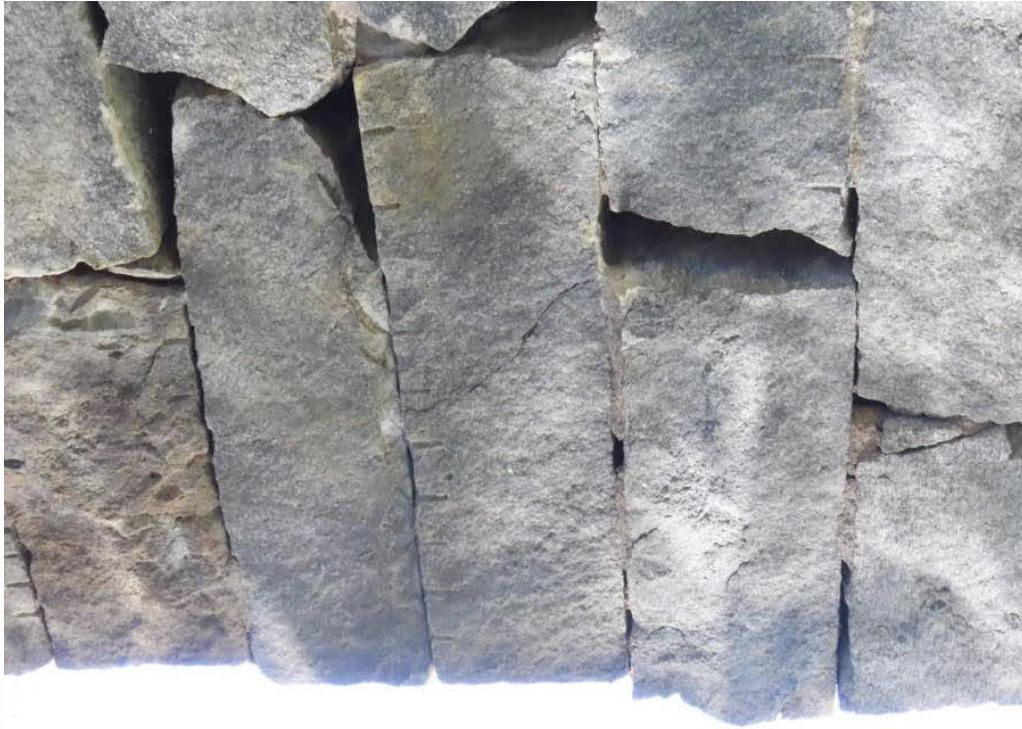
Photo 7: Cracked South archring stone near the keystone.

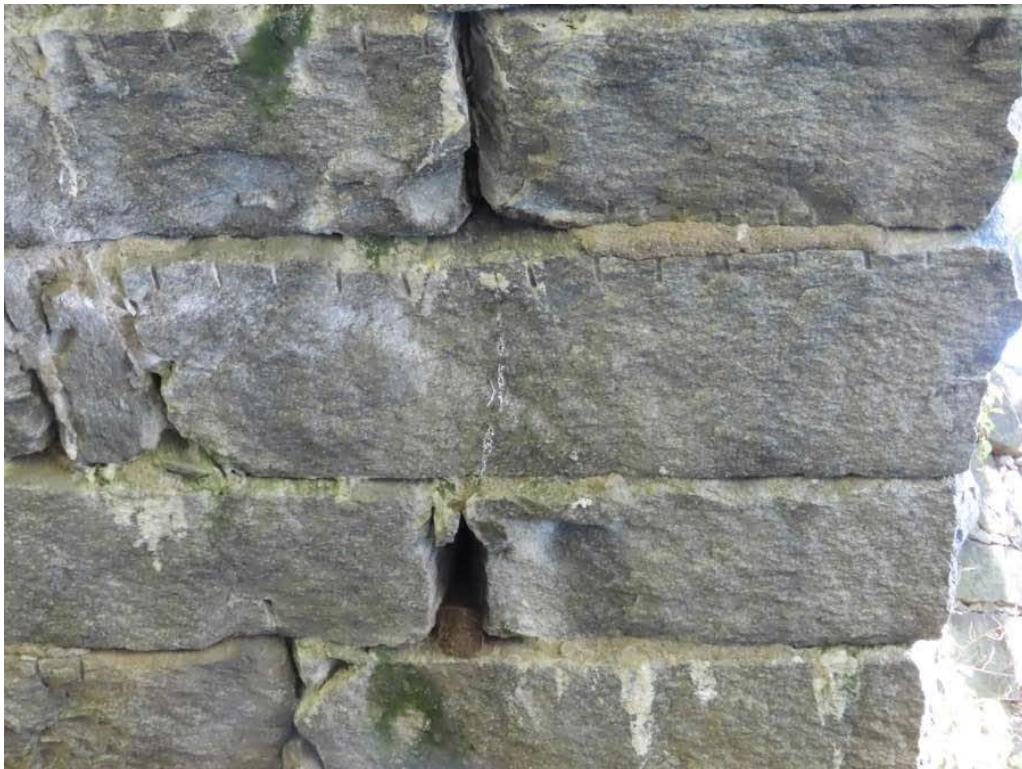
Photo 8: Cracked South archring stone above East breastwall.

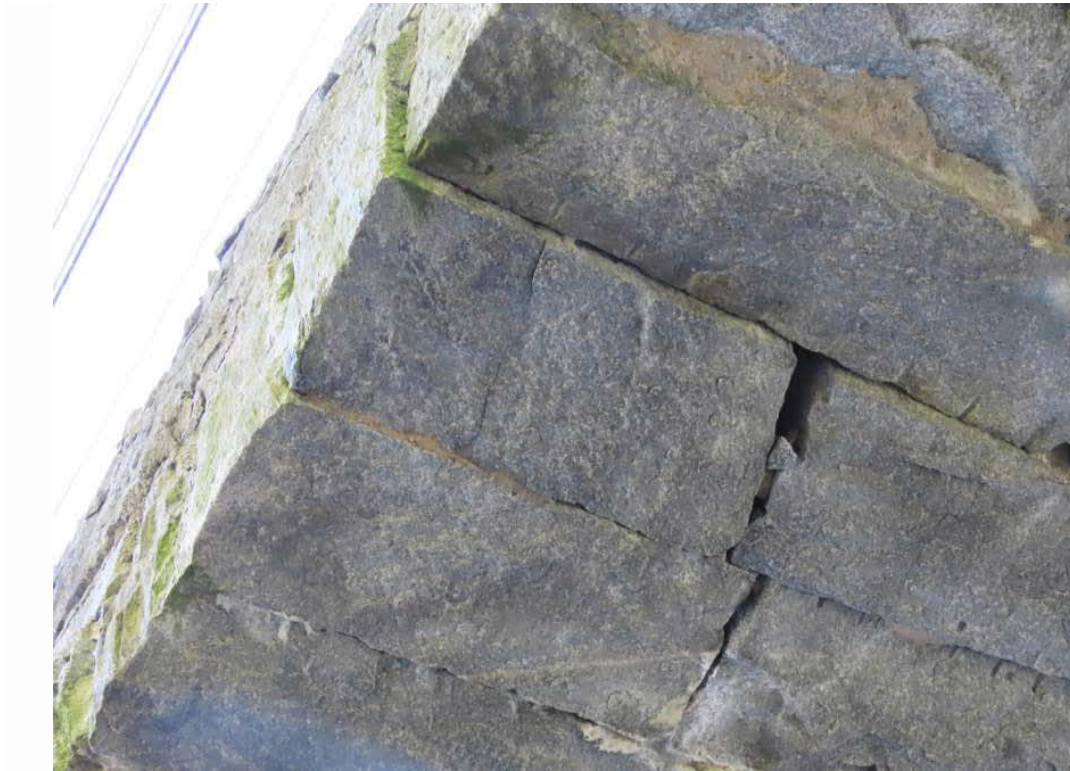
Photo 9: Cracked North archring stone West of keystone.

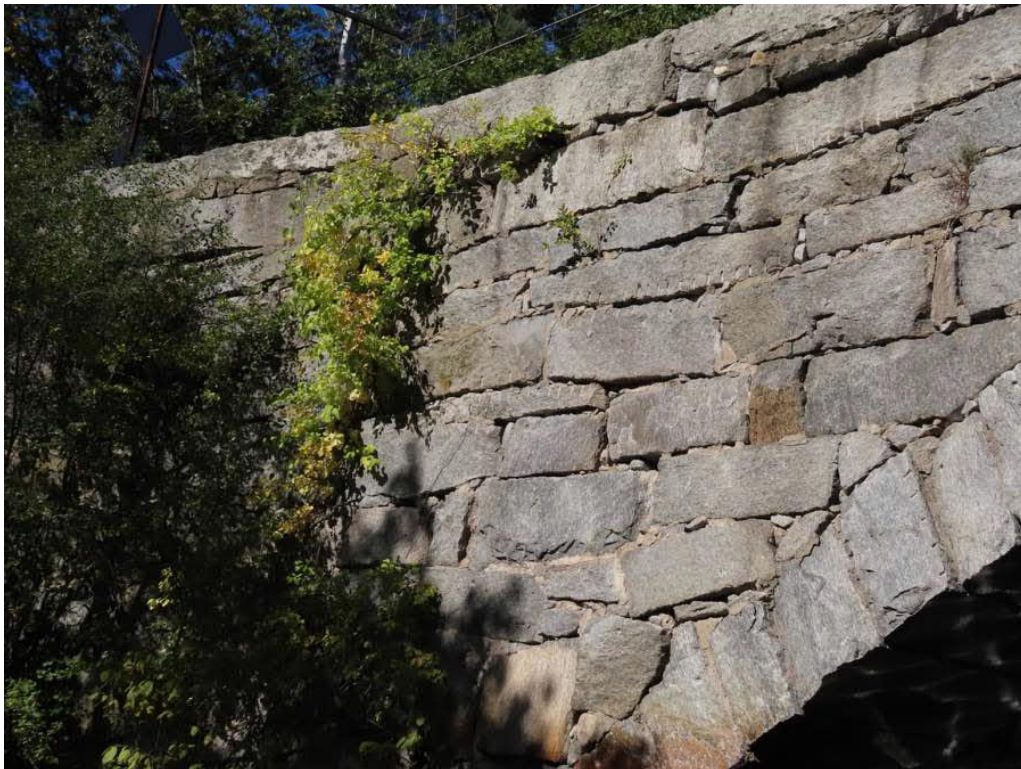
Photo 10: Vegetation growth at the West end of the South spandrel wall.

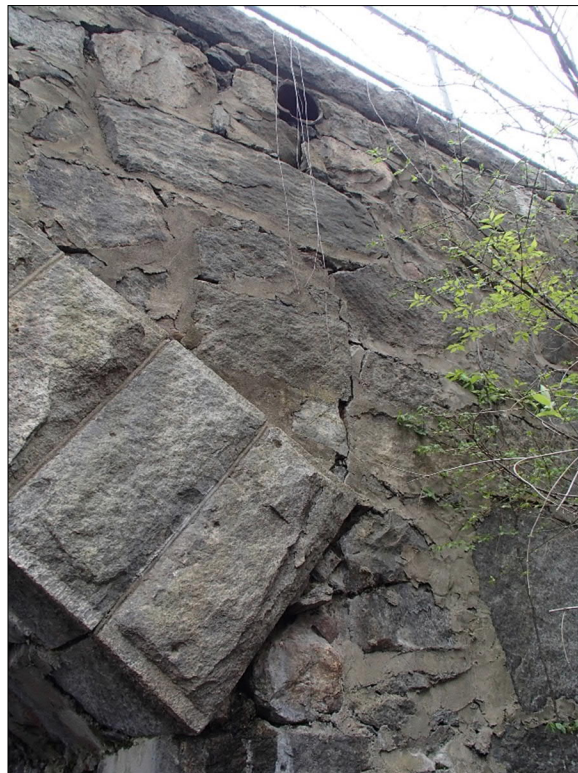
Photo 10 Looking Northwest: Crack at Northeast Corner

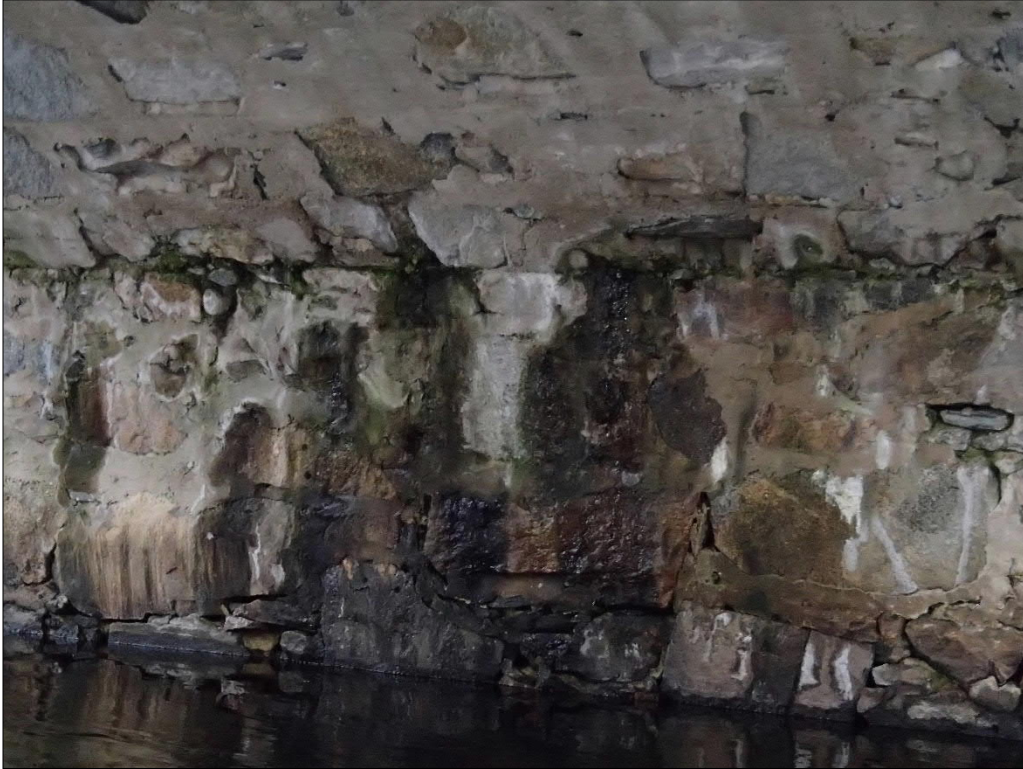
Photo 11 Looking South: South Abutment Water Stains

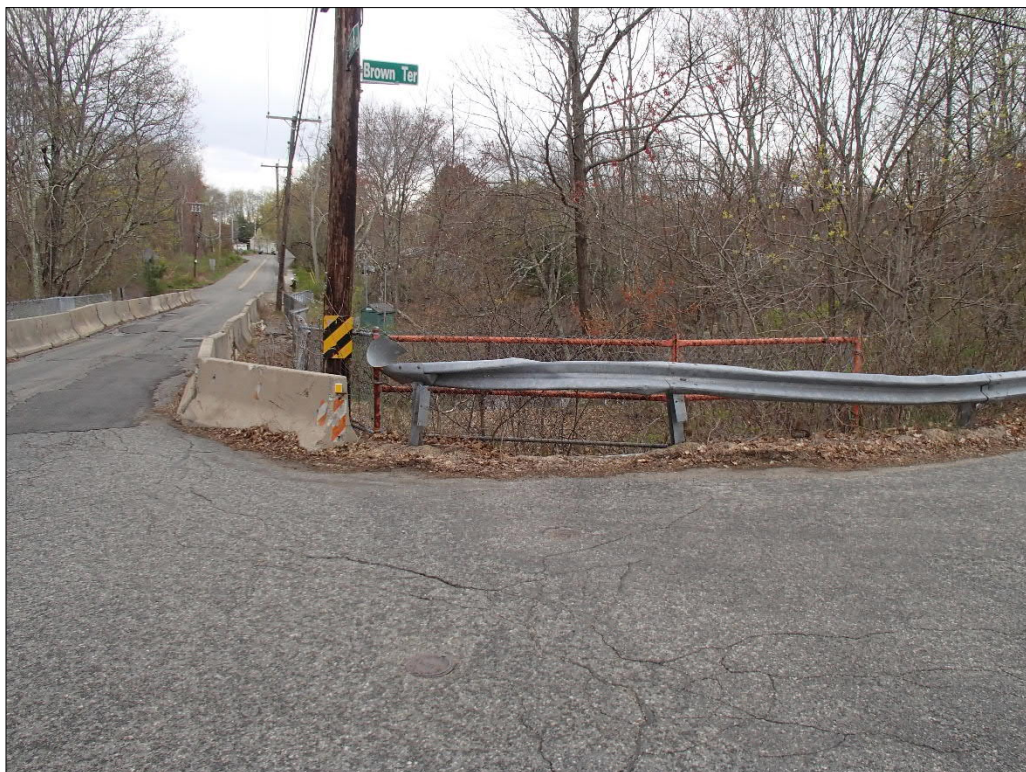
Photo 18 Looking North: Collision Damage on Southeast Approach Guardrail

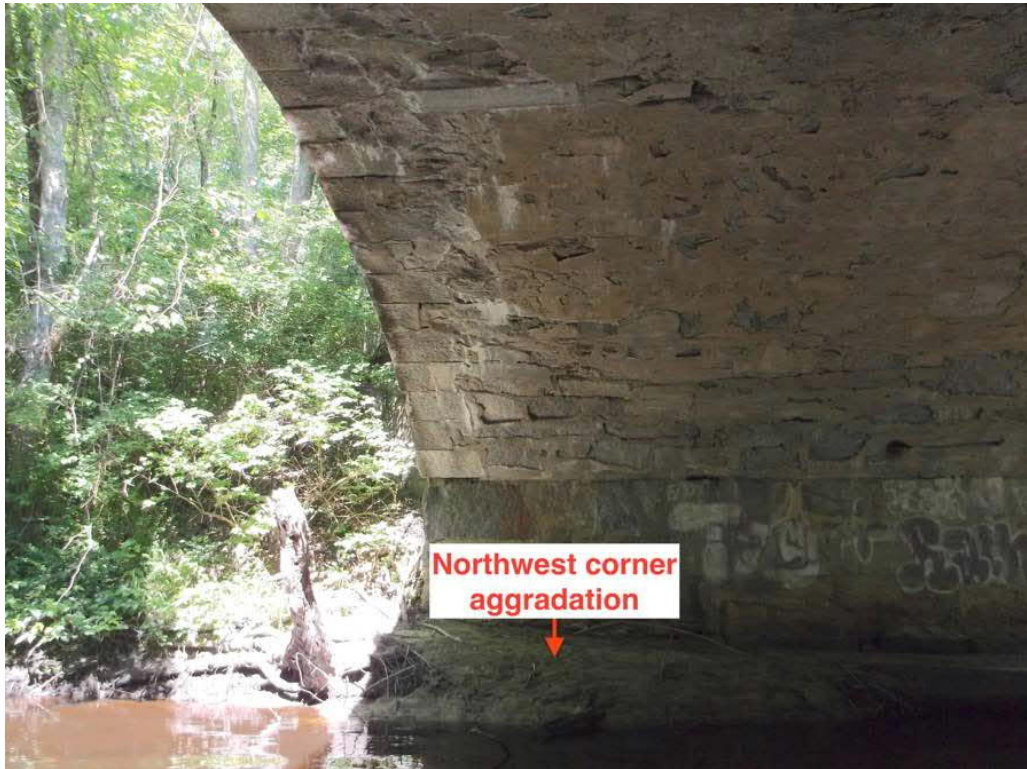
Photo 7: West side, looking North, concrete cover deterioration and aggradation.

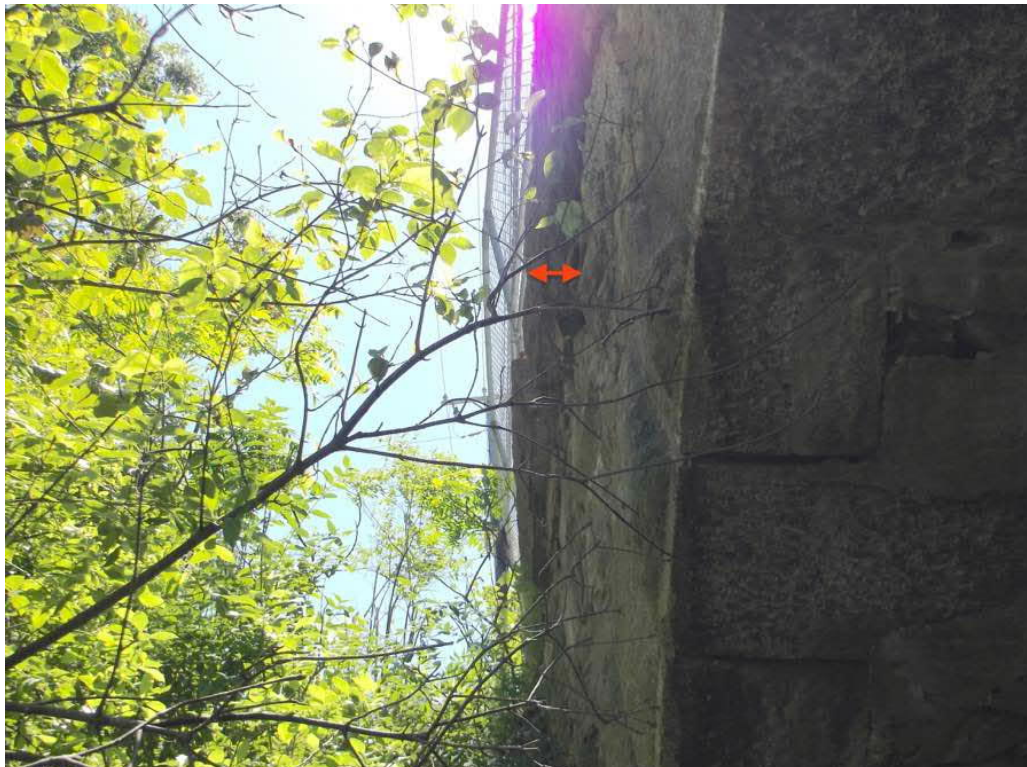
Photo 8: East spandrel wall South end, looking South, capstone displacement.

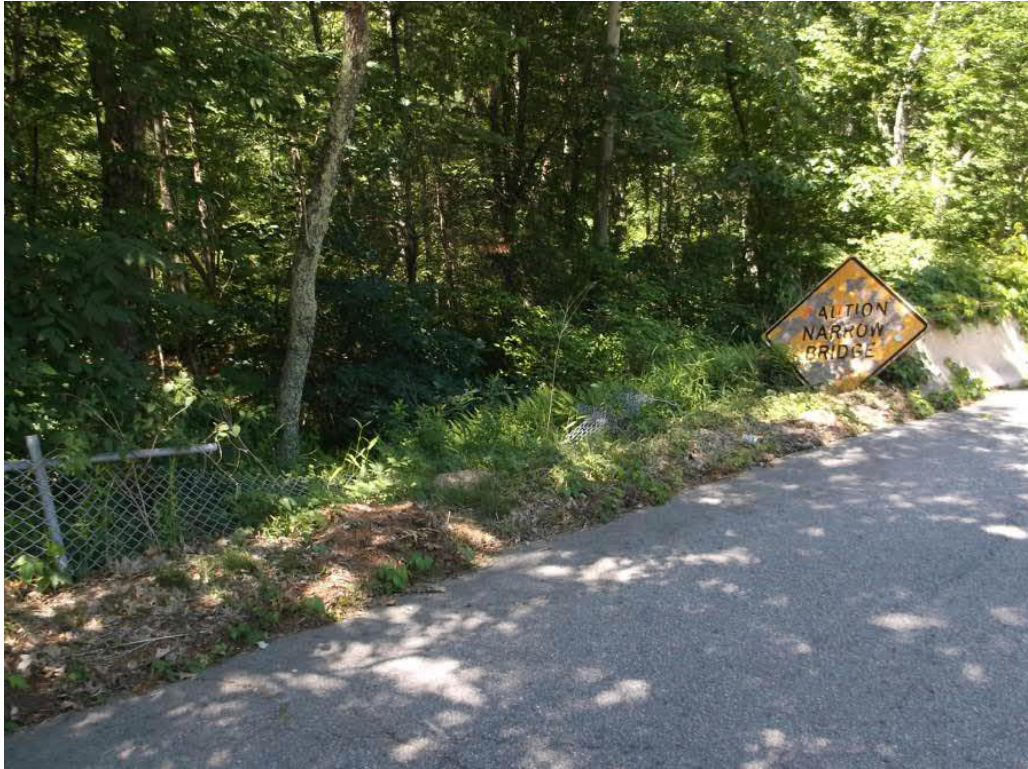
Photo 13: Southwest approach rail damage.

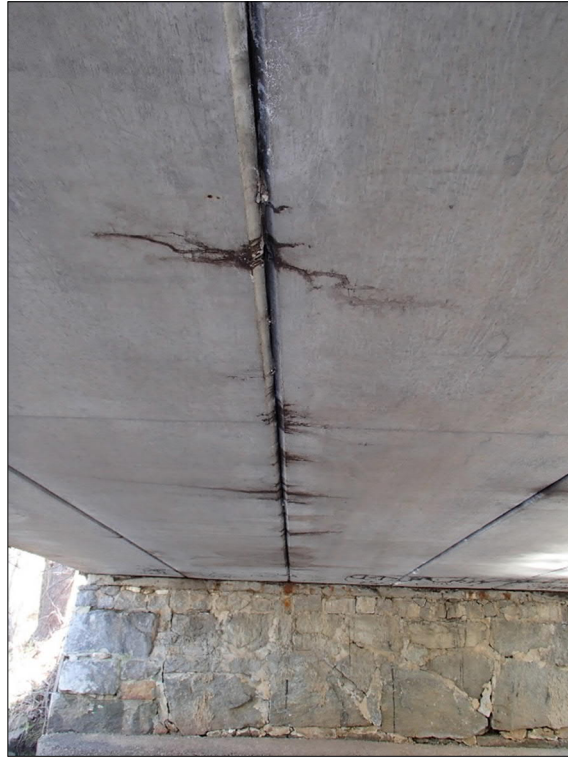
Photo 9 Looking East: Cracking and Staining at Beam Joints

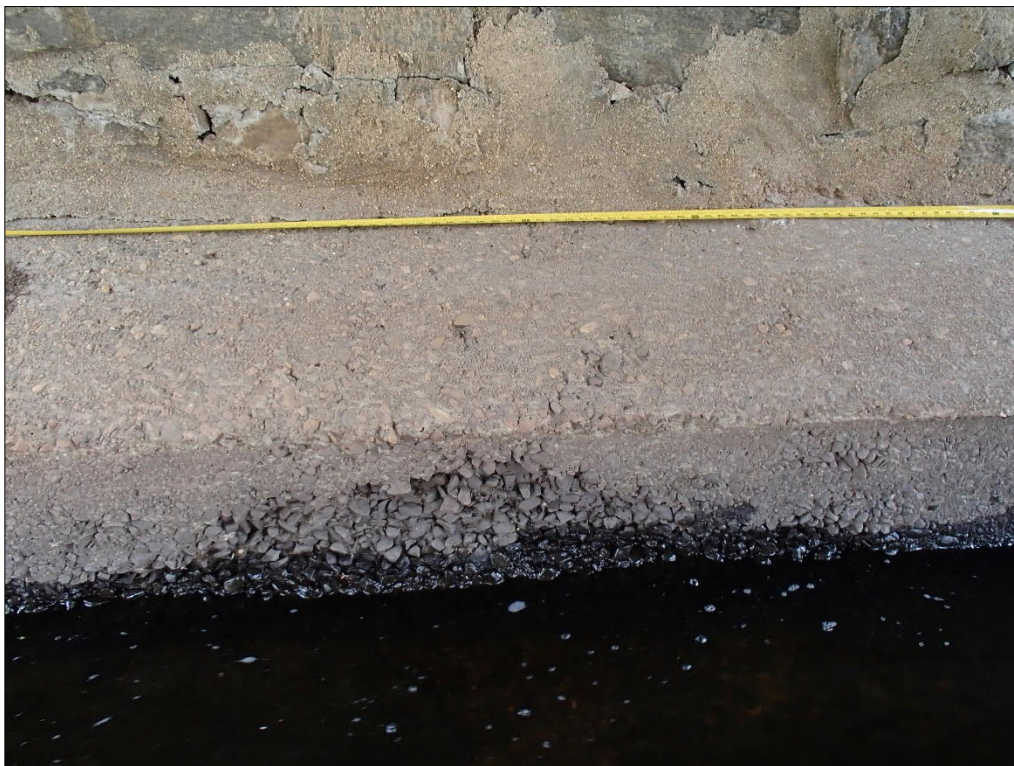
Photo 10 Looking West: Scaling and Abrasion at Concrete Apron

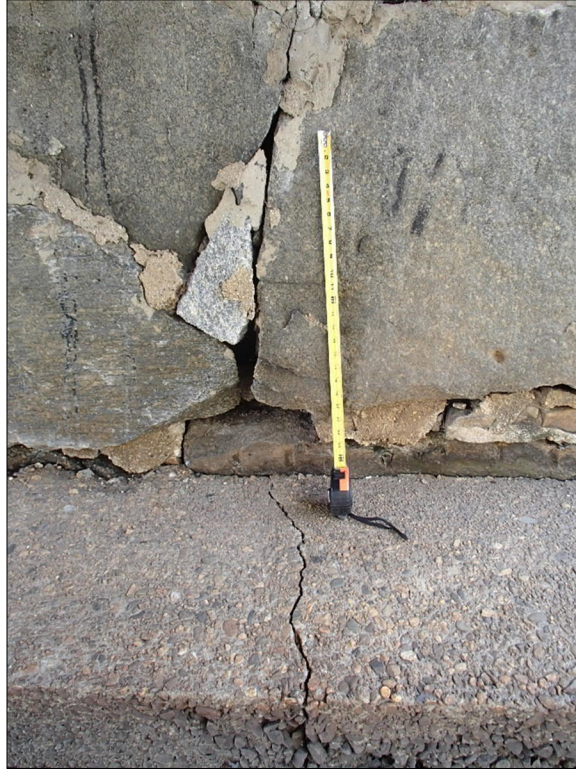
Photo 11 Looking West: West Abutment Voids and Apron Cracking

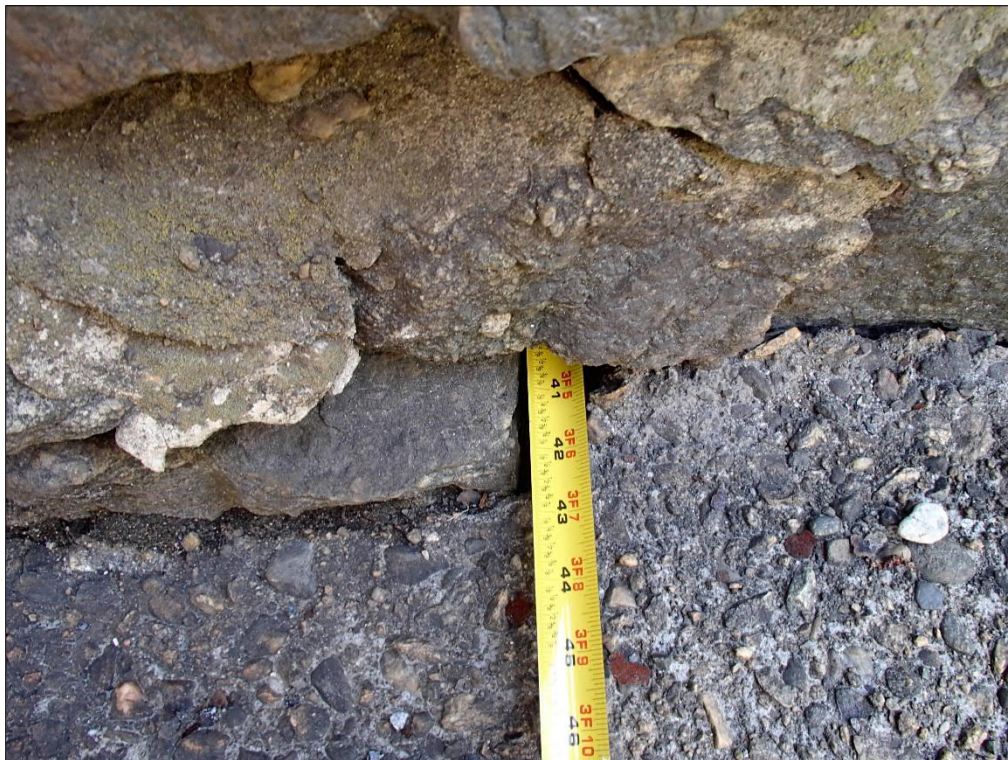
Photo 12 Looking East: Void at East Abutment

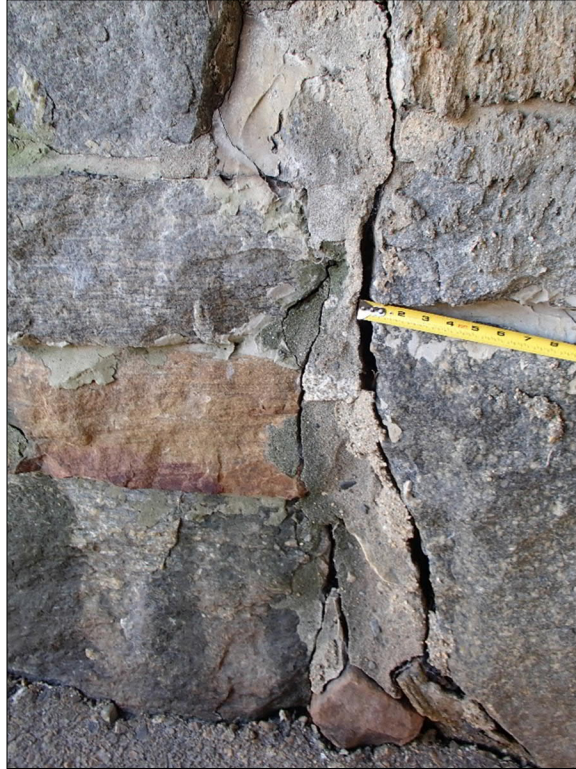
Photo 13 Looking East: Full Height Crack at East Abutment

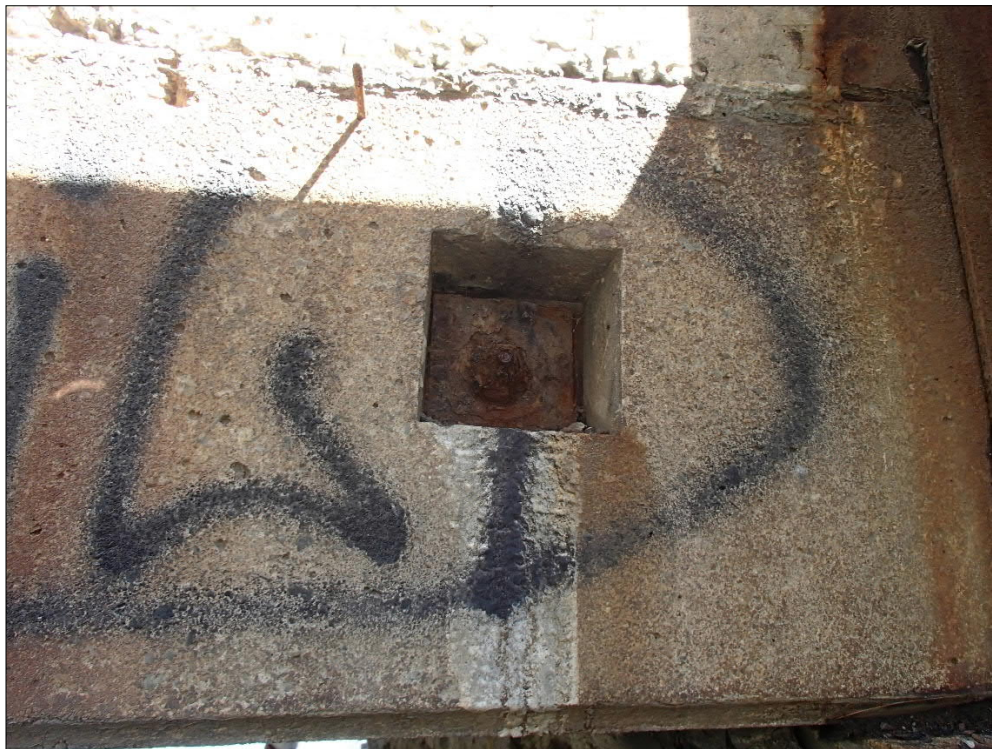
Photo 14 Typical Corrosion of Post Tension Ties
