Uxbridge, Massachusetts
Evaluation Report
Project Number: 7533
June 2021

BRIDGE / CULVERT MANAGEMENT PLAN

Prepared by: BETA GROUP, INC.
Prepared for: Town of Uxbridge

June 2021

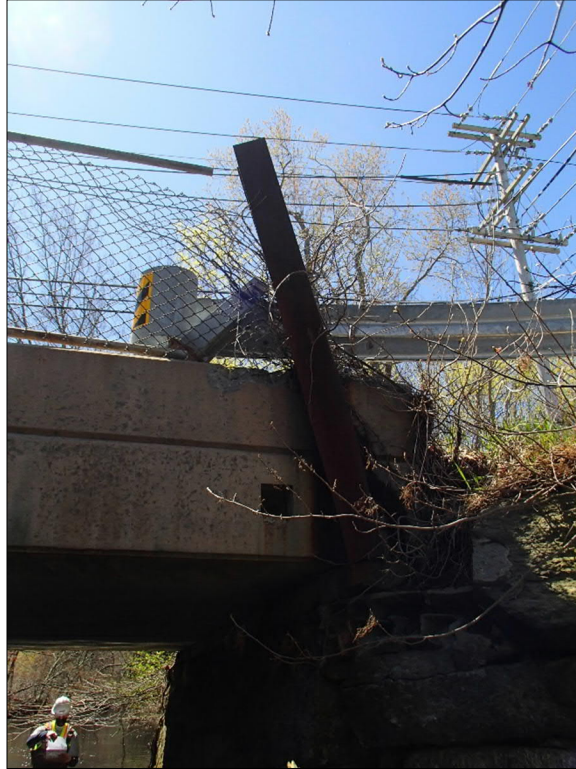
Photo 21 Looking Southwest: Post Damage at North Approach Guardrail

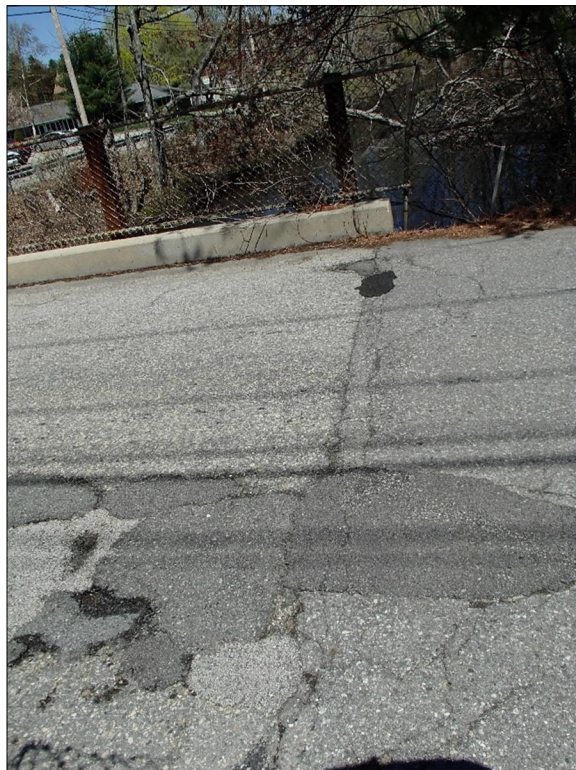
Photo 22 Looking North: Cracking at East Joint

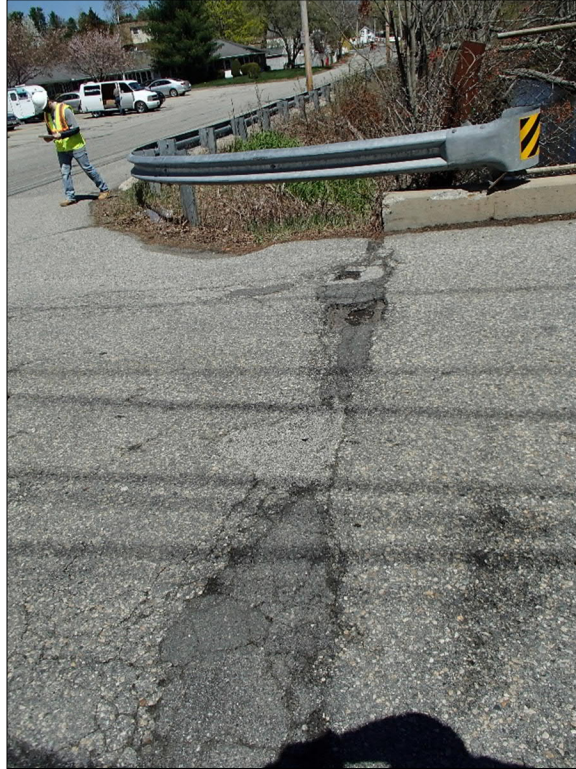
Photo 23 Looking North: Cracking at West Joint

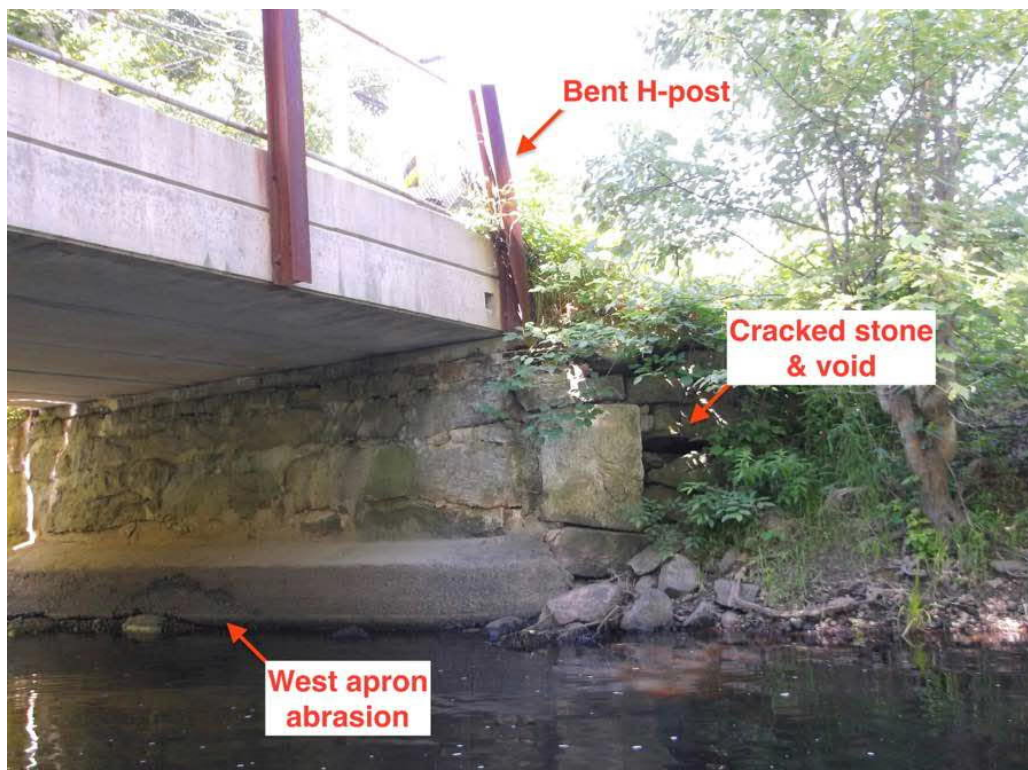
Photo 2: Bent North rail post, Northwest wingwall void, and West apron abrasion.

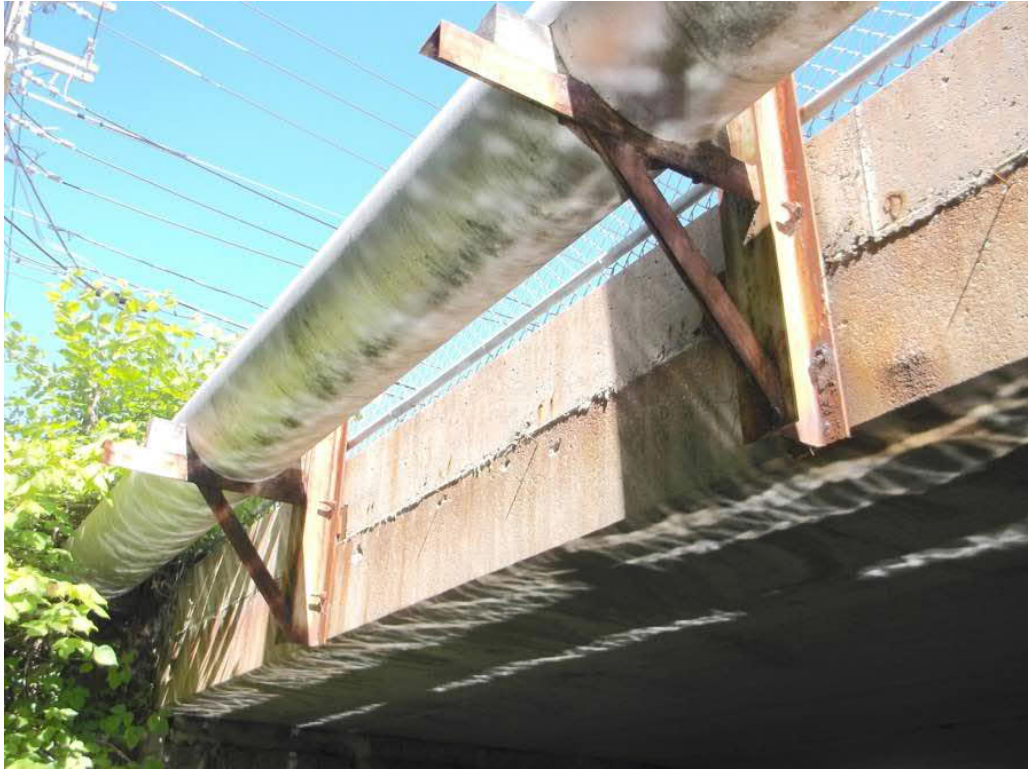
Photo 3: South fascia, rusted utility supports.

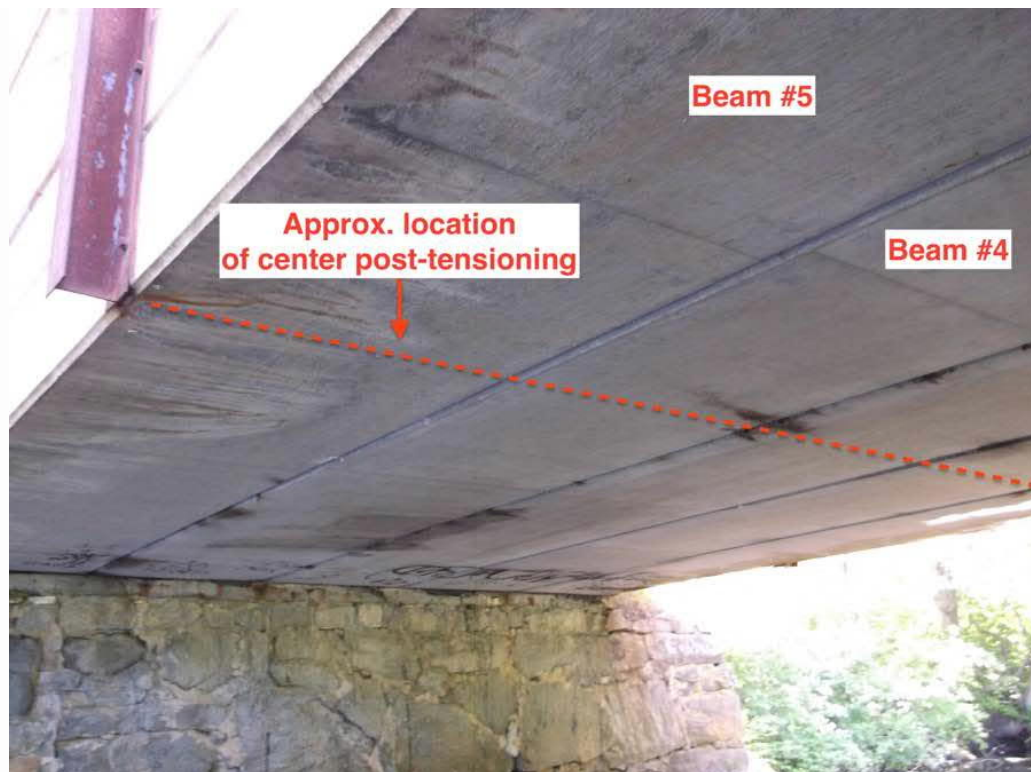
Photo 5: Underside of beams looking Southeast, typical moisture stains.

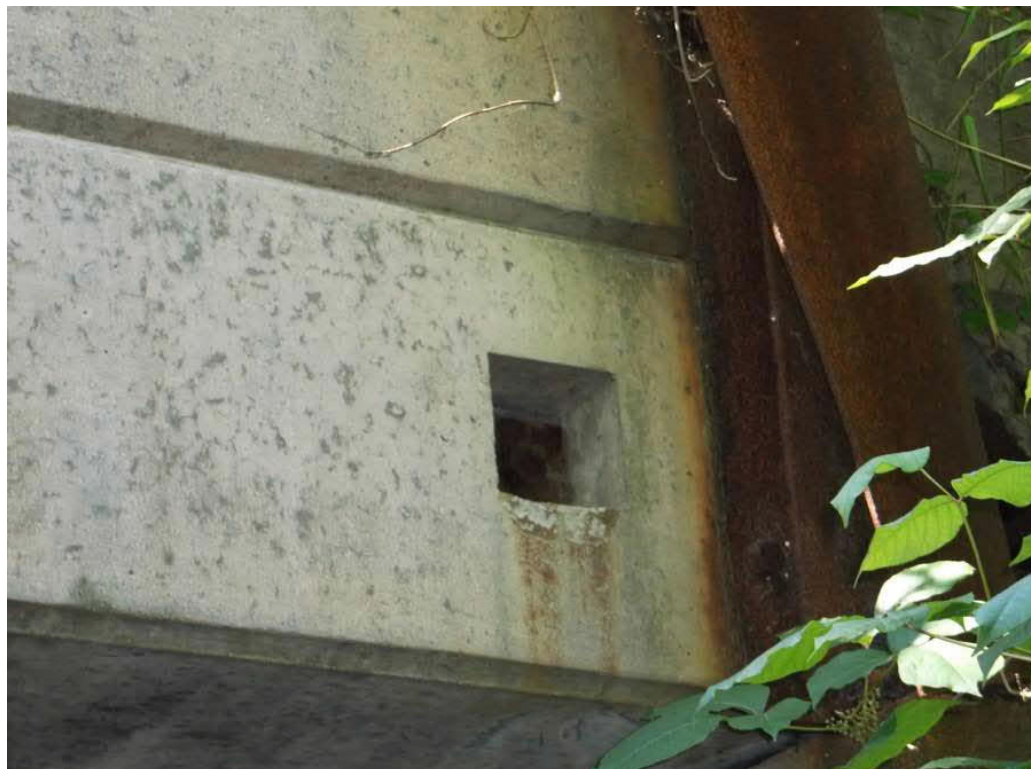
Photo 6: Northwest post-tensioning hole, typical rusted assembly.
