Uxbridge, Massachusetts
Evaluation Report
Project Number: 7533
June 2021

BRIDGE / CULVERT MANAGEMENT PLAN

Prepared by: BETA GROUP, INC.
Prepared for: Town of Uxbridge

June 2021

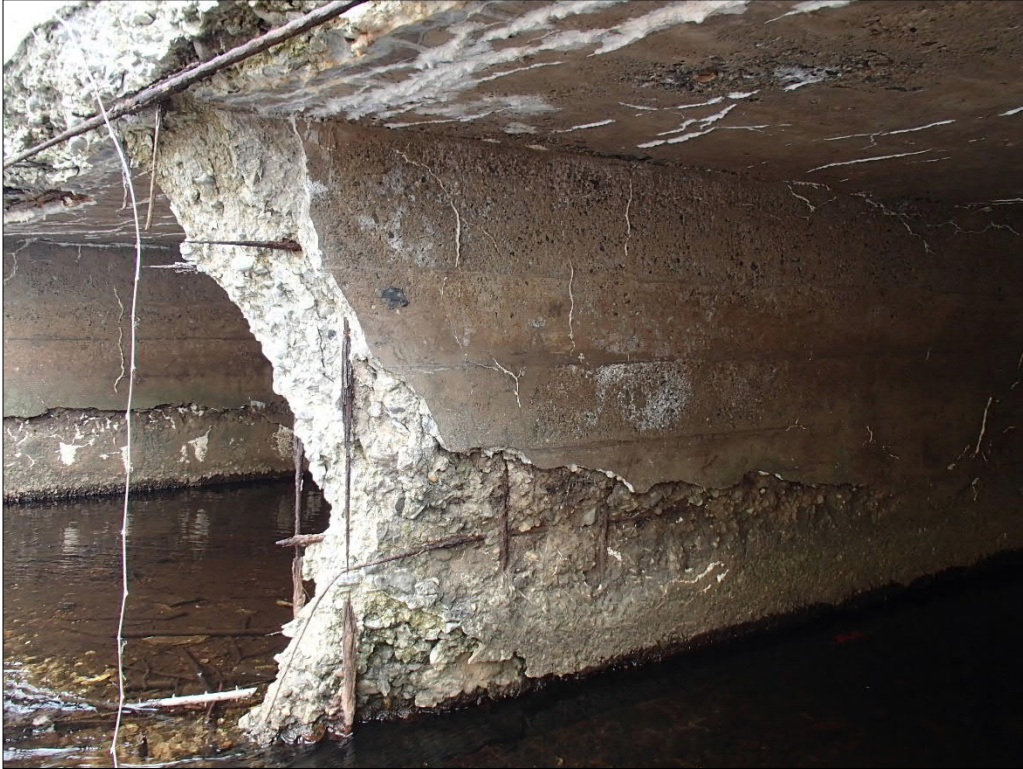
Substructure elements are also in poor condition. The abutments show moderate-to-heavy scaling up to 6" above the water line. Spalling and delamination is also typical at all four abutment corners (Photo 18). The center wall pier is in poor-to-critical condition with full length severe scaling and 3" deep spalls up to 2' above the waterline. The pier ends at both openings are experiencing advanced concrete deterioration with 100% section loss of exposed steel reinforcement (Photos 5 and 6).

Photo 5 Looking South: Center Pier

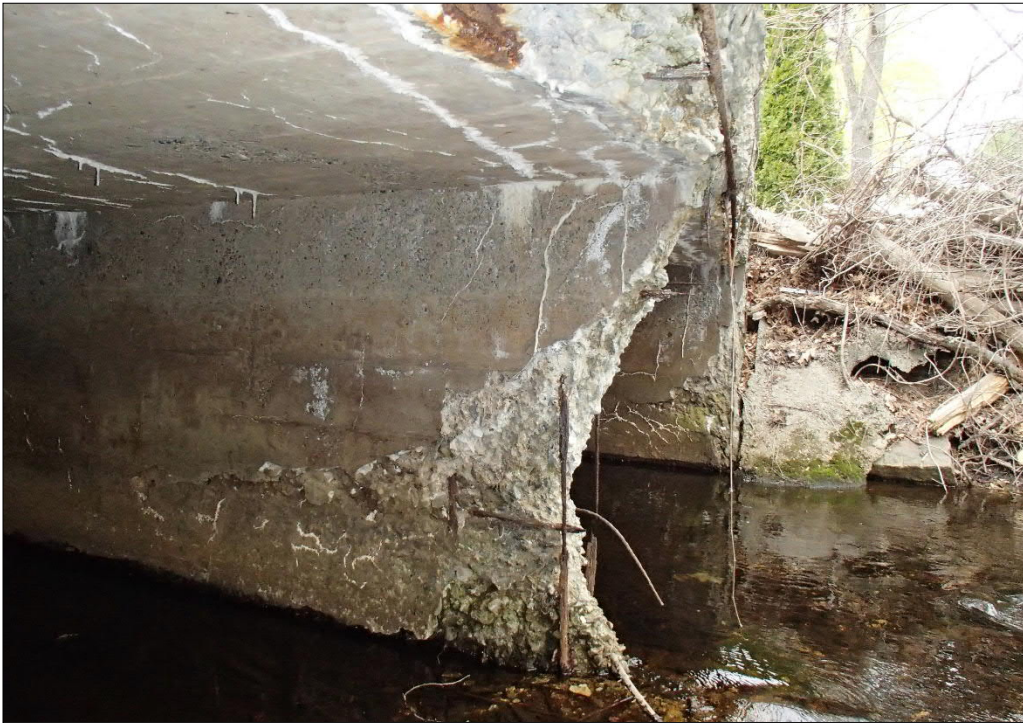
Photo 6 Looking North: Center Pier

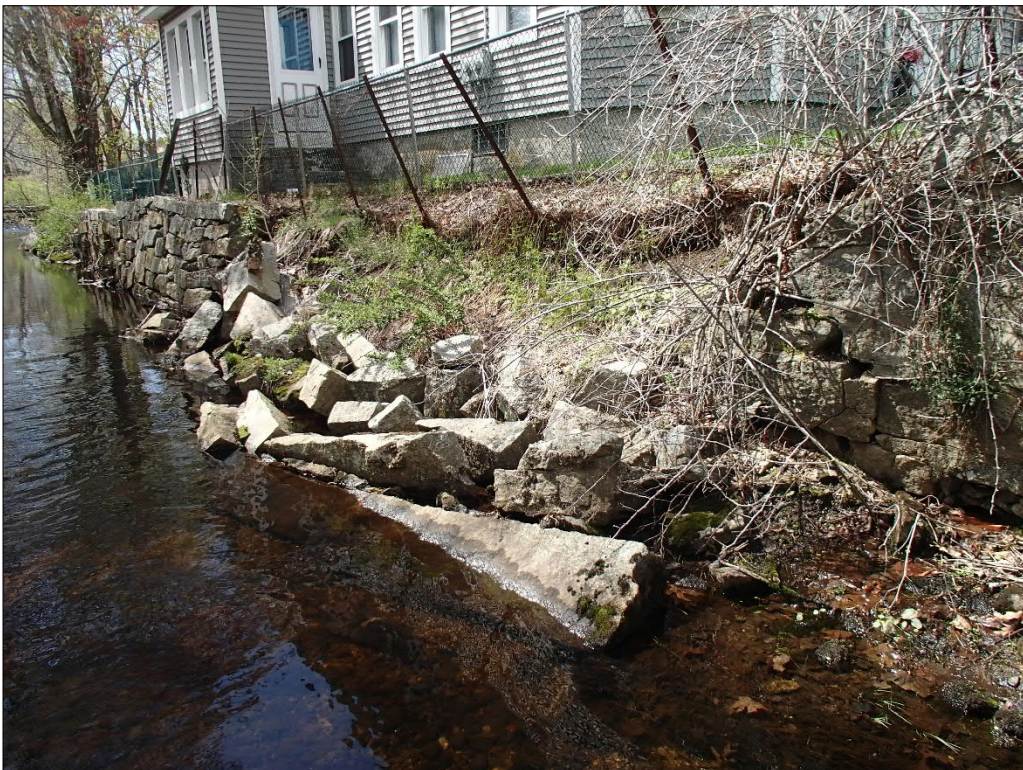
All four wingwall surfaces also exhibit 100% delamination with areas of heavy vegetation. Additionally, the northwest training wall which is located directly adjacent to a residential building has collapsed (Photo 16).

Photo 16 Looking Northwest: Northwest Training Wall

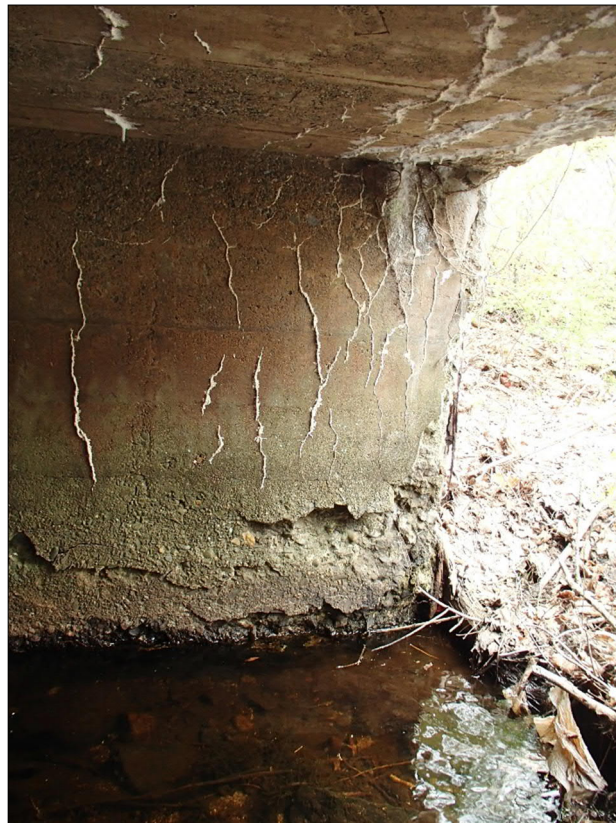
Photo 18 Looking South: Southwest Abutment Corner

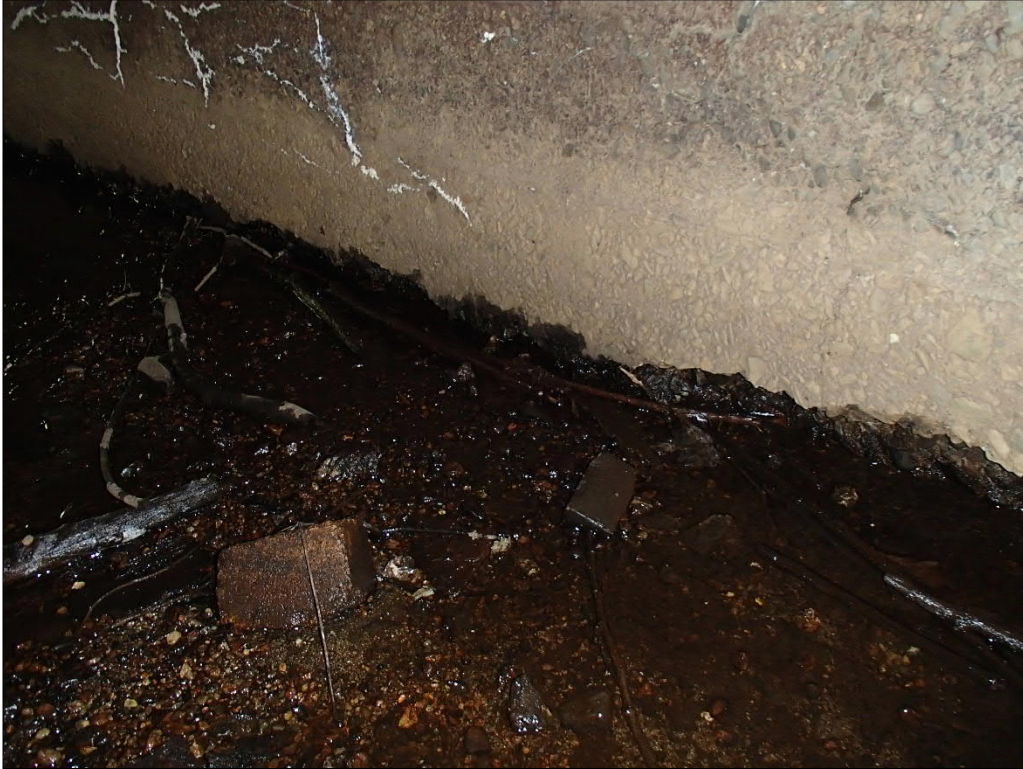
Photo 19 Looking North: Abrasion at Water Line

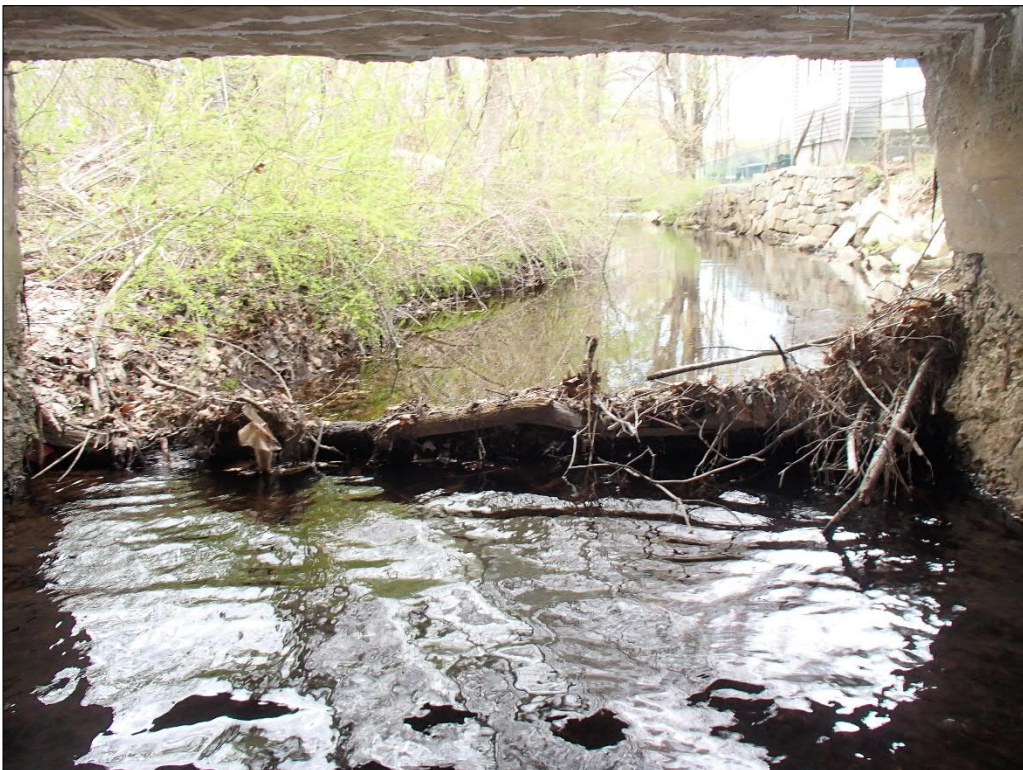
Waterway debris was present throughout and heaviest at the upstream opening, adjacent to the center pier (Photo 20).

Photo 20 Looking West: Debris at West Entrance

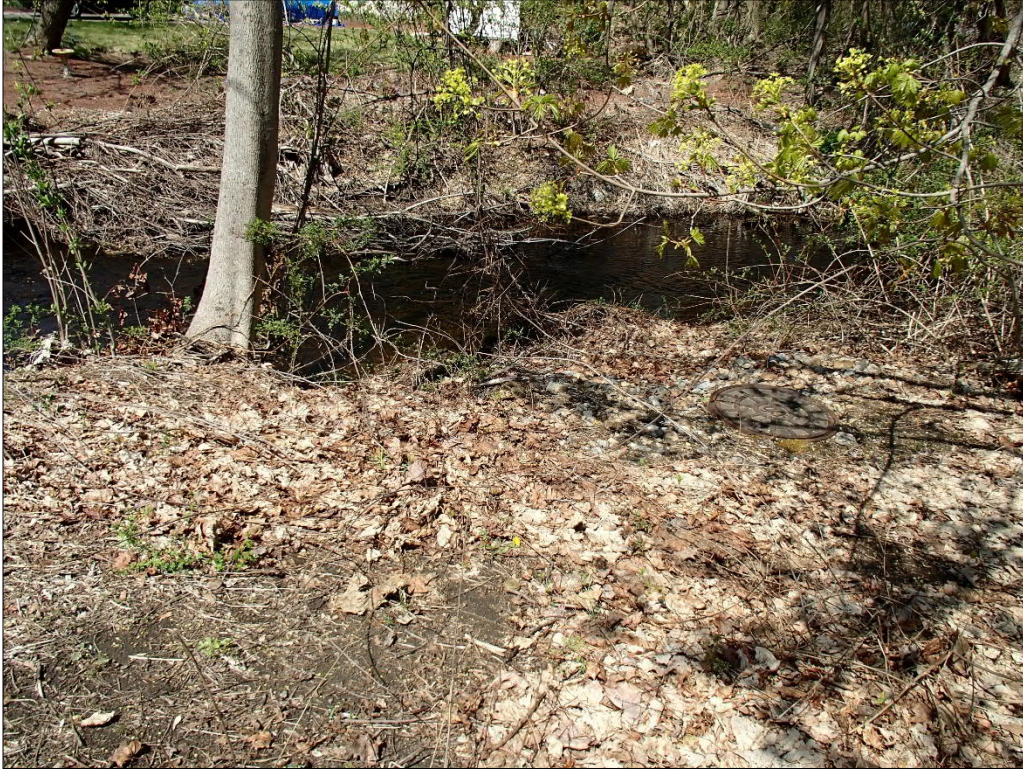
Utilities carried by the structure include overhead wires that run along the east side of the street, and sewer manholes at the north approach, south approach, and southeast embankment (Photo 21). However, it was unclear whether the sewer crosses above or below the culvert. Two catch basins are also present at the north approach and drain to outfalls located in the north abutment.

Photo 21 Looking East: Sewer Manhole on Southeast Embankment

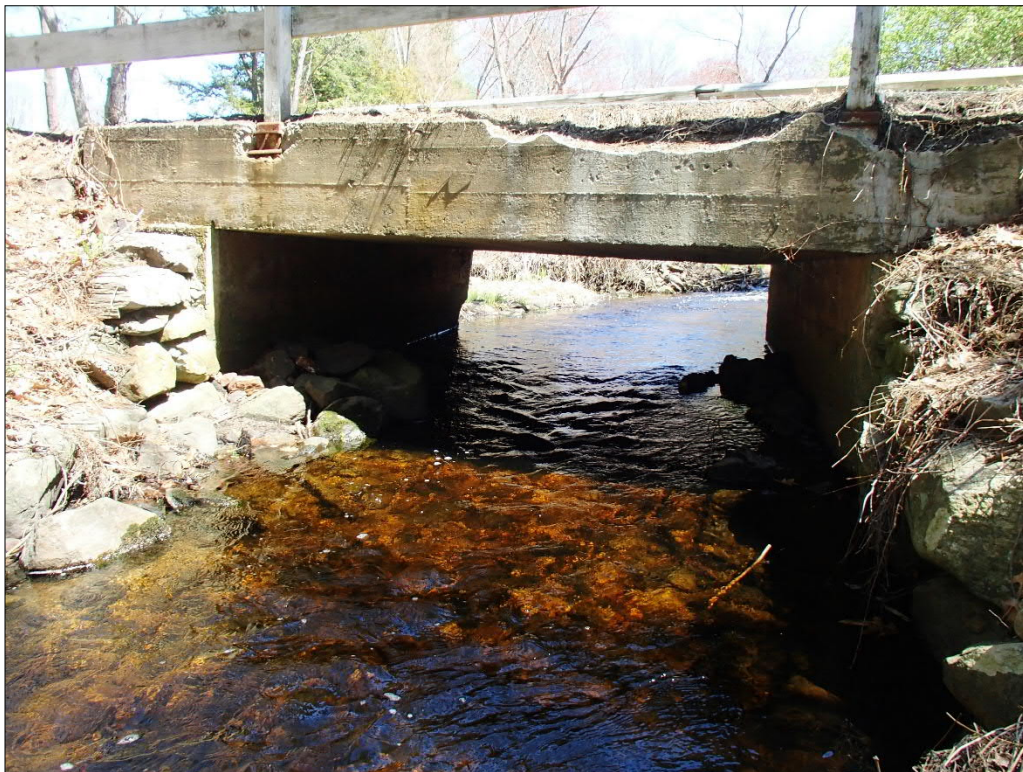
Photo 1 Looking West: East Culvert Elevation

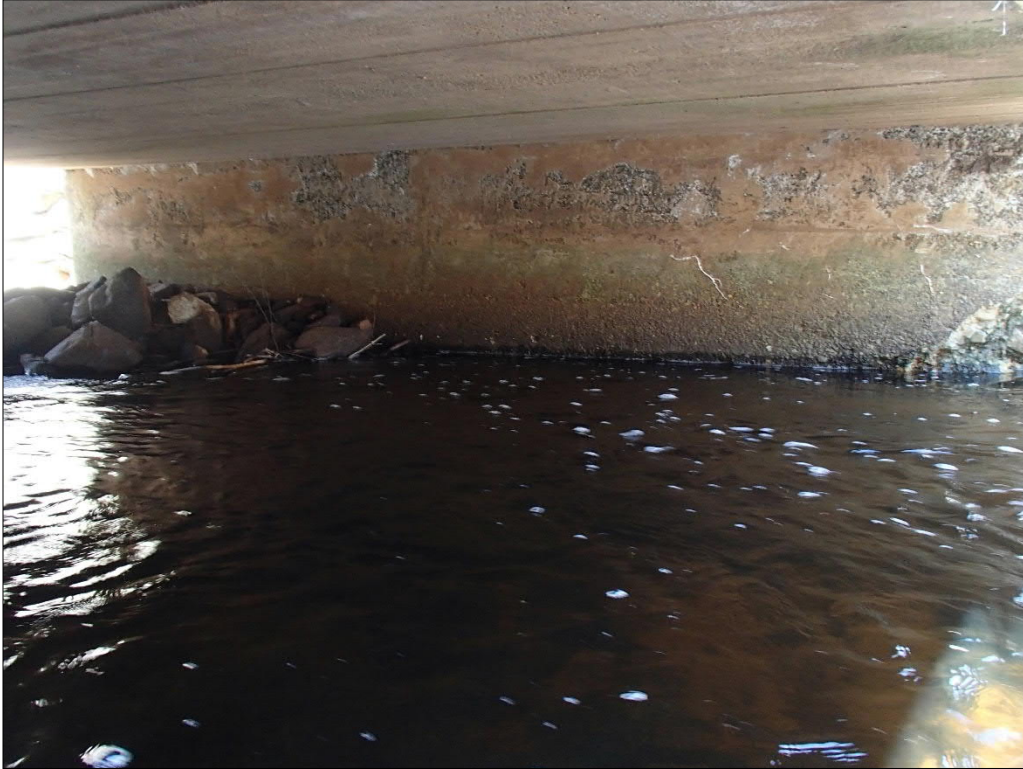
Photo 2 Looking East: West Culvert Elevation

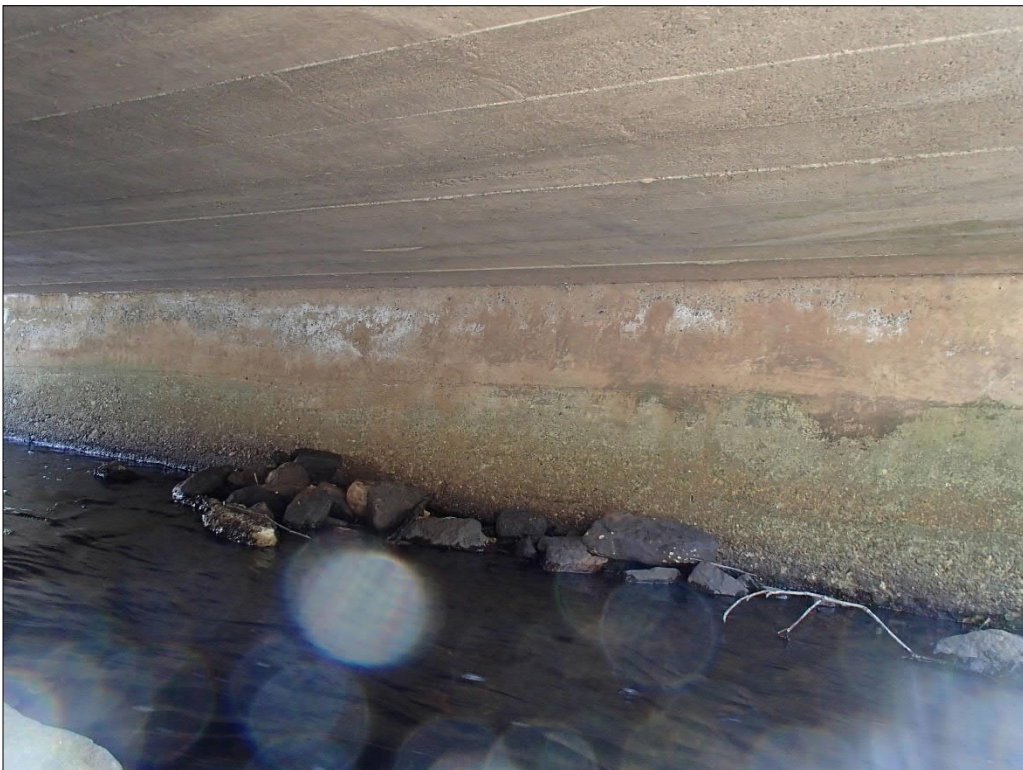
Photo 3 Looking North: North Abutment Elevation

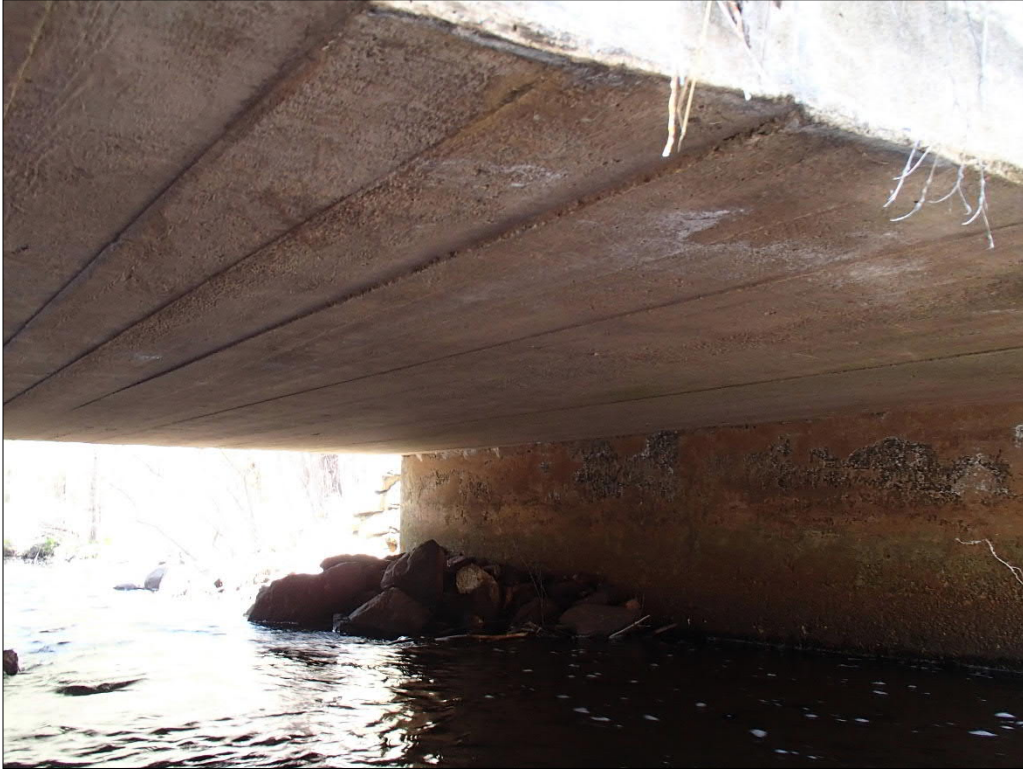
Photo 4 Looking South: South Abutment Elevation

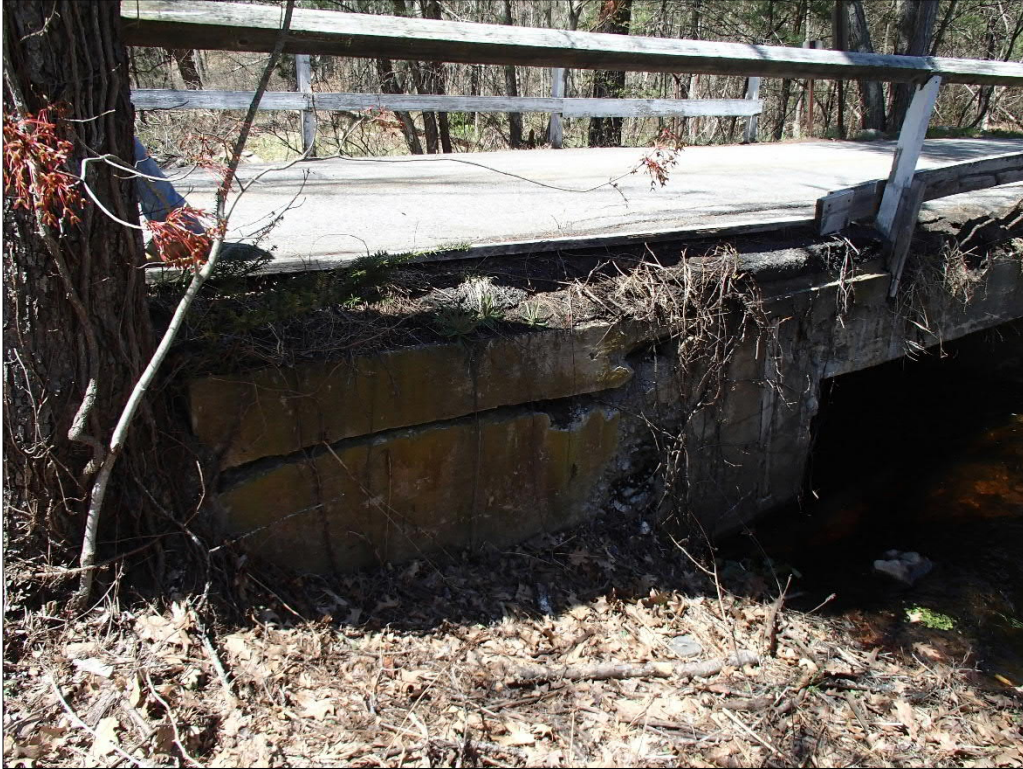
Photo 6 Looking West: Northeast Wingwall Elevation

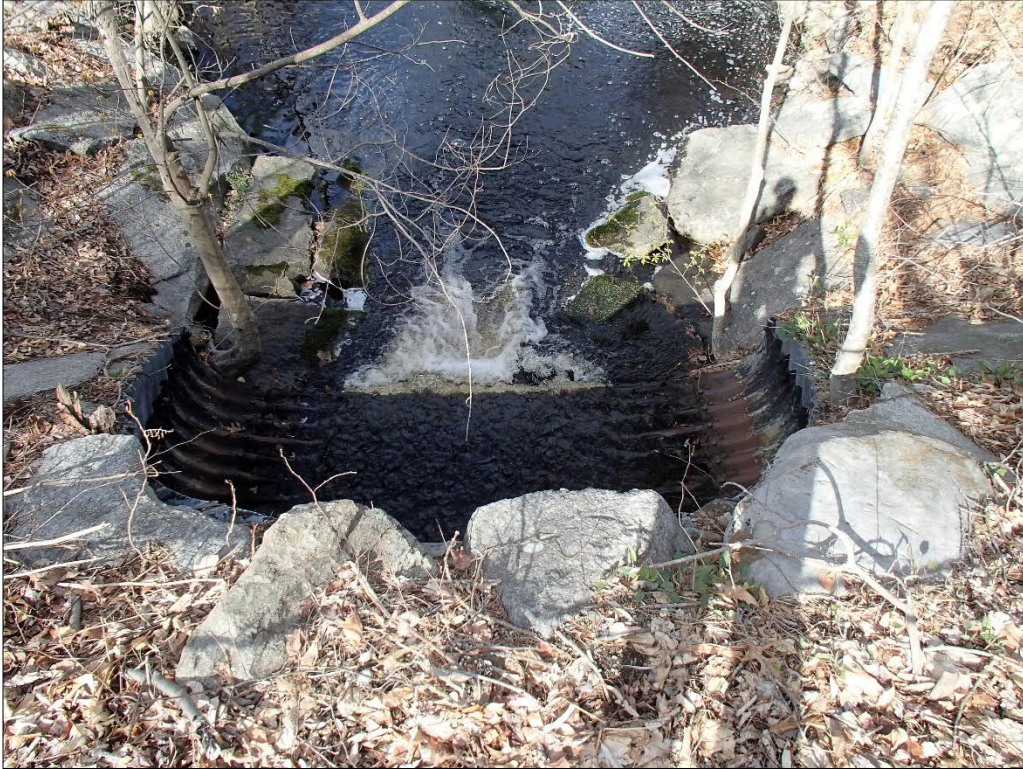
Photo 1 Looking West: West Culvert Entrance

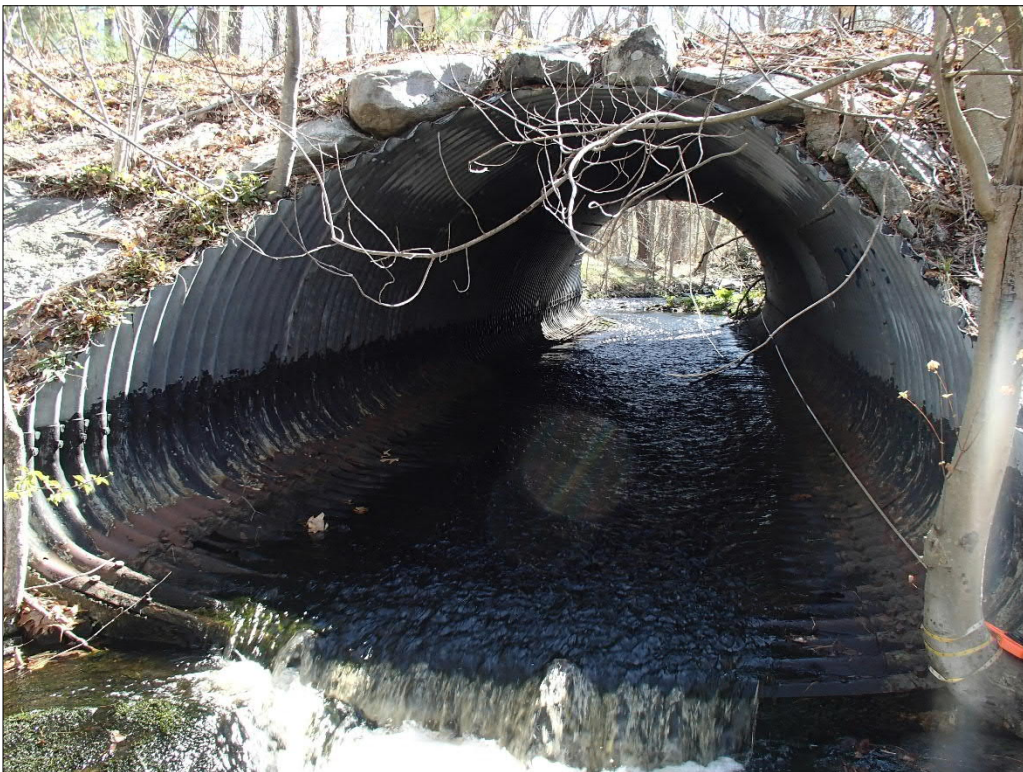
Photo 2 Looking East: West Culvert Elevation

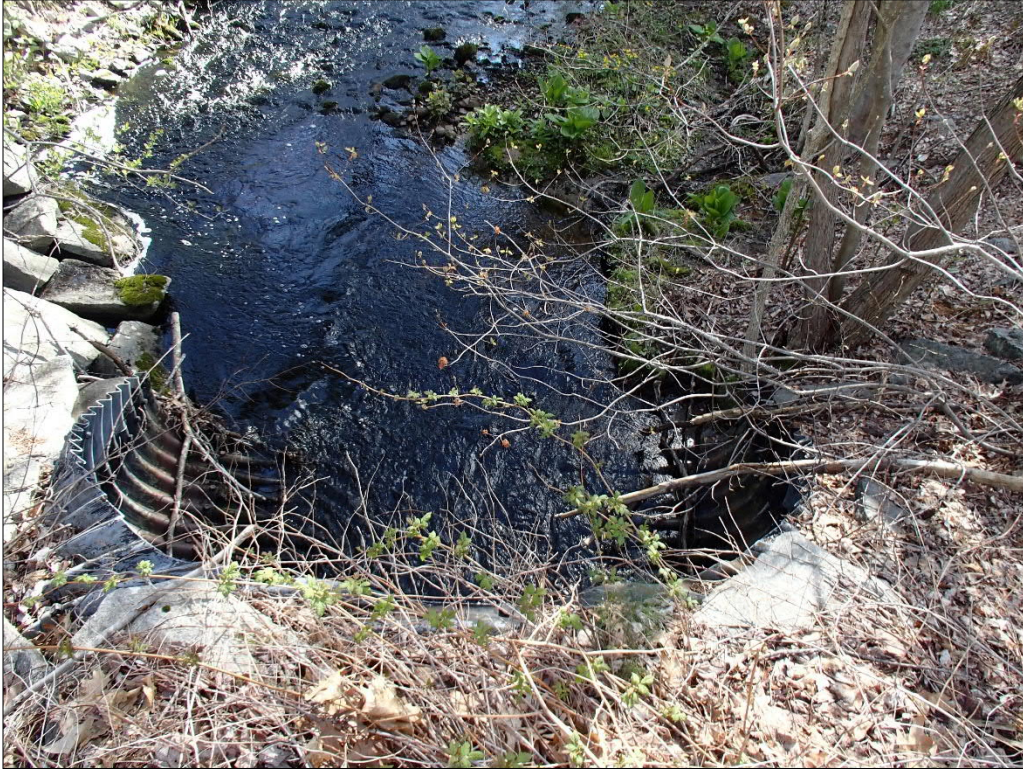
Photo 3 Looking East: East Culvert Entrance

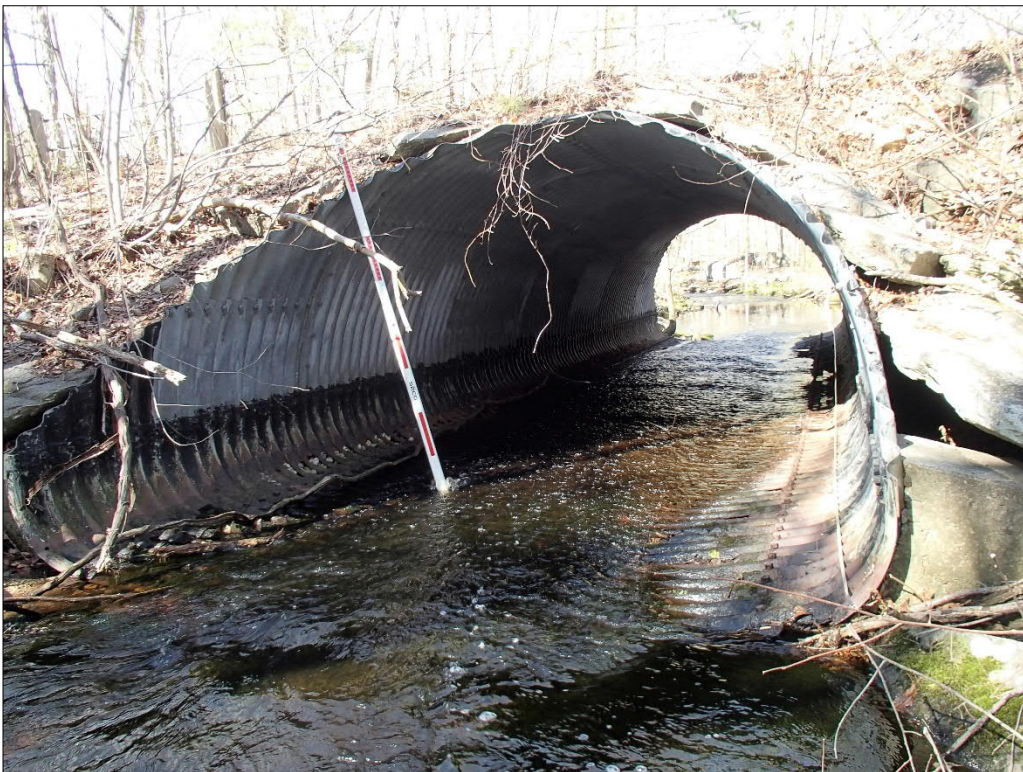
Photo 4 Looking West: East Culvert Elevation

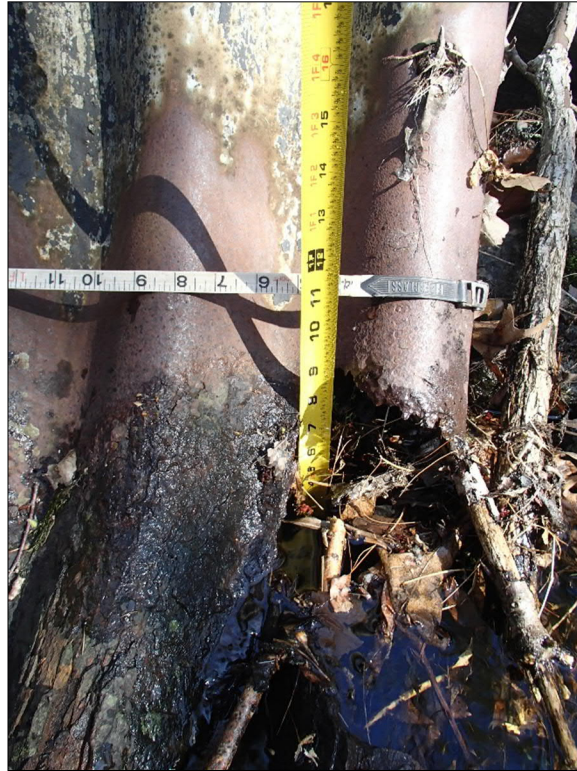
Photo 5 Looking North: Northeast Corner of Pipe

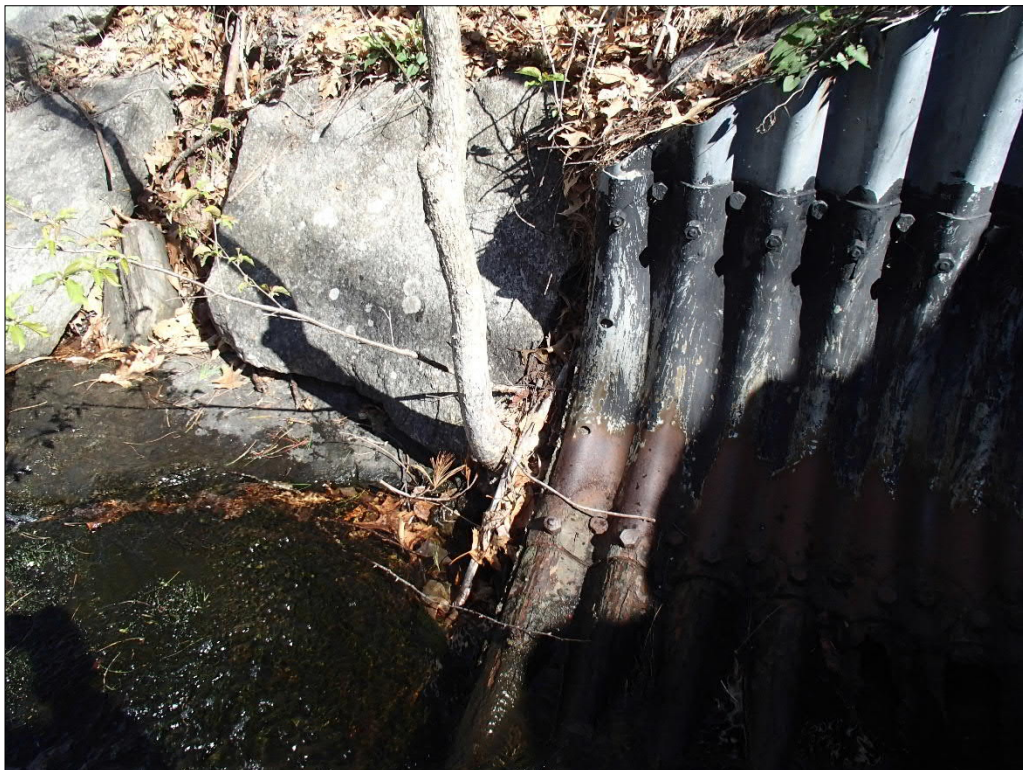
Photo 6 Looking North: Northwest Corner of Pipe

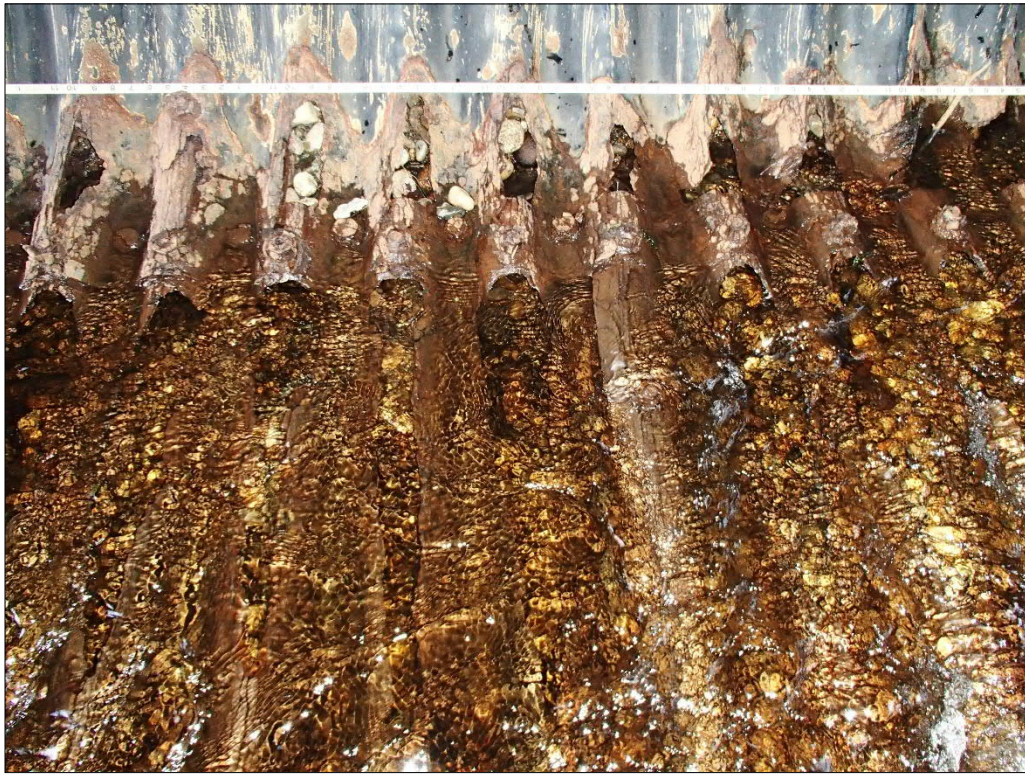
The corrugated pipe sidewalls and roof are in fair condition above the water line with no deficiencies noted. However, the pipe floor is in critical condition, showing heavy corrosion with voids and 100% section loss in some areas (Photo 7). Numerous holes in the floor were found to be typical due to advanced corrosion (Photos 6 and 8). Section loss was typical throughout the entirety of the pipe floor. It is also noted that the pipe is showing signs of distortion (Photo 14).

Photo 7 Looking North: North Wall of Pipe

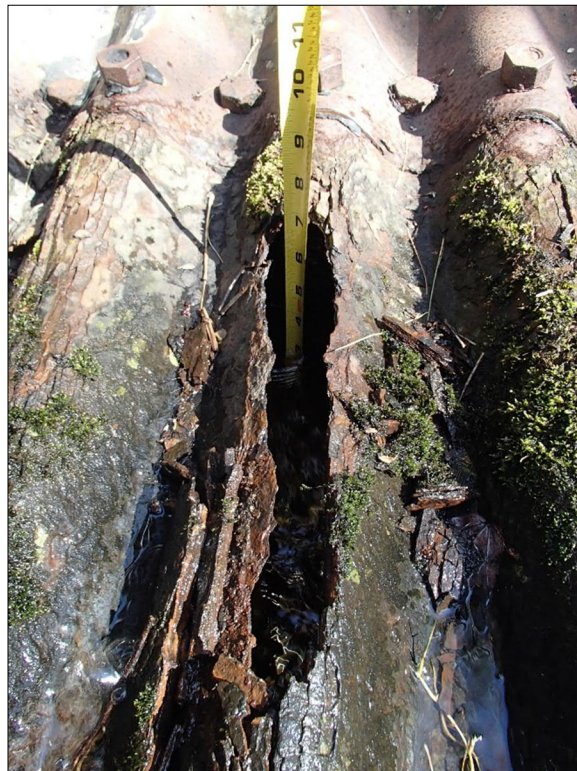
Photo 8 Looking North: Section Loss at North Wall of Pipe

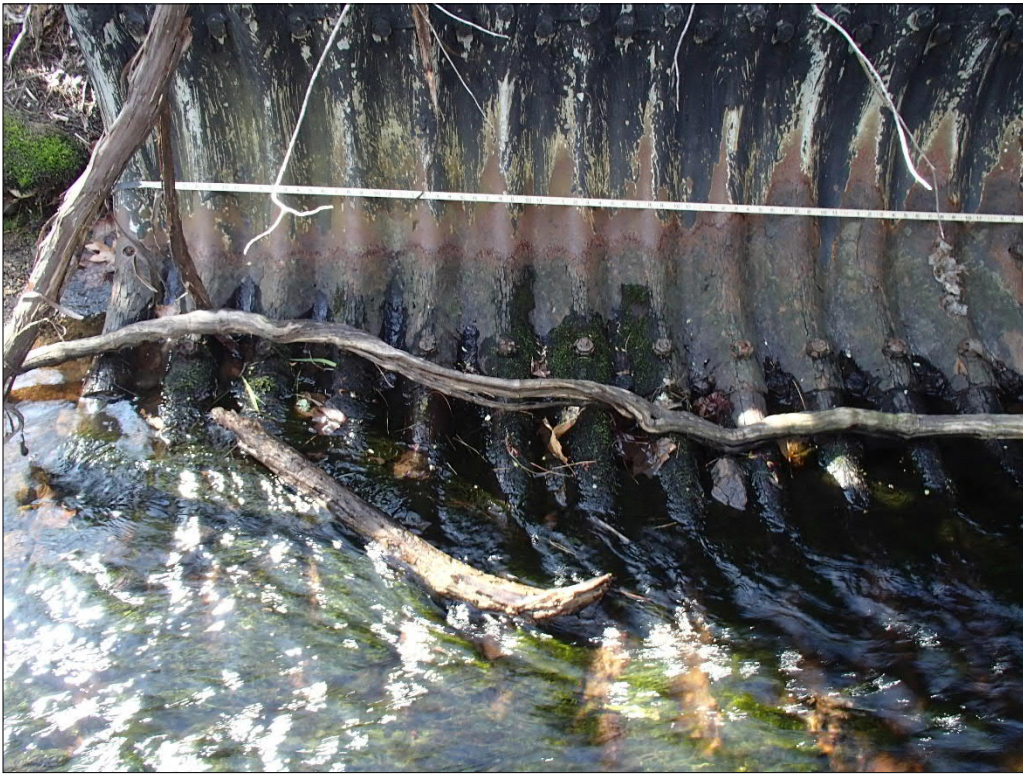
Photo 9 Looking South: Southeast Corner of Pipe

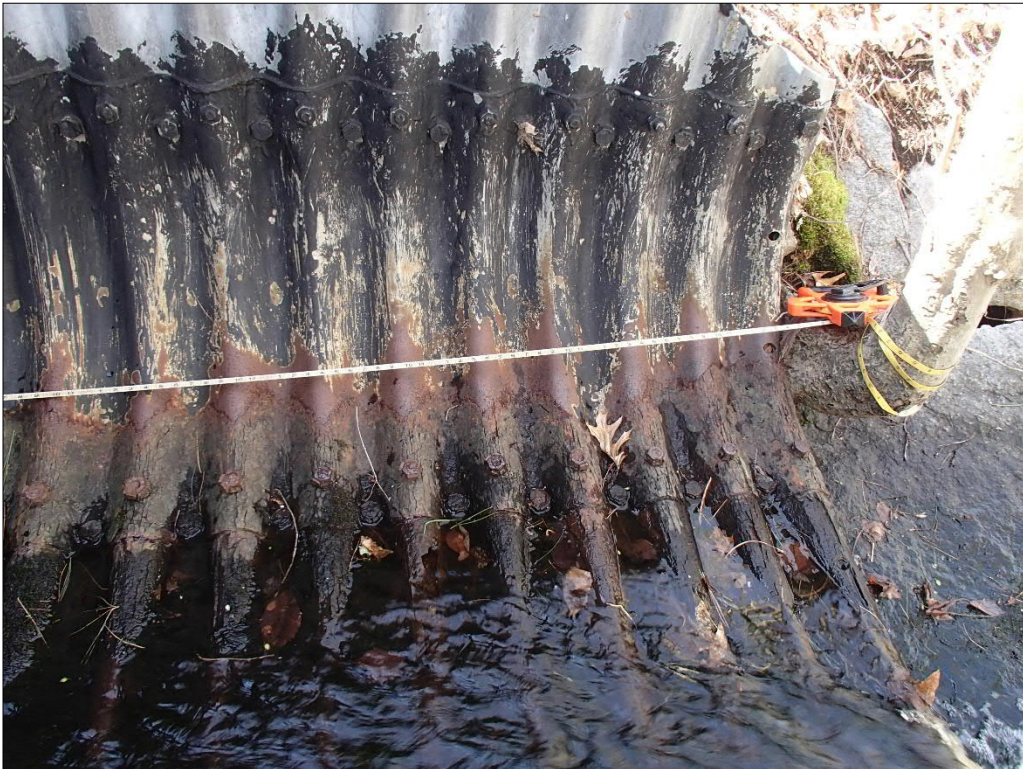
Photo 10 Looking South: Southwest Corner of Pipe

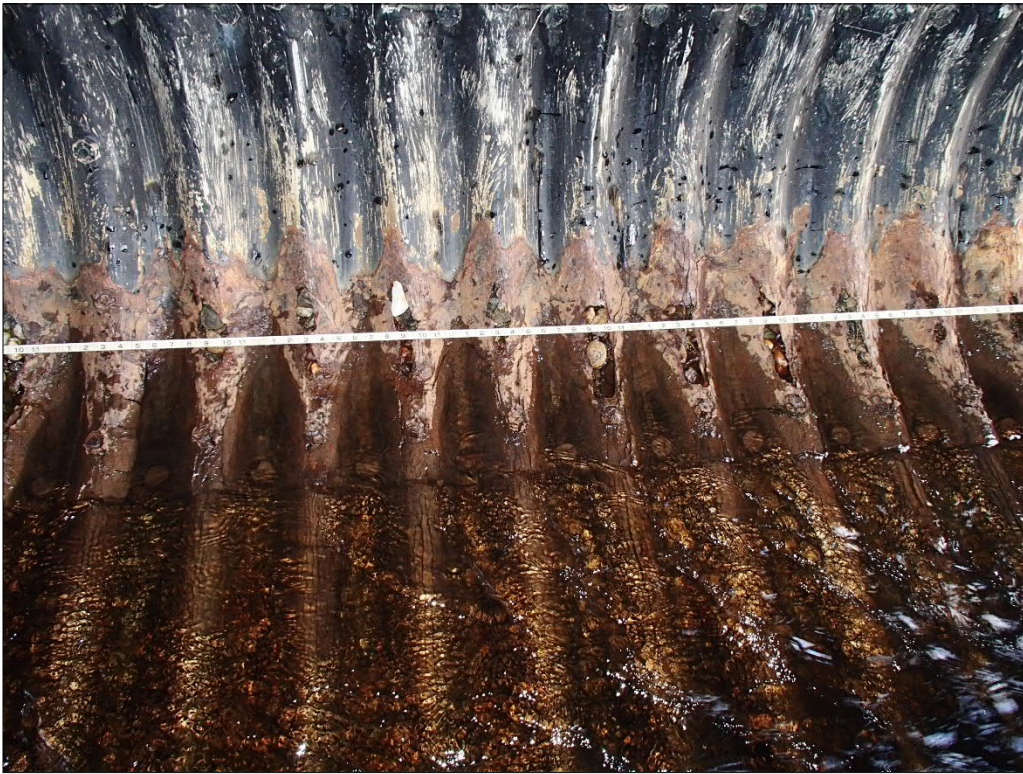
Photo 11 Looking South: South Wall of Pipe

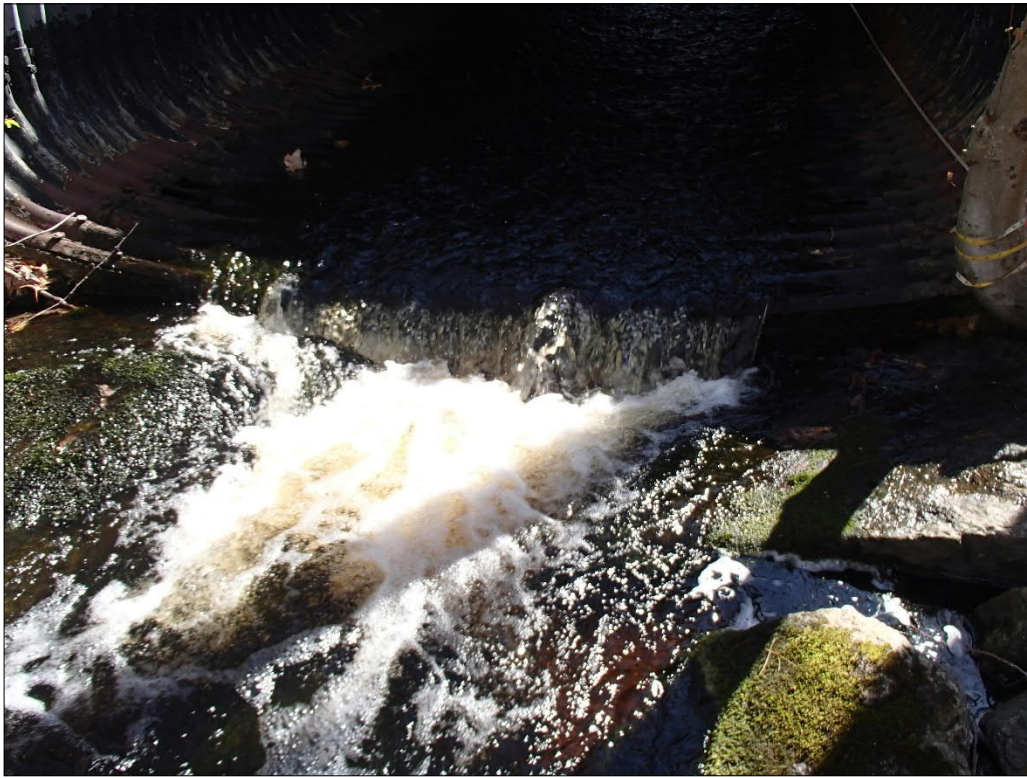
The pipe rests on concrete toewalls at each opening. The walls were found to be in fair condition. The wall at the west side opening is exposed full length and has spots of undermining. Additionally, there is a 3' wide x 2.2' deep area of scour at the west toewall (Photo 13).

Photo 13 Looking Northeast: West Toewall

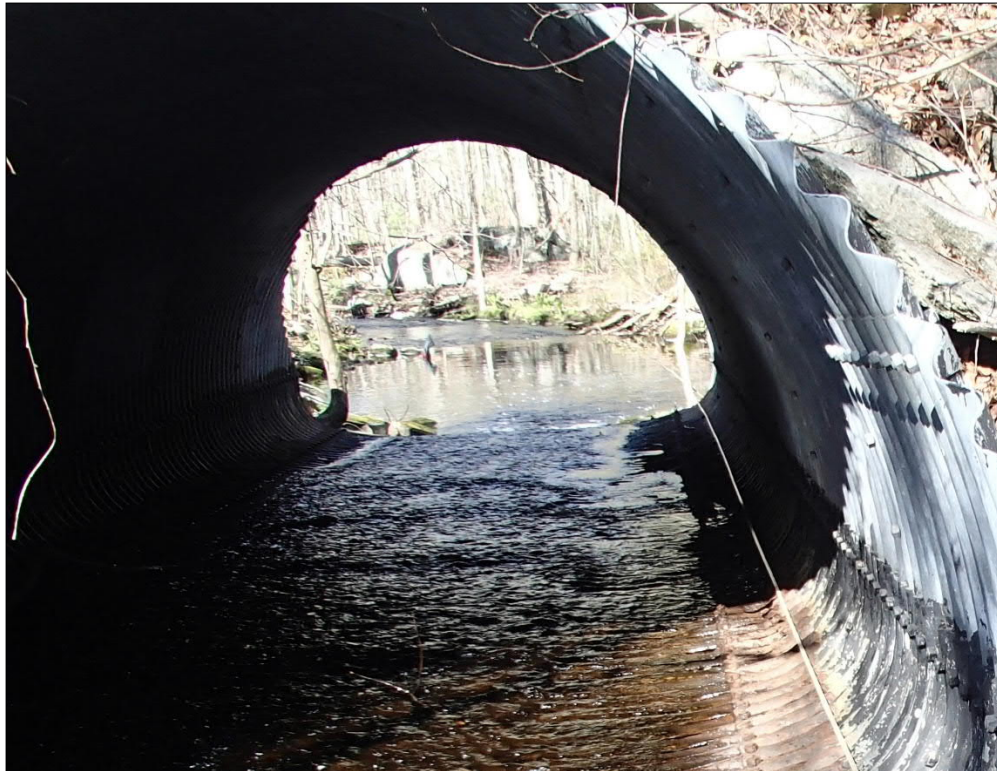
Photo 14 Looking West: Distortion of Pipe

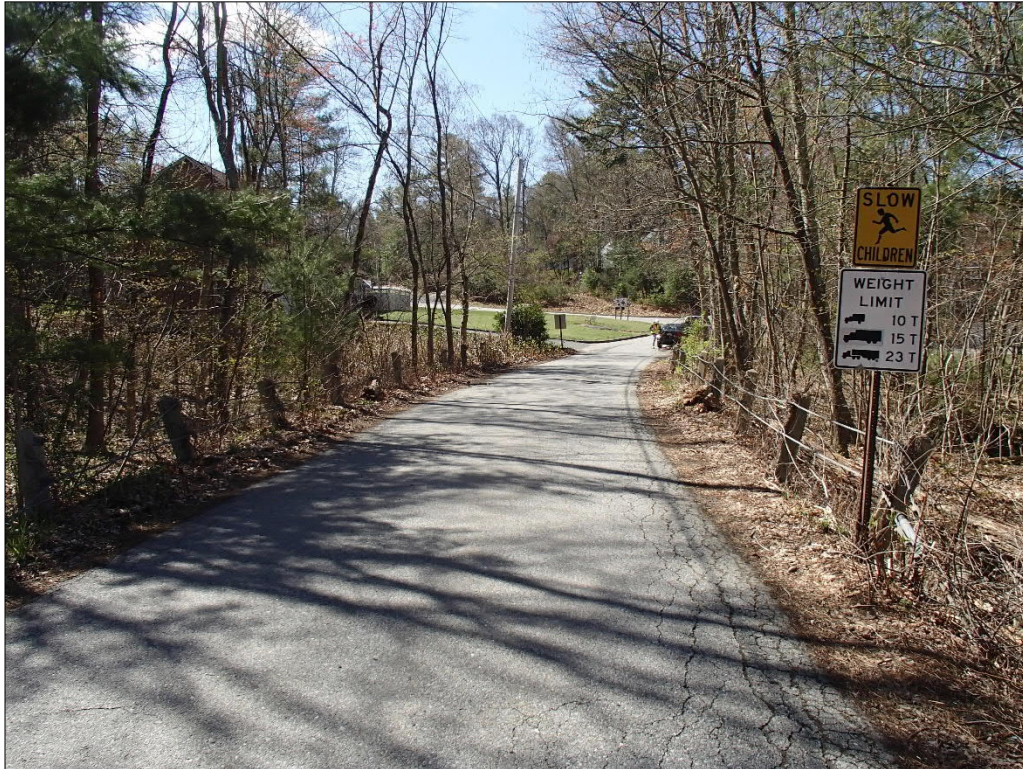
Photo 15 Looking South: North Approach

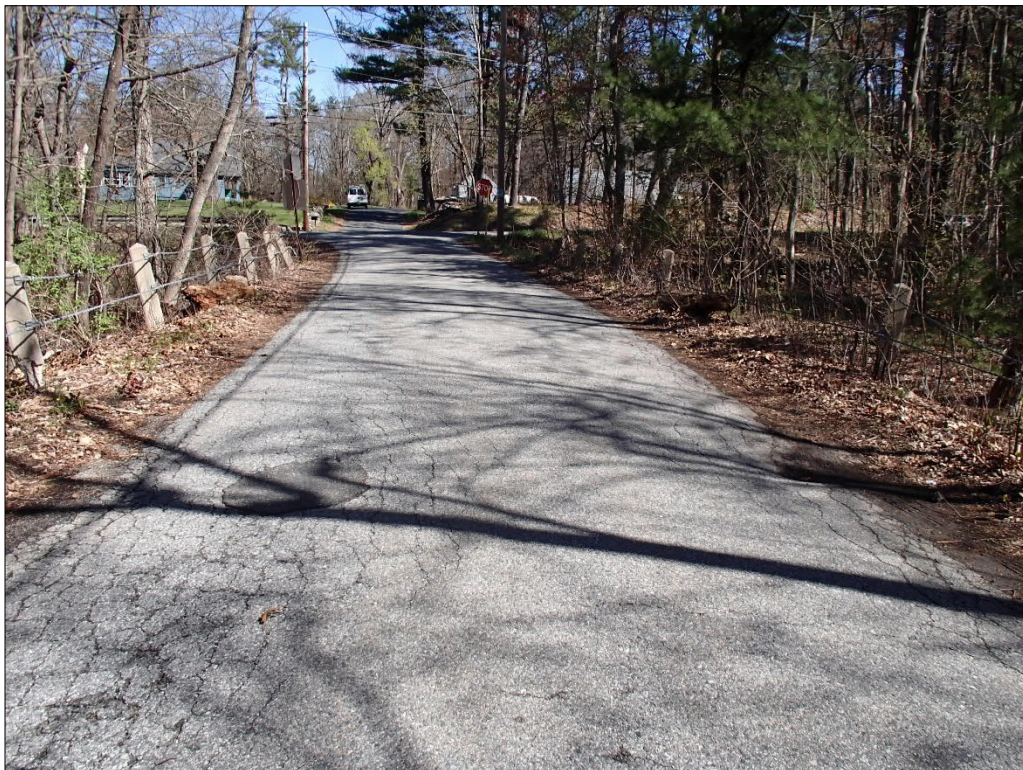
Photo 16 Looking North: South Approach

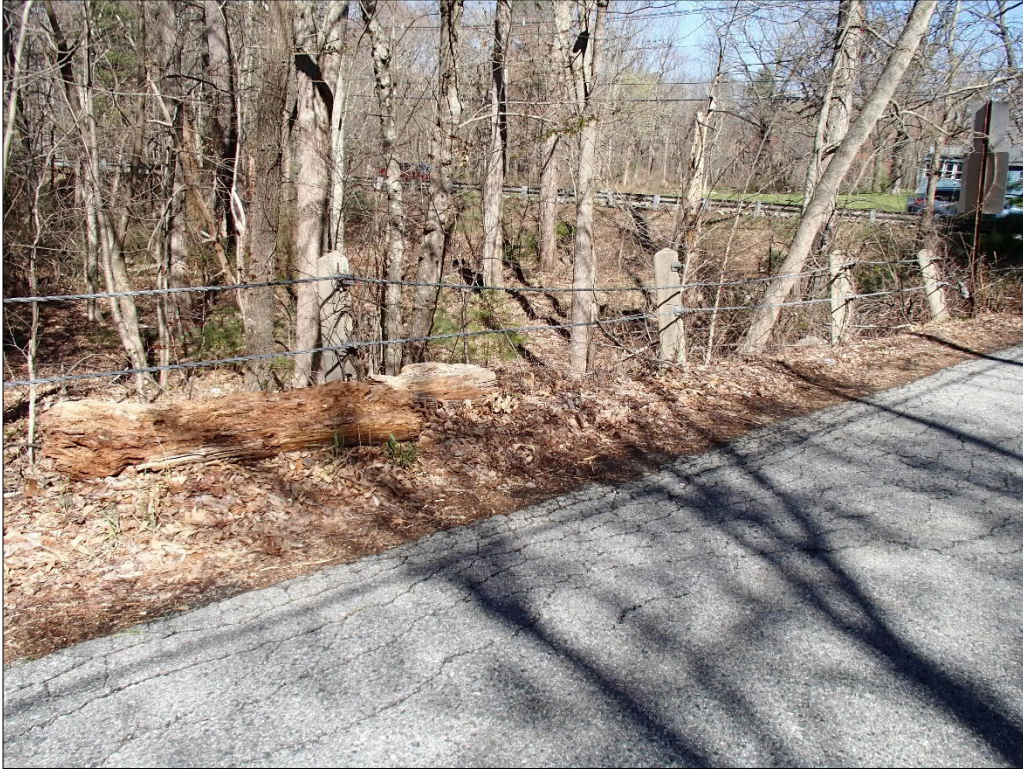
Photo 17 Looking Northwest: West Railing

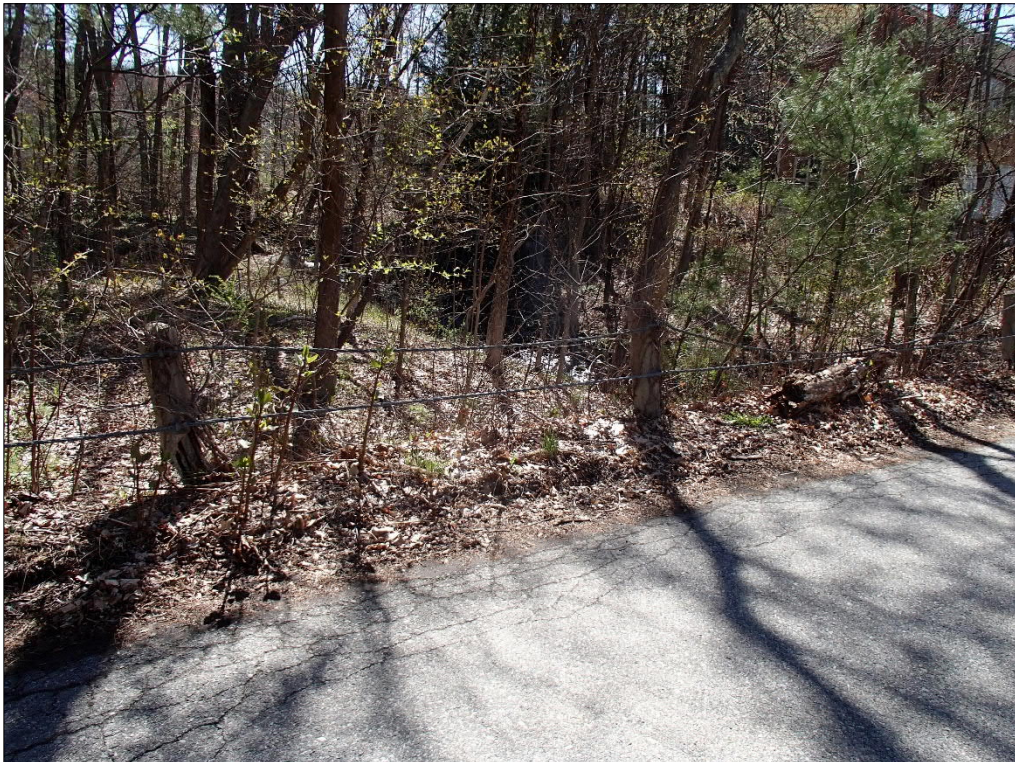
Photo 18 Looking Southeast: East Railing
