Uxbridge, Massachusetts
Evaluation Report
Project Number: 7533
June 2021

BRIDGE / CULVERT MANAGEMENT PLAN

Prepared by: BETA GROUP, INC.
Prepared for: Town of Uxbridge

June 2021

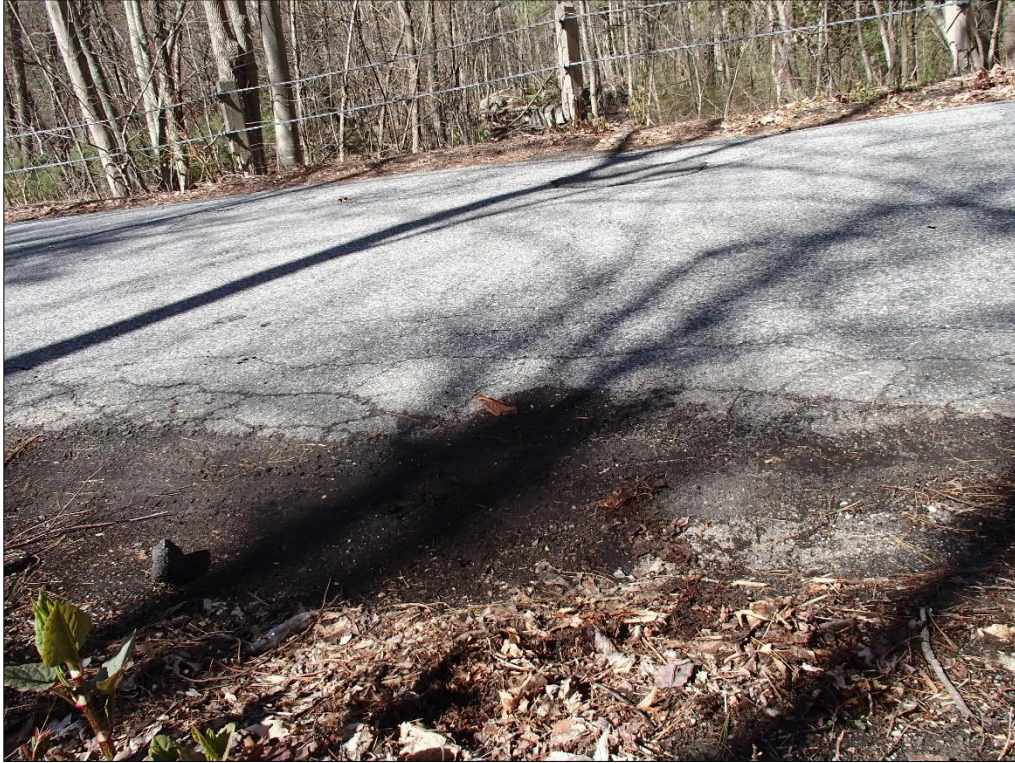
The roadway is narrow but in fair condition with moderate alligator cracking on the west side of the roadway and minor wheel line rutting in the north approach. There is a pothole on the south approach and there is an area of settling at the northeast corner over the culvert (Photo 19). The horizontal curve at the south approach yields poor visibility. Also, there is heavy vegetation growth on both sides of the street that contributes to the lack of sight distance.

Photo 19 Looking West: Washout/Settling near Northeast Corner over Culvert

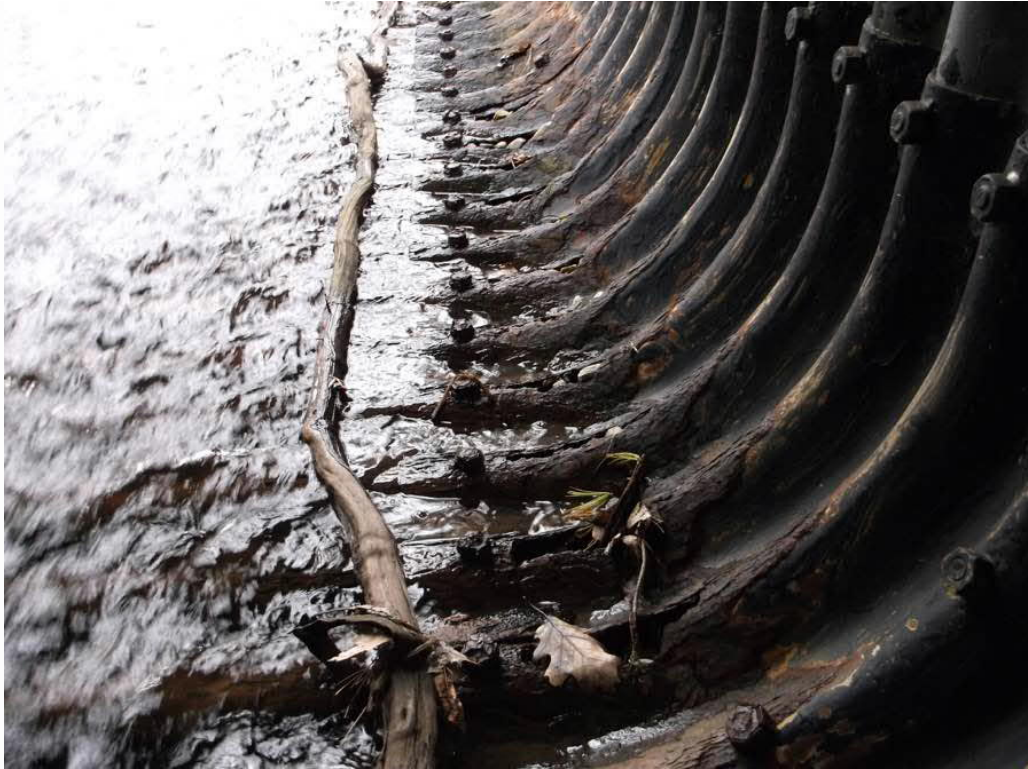
Photo 1: South waterline looking East, typical 100% section loss.

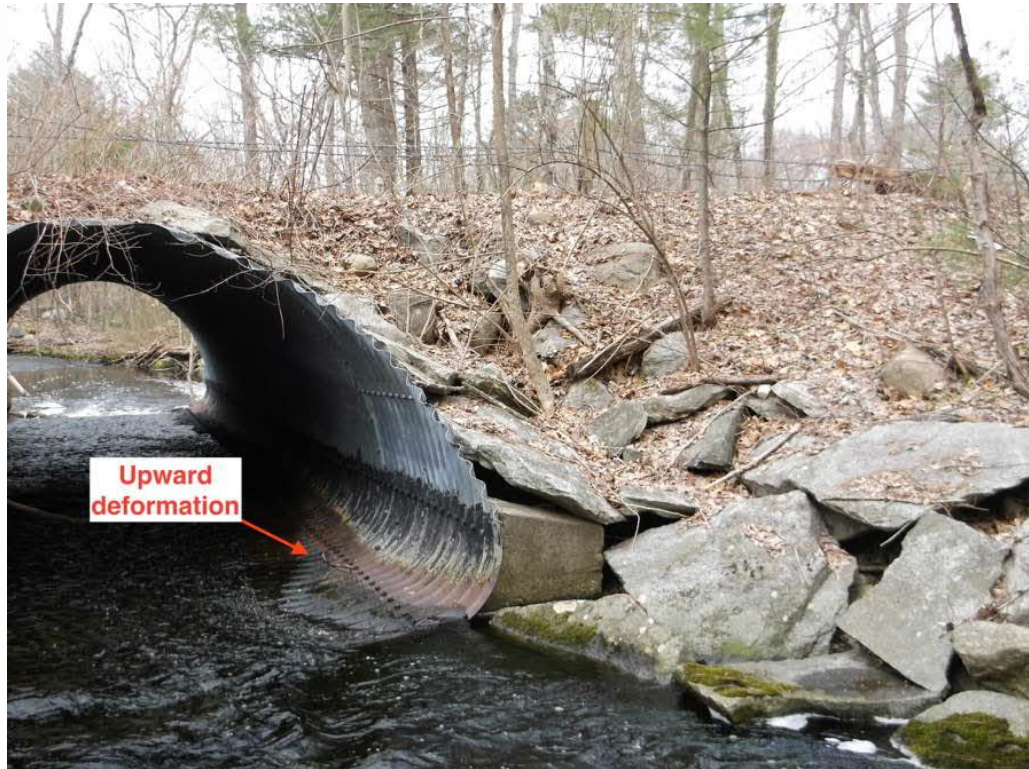
Photo 3: Northeast embankment.

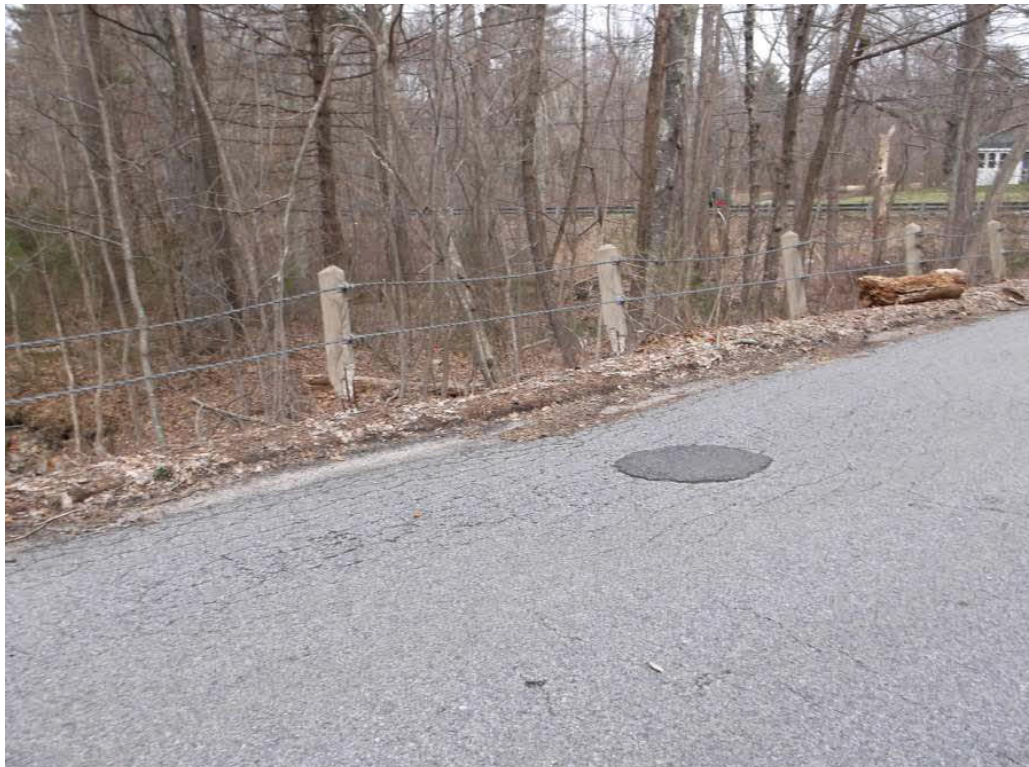
Photo 4: Wearing surface and North approach pavement, looking Northwest.

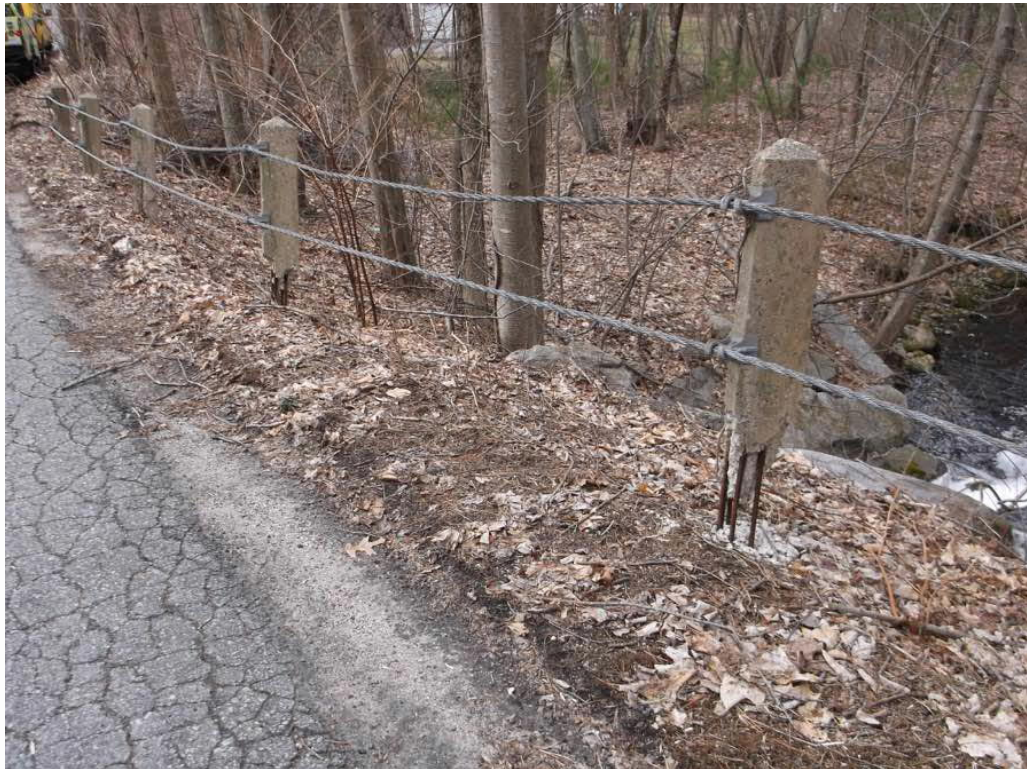
Photo 7: West rail South end, typical post concrete section loss.

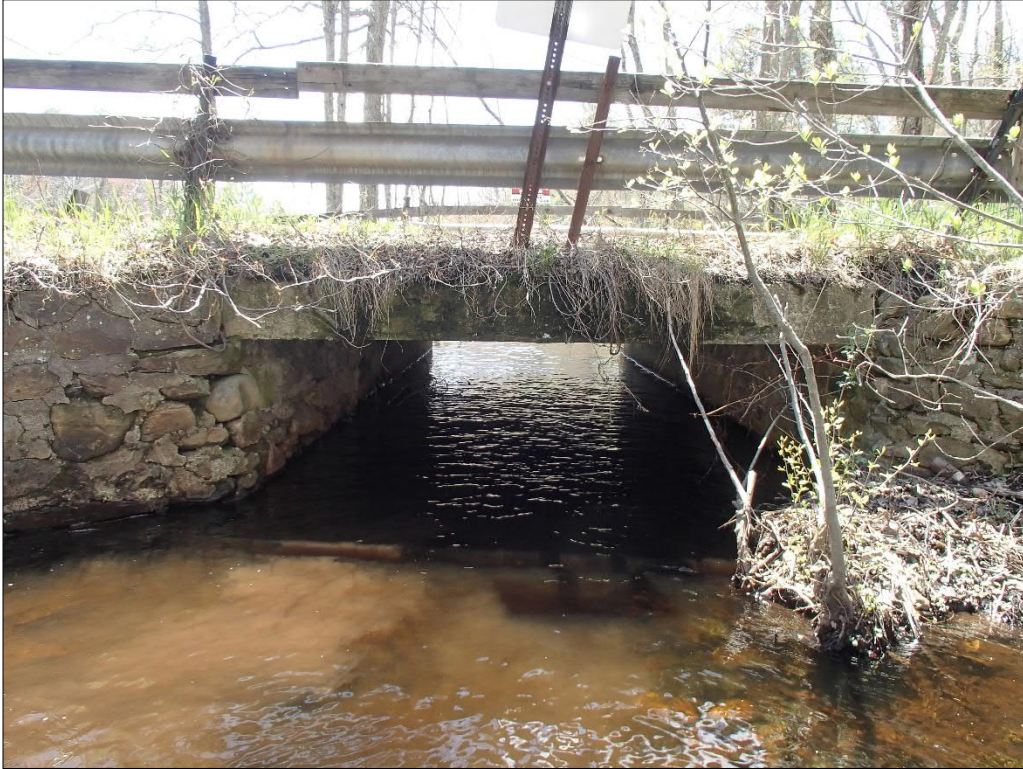
Photo 1 Looking South: North Culvert Elevation

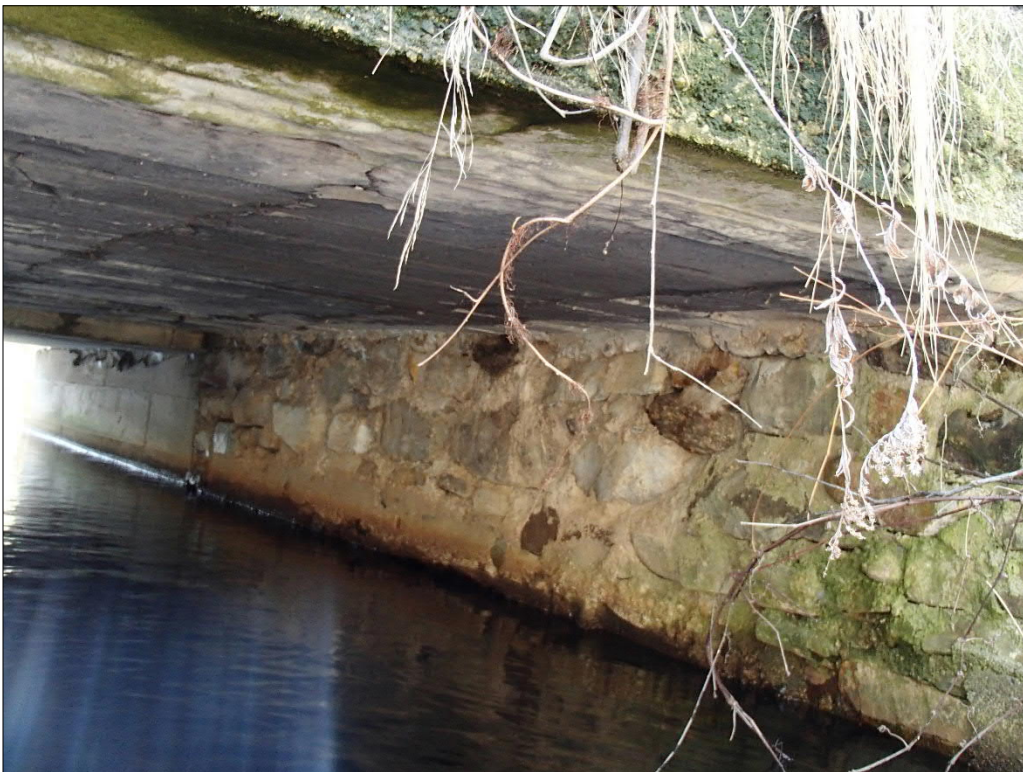
Photo 2 Looking Southwest: West Abutment of Structure 1

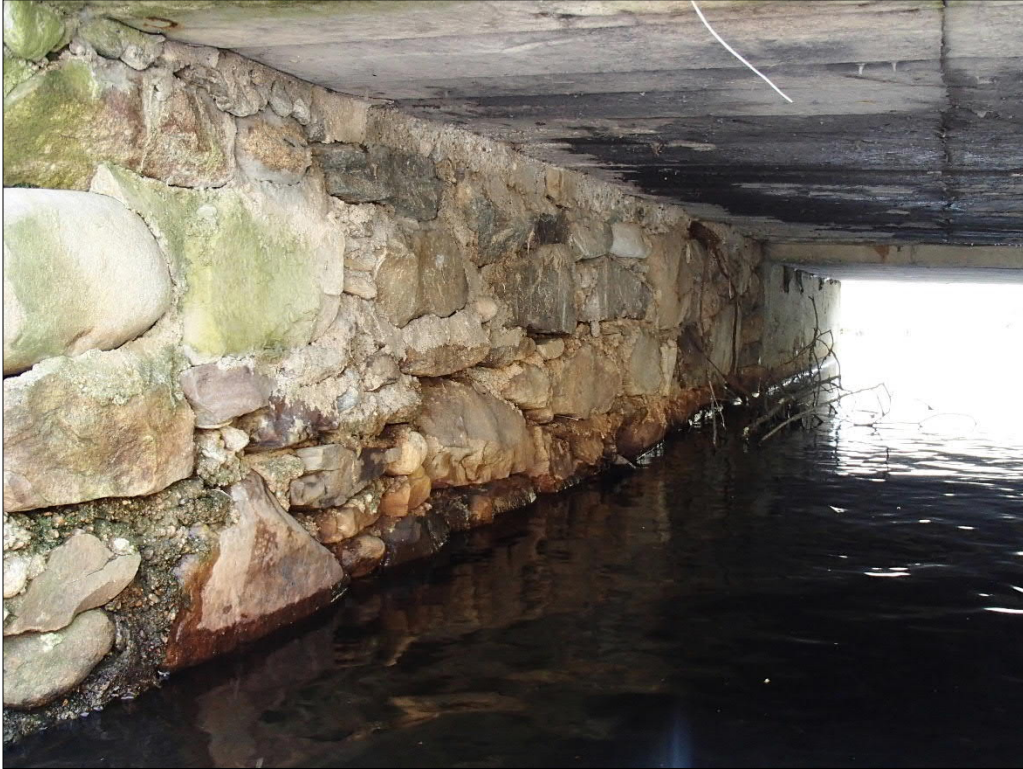
Photo 3 Looking Southeast: East Abutment of Structure 1

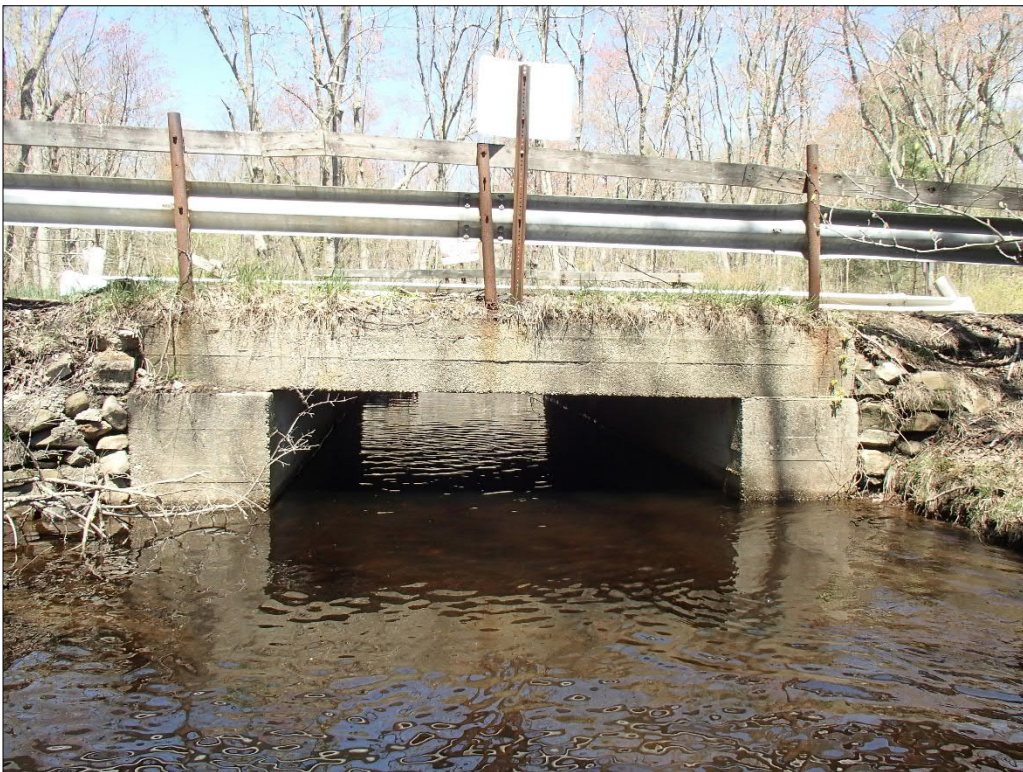
Photo 4 Looking North: South Culvert Elevation

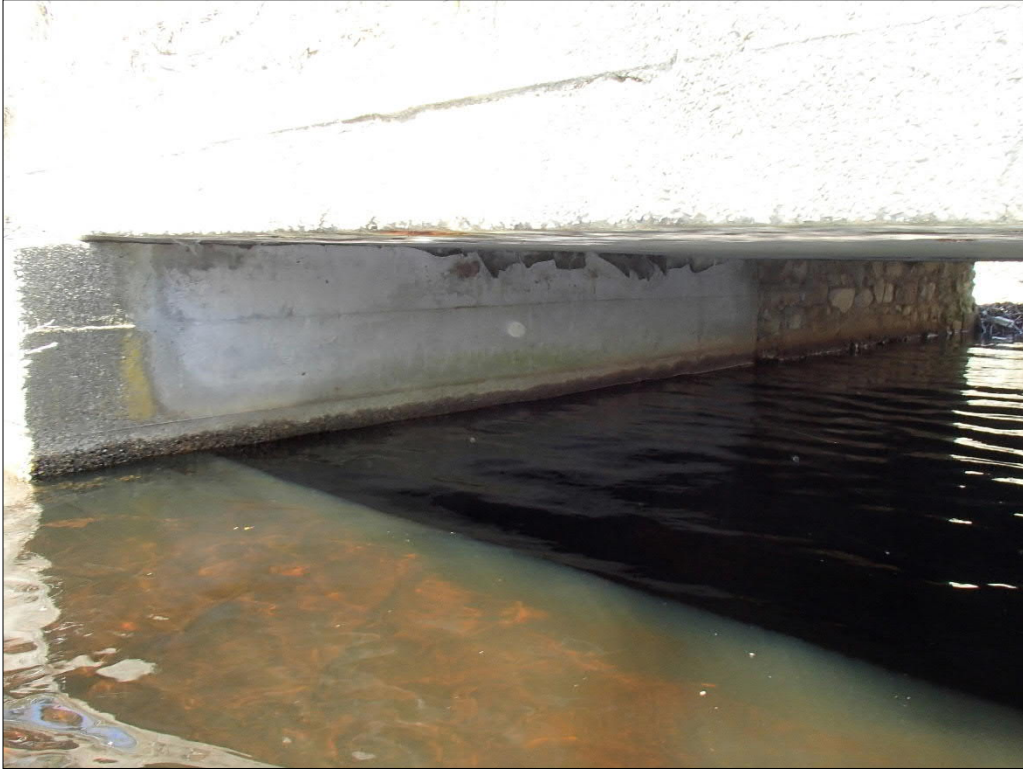
Photo 5 Looking Northwest: West Abutment of Structure 2

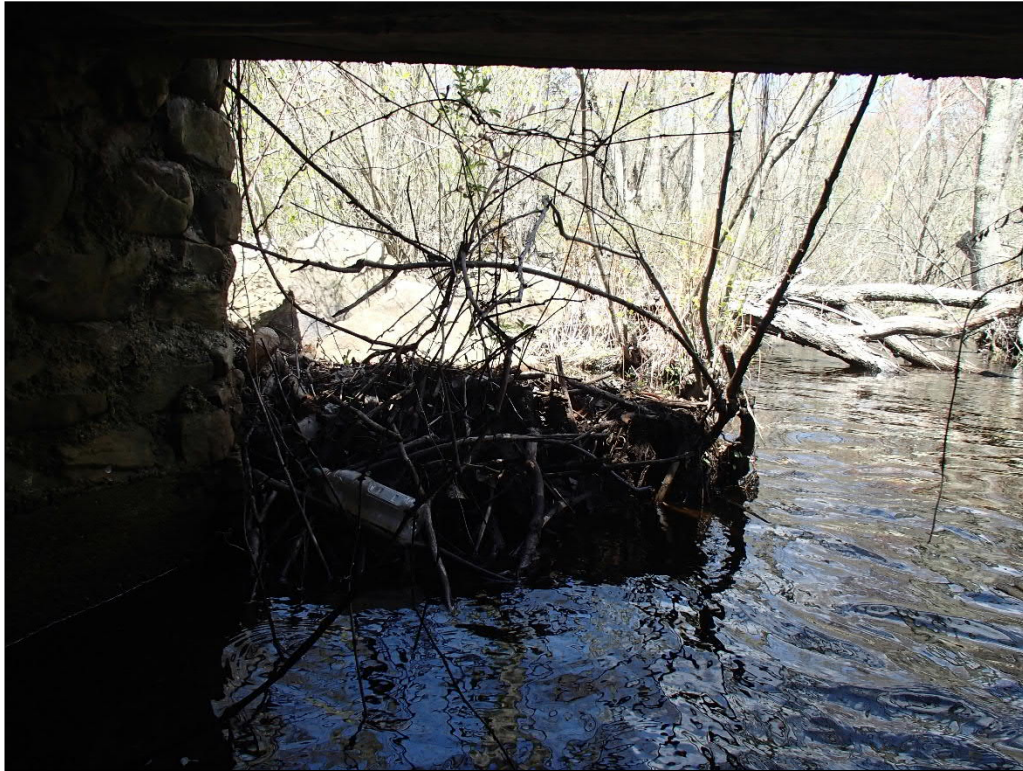
Photo 13 Looking North: Vegetation Impeding Flow at Northwest Corner

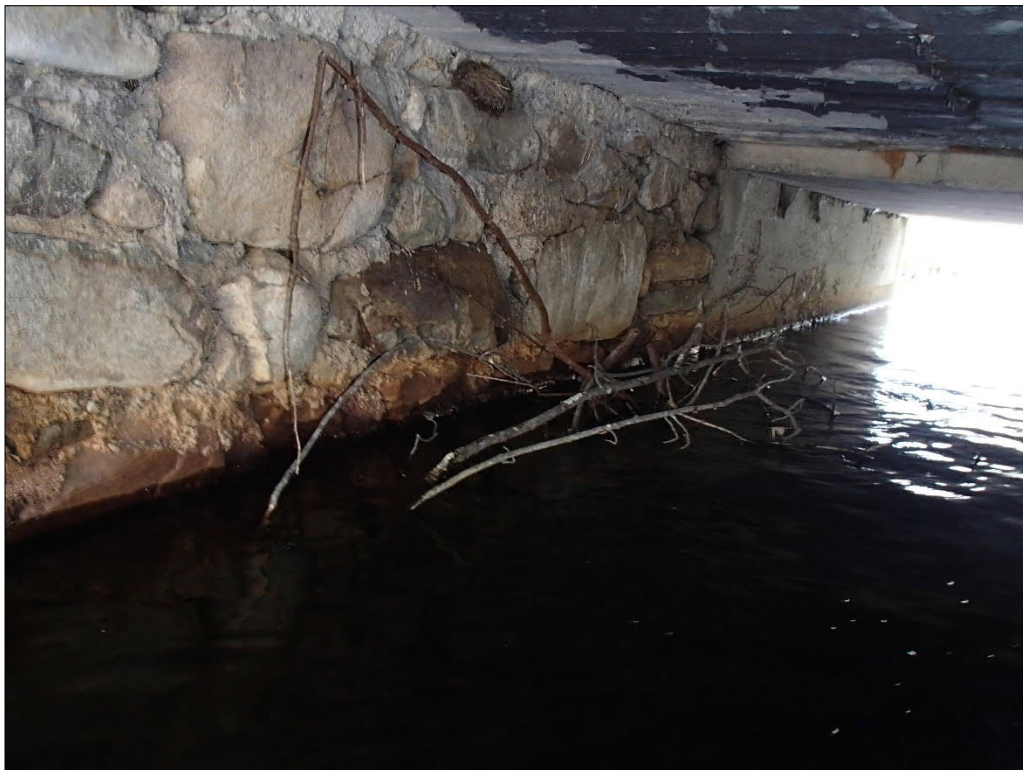
Photo 14 Looking Southeast: Debris in Brook at East Abutment Wall

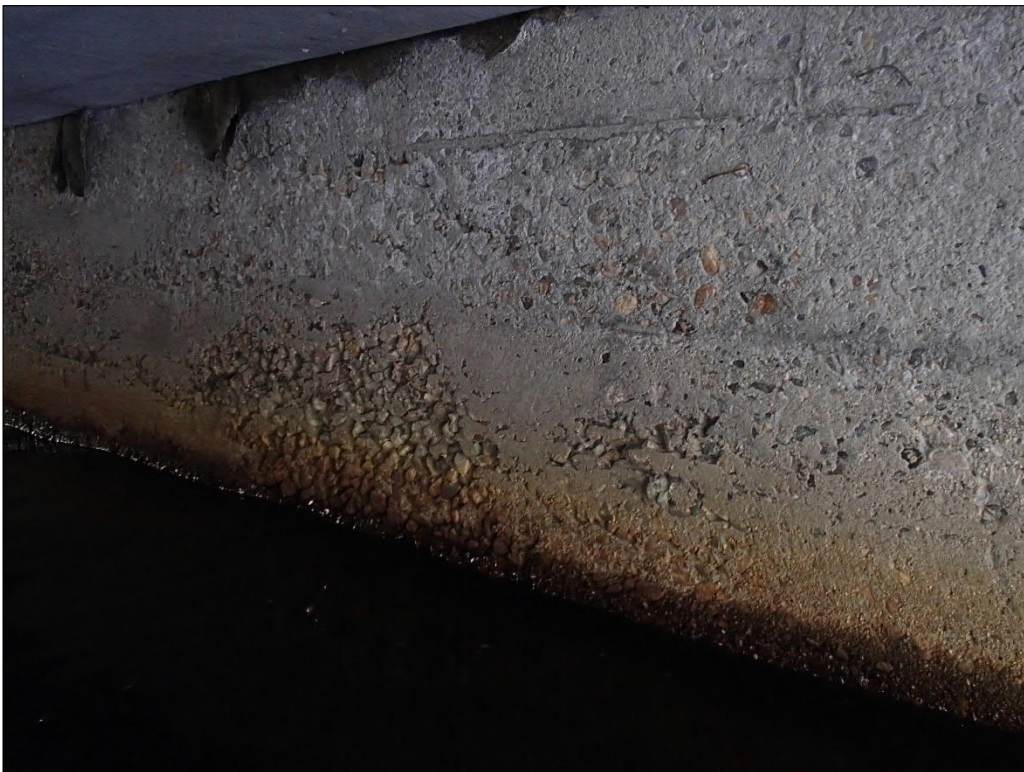
in fair condition with random missing chinking stones and loss of mortar. The concrete abutments at structure 2 are in fair condition. Moderate scaling was typical up to a foot above the waterline with abrasion typical along the water line (Photo 16). Random spalls at the construction joints were also noted.

Photo 16 Looking Northeast: East Abutment of Structure 2

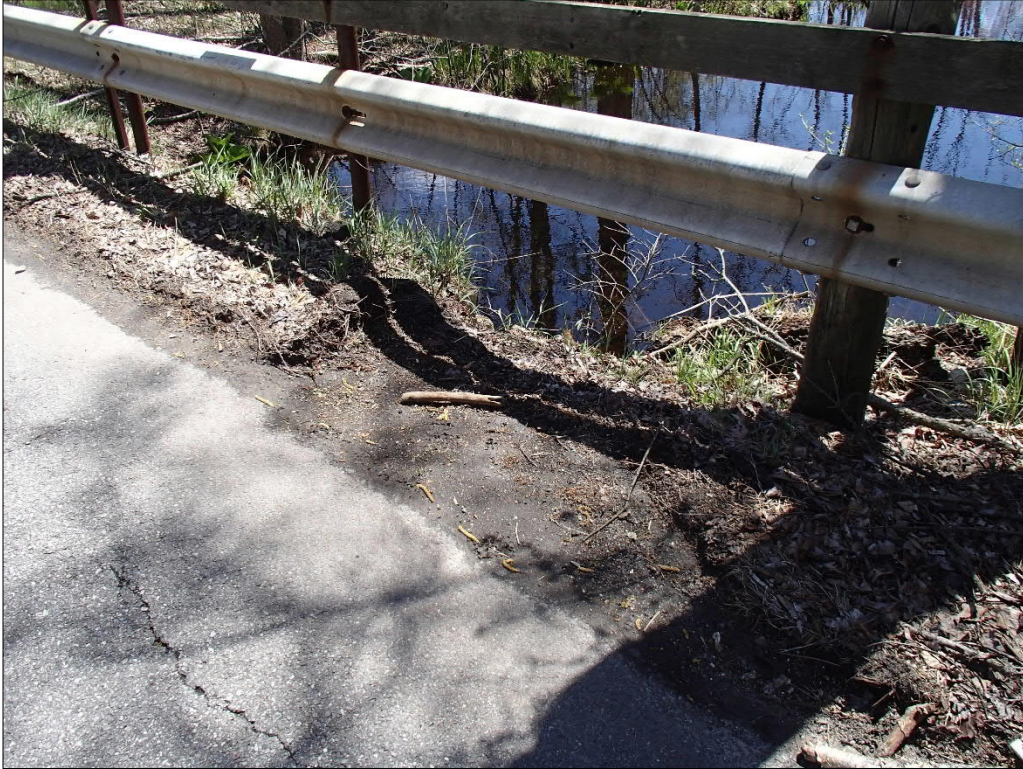
The pavement over the culvert shows moderate linear cracking, patching, and debris in the shoulders. There is also an area of washout on the southwest corner over the culvert (Photo 21). The sharp horizontal curve in the east approach greatly reduces visibility. The north guardrail over the culvert is leaning away from the roadway due to past vehicular collision, causing it to become unstable (Photo 19). The south guardrail over the culvert has collision damage at the east end (Photo 20). Additionally, guardrail posts typically exhibit corrosion (Photo 22). No approach guardrail is present.

Photo 21 Looking South: Washout at Southwest Corner over Culvert

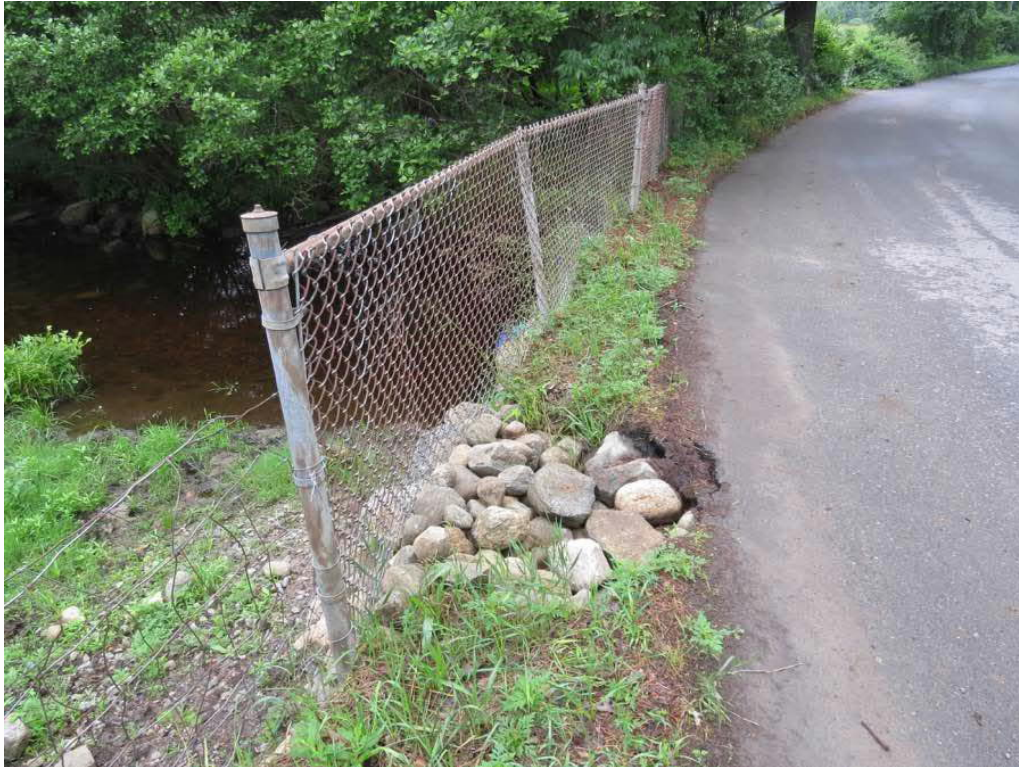
Photo 1: West fence South end and shoulder fill.

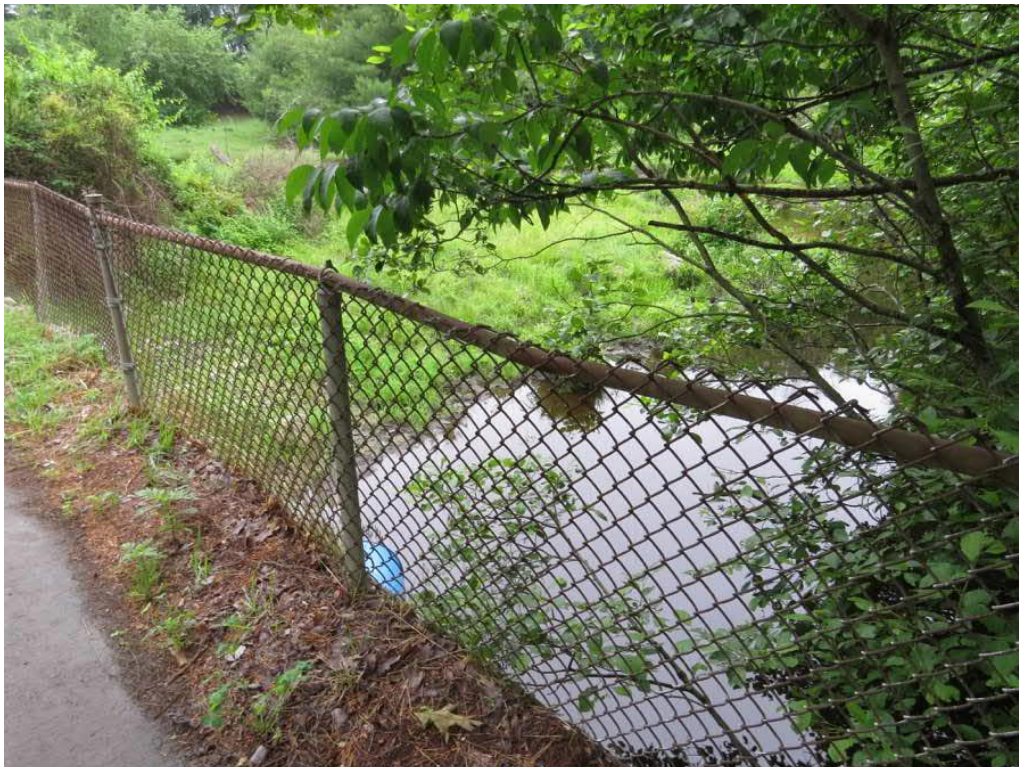
Photo 2: West fence, bent top rail.

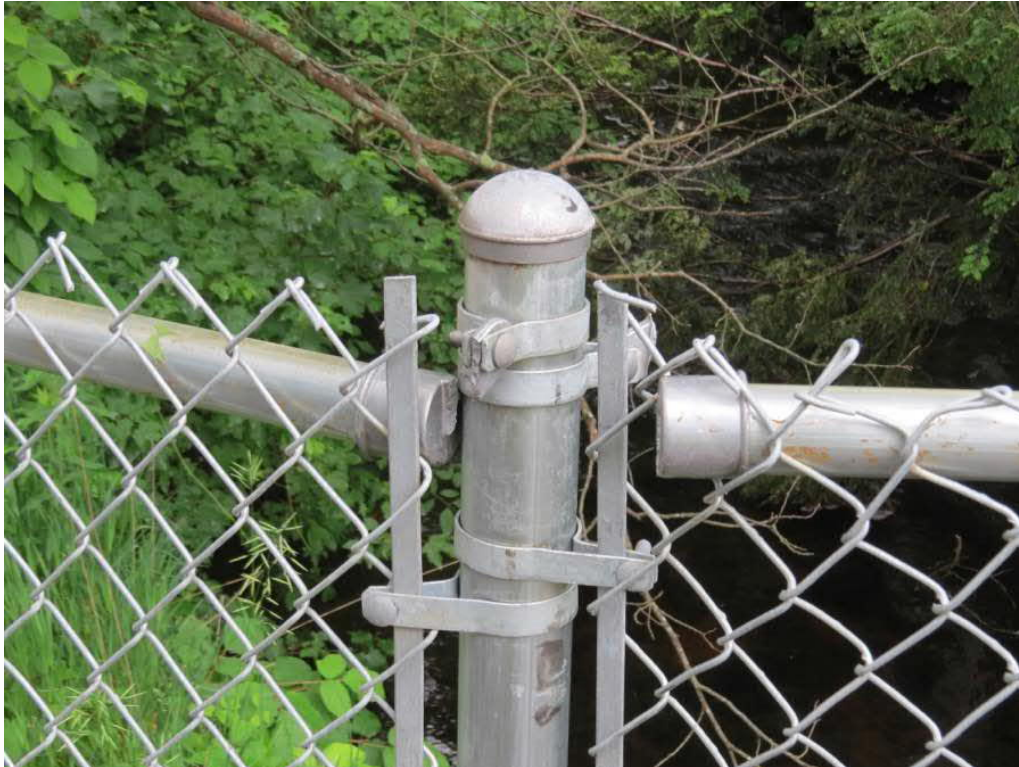
Photo 3: East fence North end, disconnected top rail.

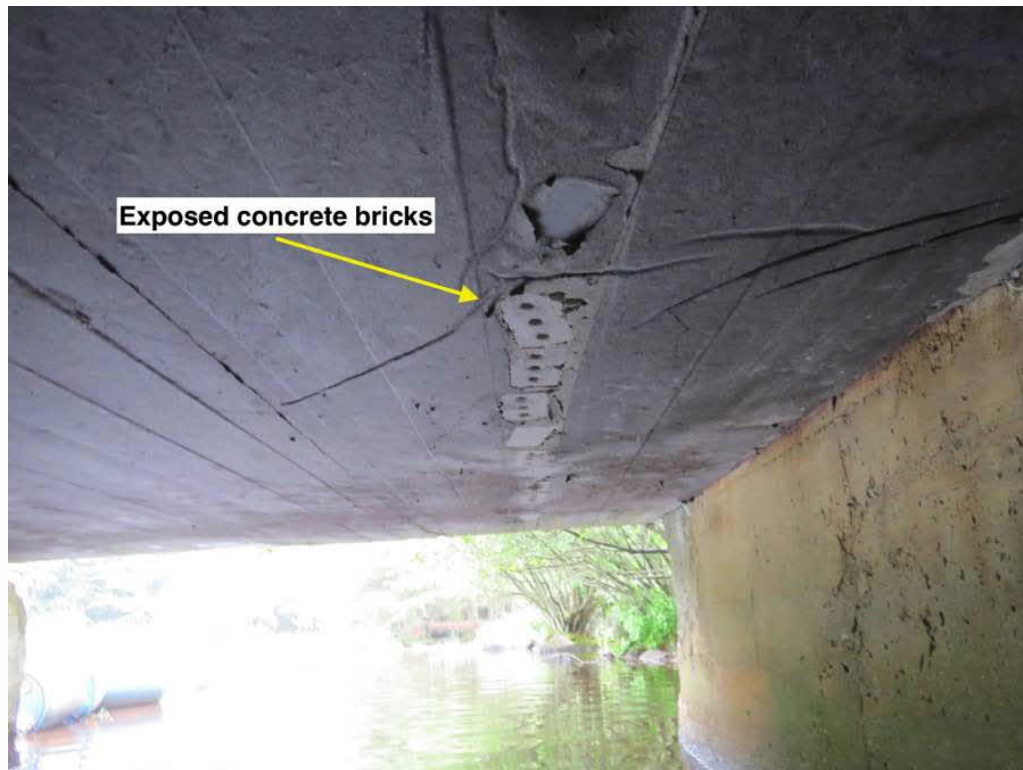
Photo 5: Deck slab underside, North end looking West.

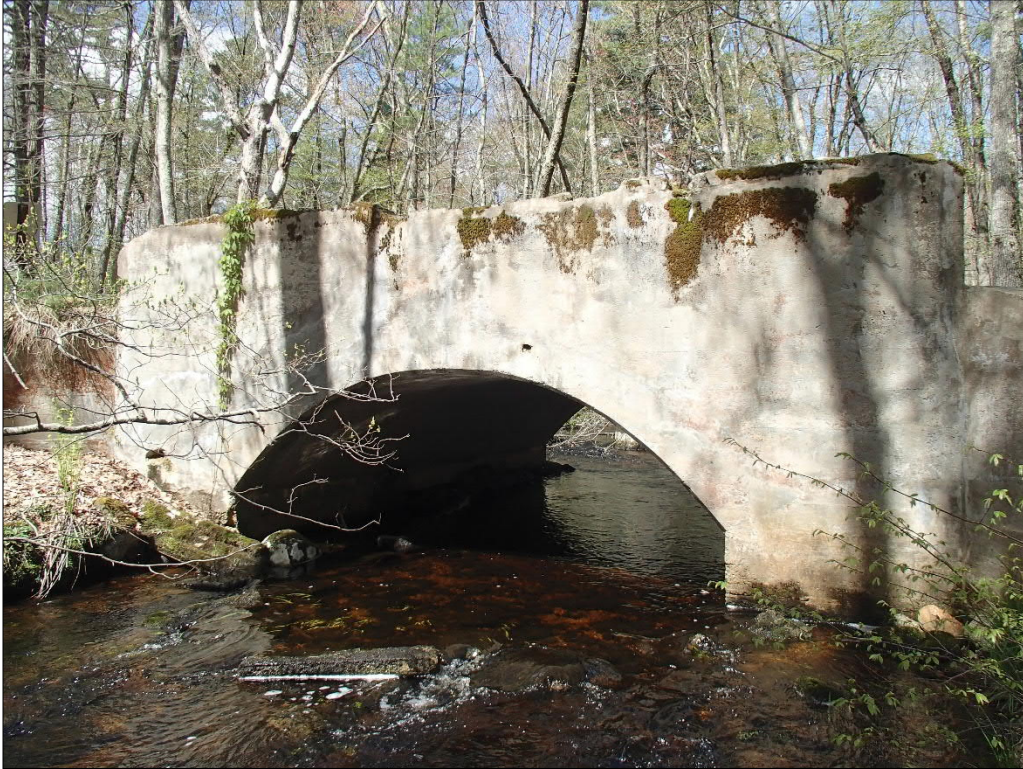
Photo 1 Looking West: East Culvert Elevation

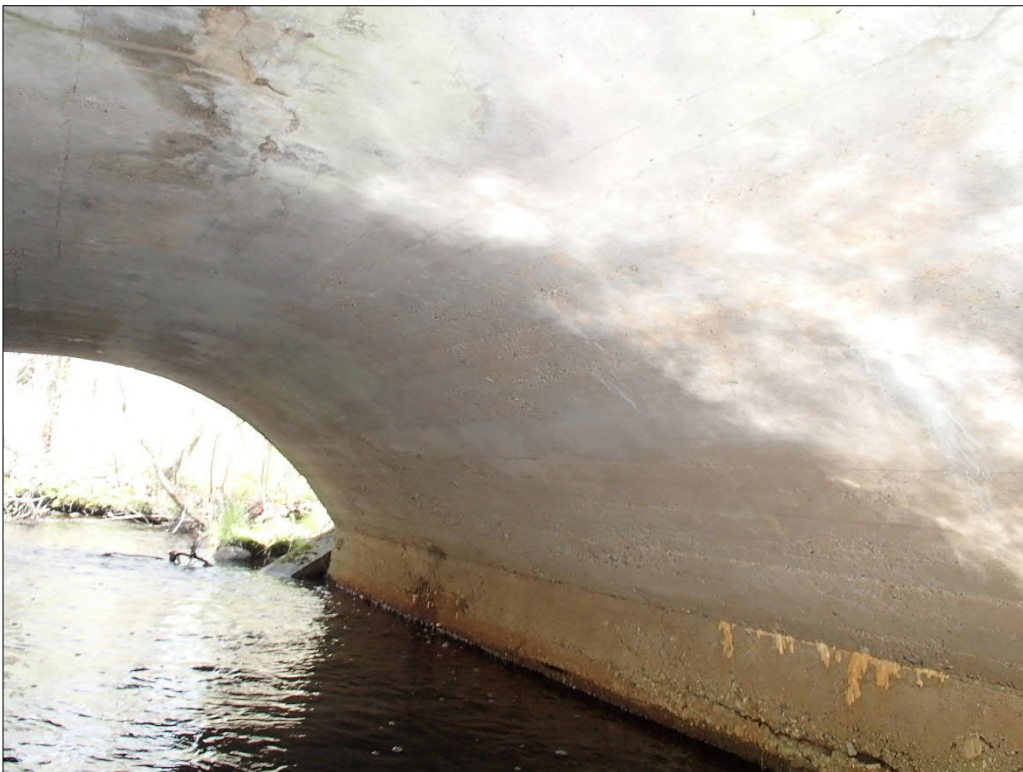
Photo 2 Looking Northwest: North Abutment

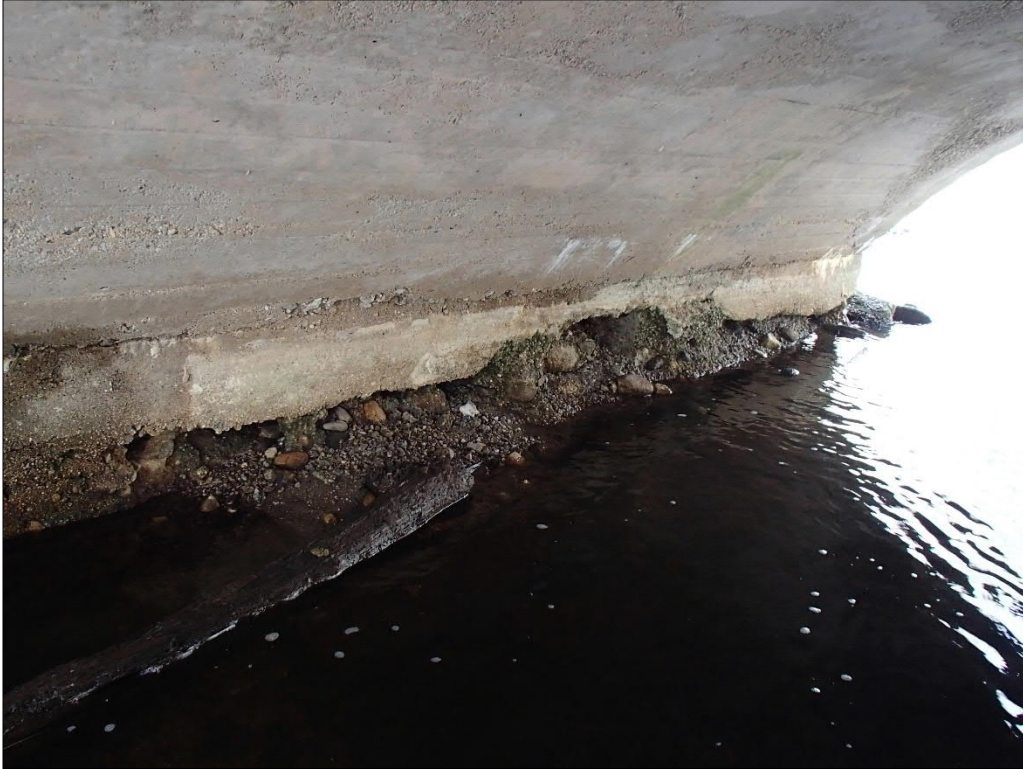
Photo 3 Looking Southwest: South Abutment

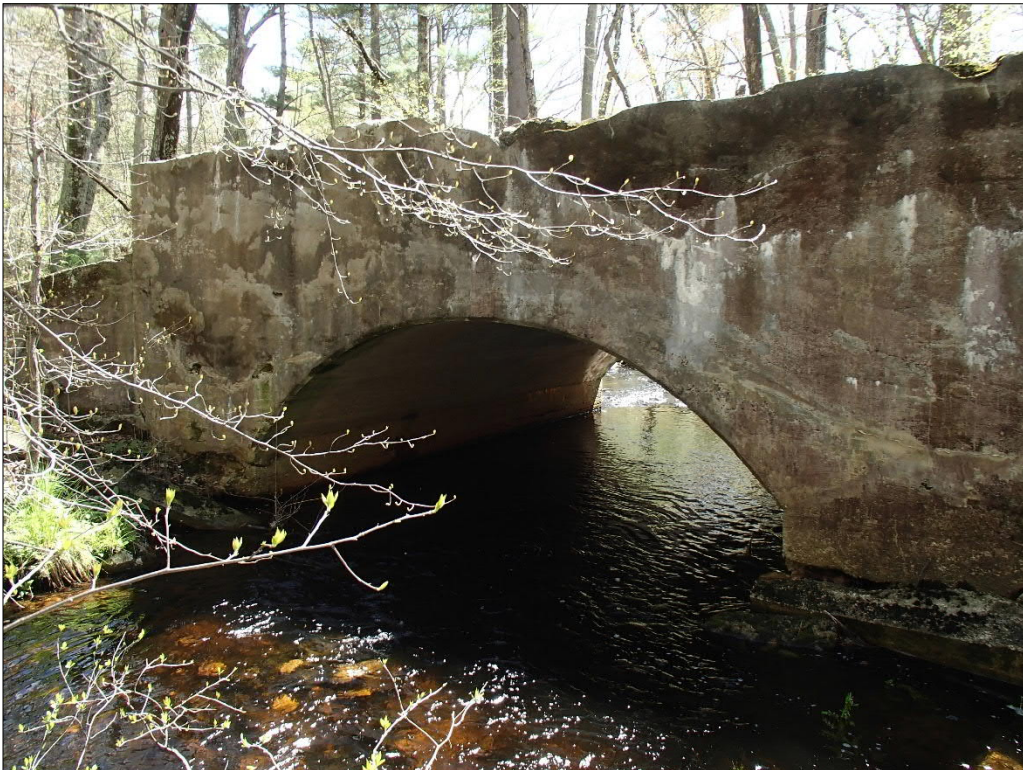
Photo 4 Looking East: West Culvert Elevation

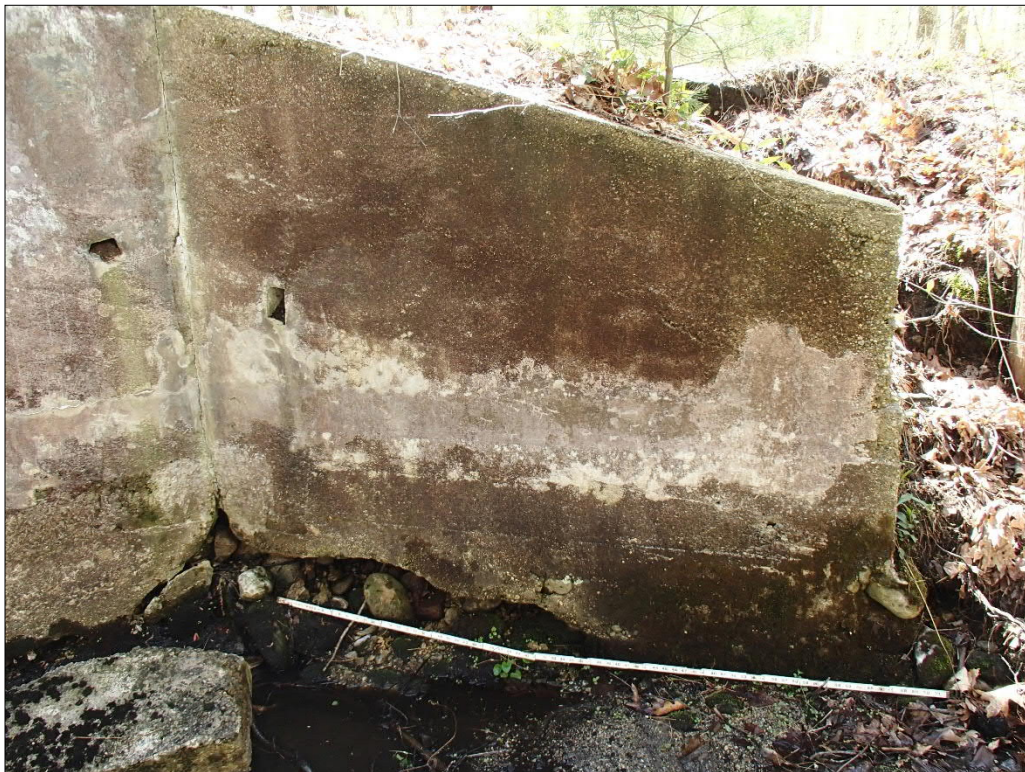
Photo 6 Looking South: Southwest Wingwall

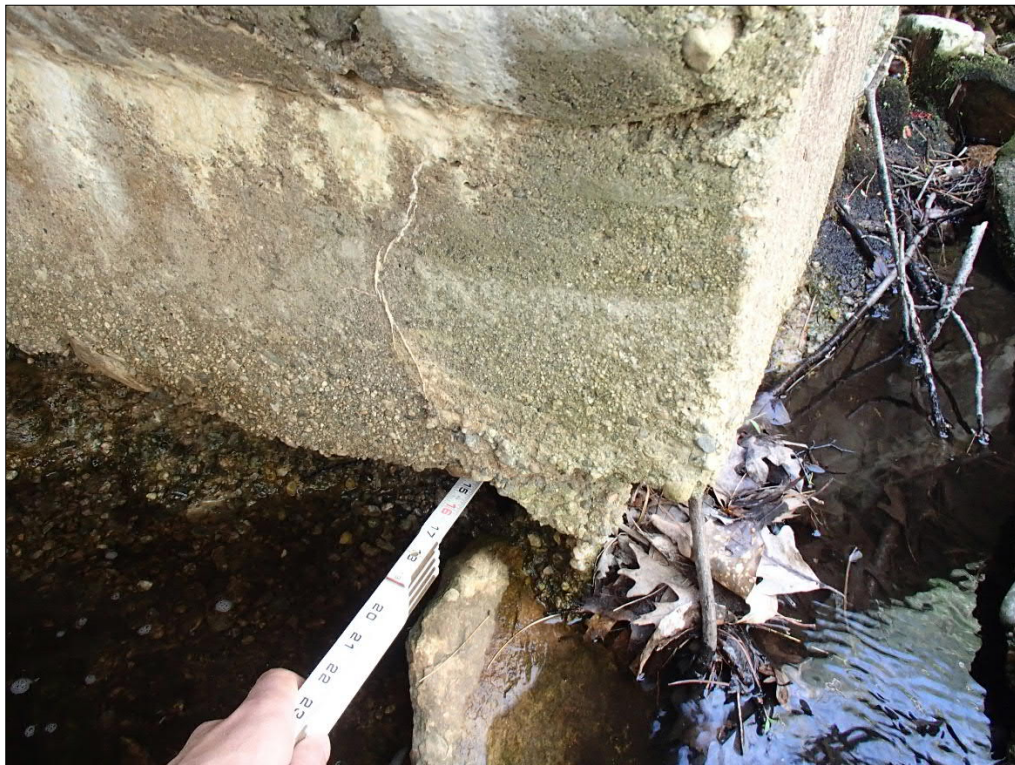
Photo 8 Looking South: Southwest Abutment Corner Void

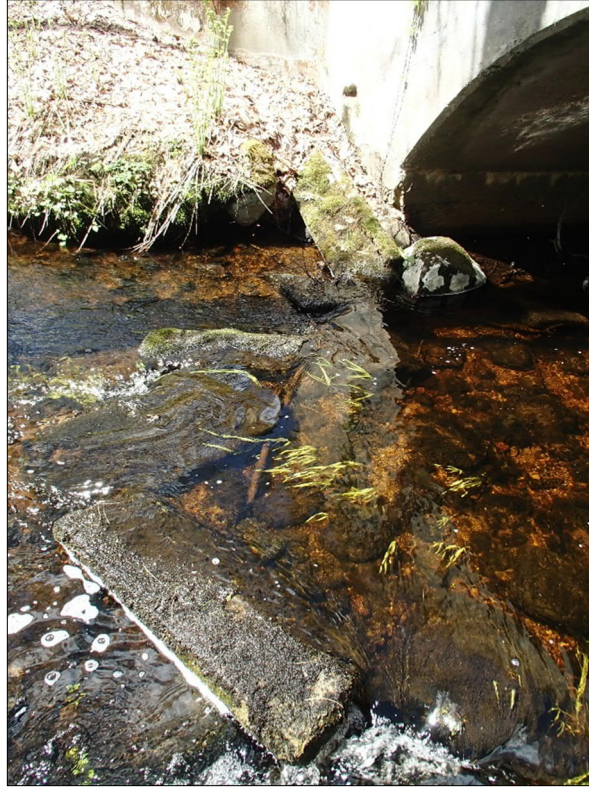
Photo 9 Looking South: Debris at East Entrance to Culvert

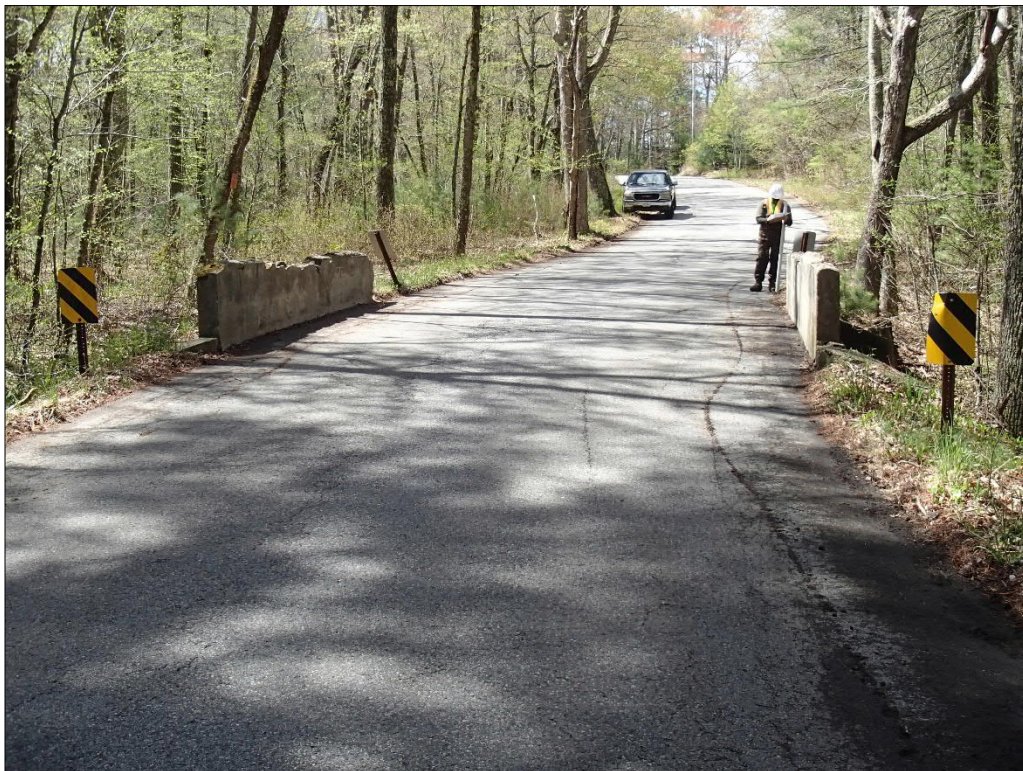
Photo 10 Looking South: North Approach

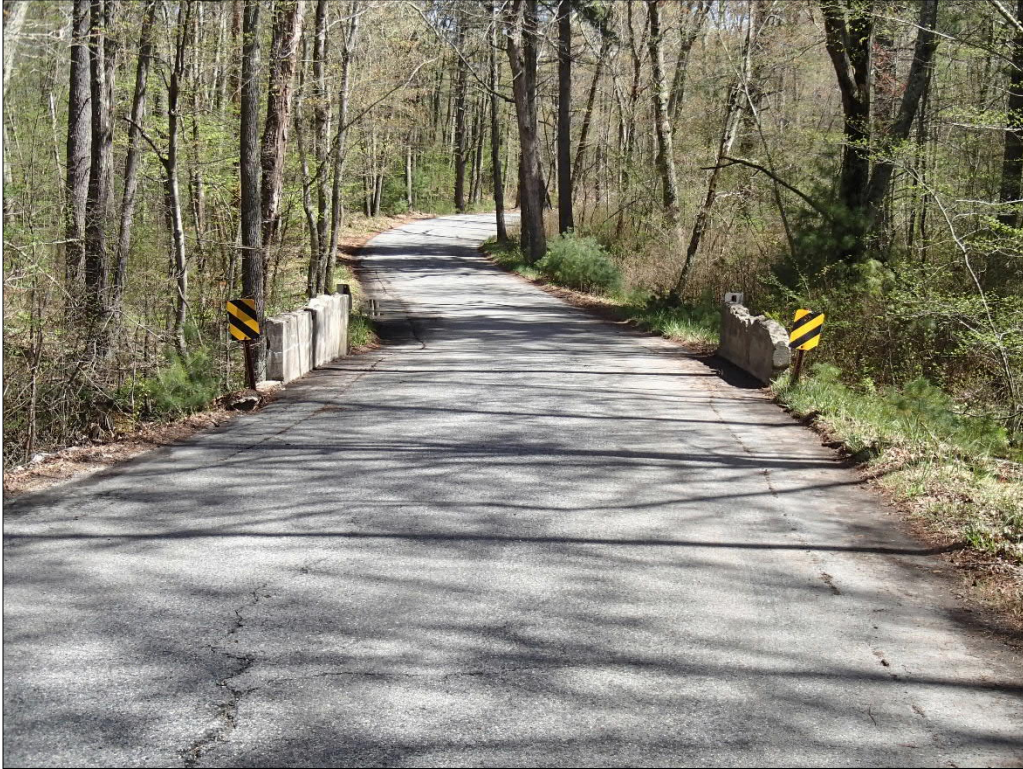
Photo 11 Looking North: South Approach

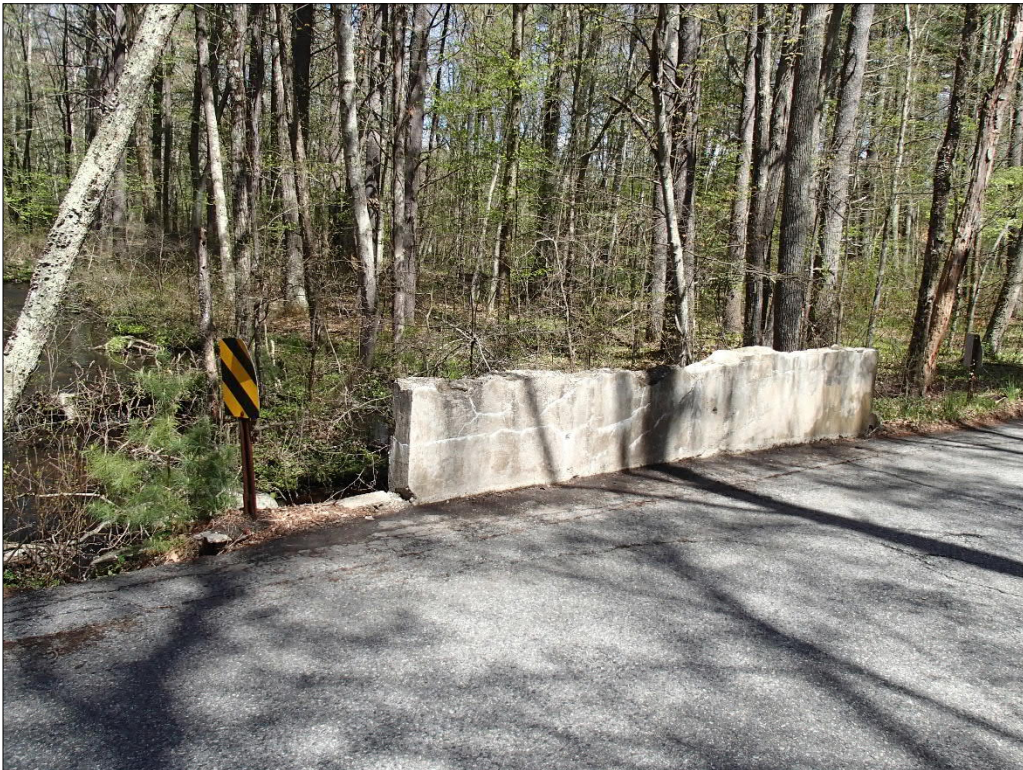
Photo 12 Looking Northwest: West Barrier

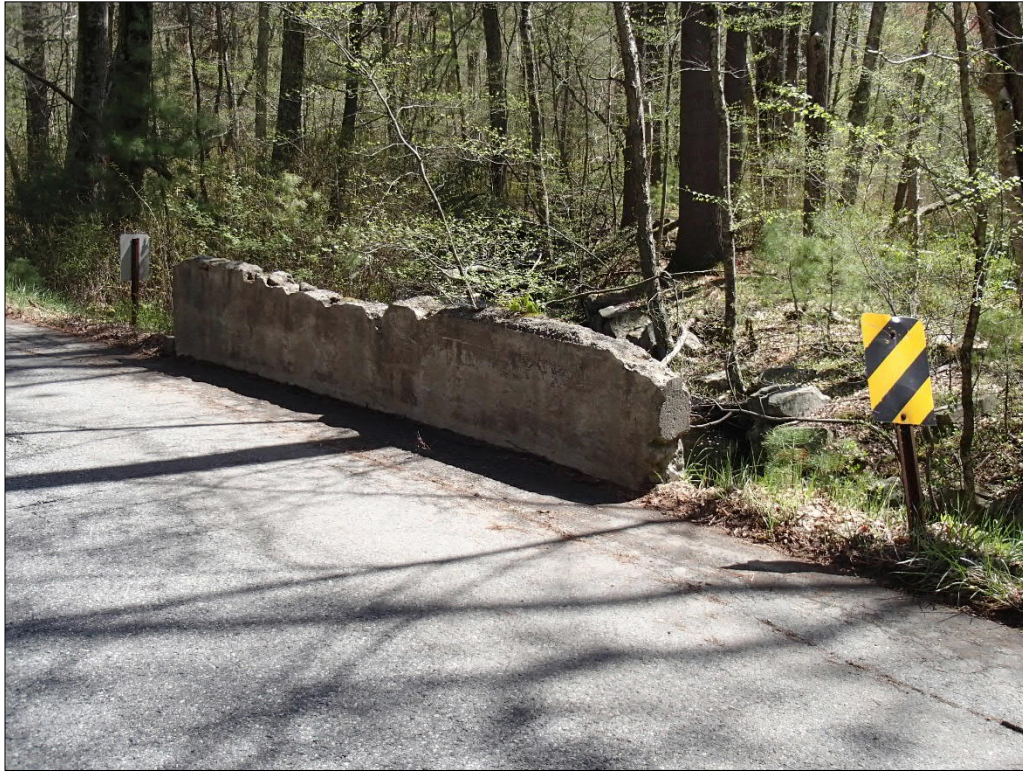
Photo 13 Looking Northeast: East Barrier
