Uxbridge, Massachusetts
Evaluation Report
Project Number: 7533
June 2021

BRIDGE / CULVERT MANAGEMENT PLAN

Prepared by: BETA GROUP, INC.
Prepared for: Town of Uxbridge

June 2021

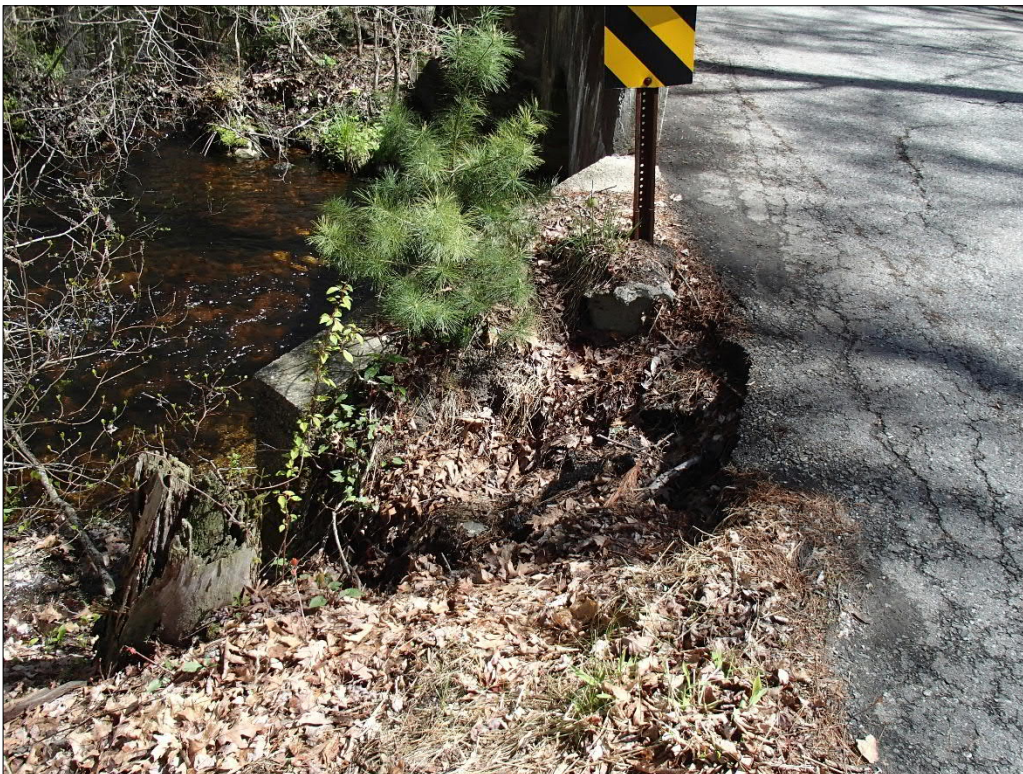
Photo 14 Looking North: Collapse behind Southwest Wingwall

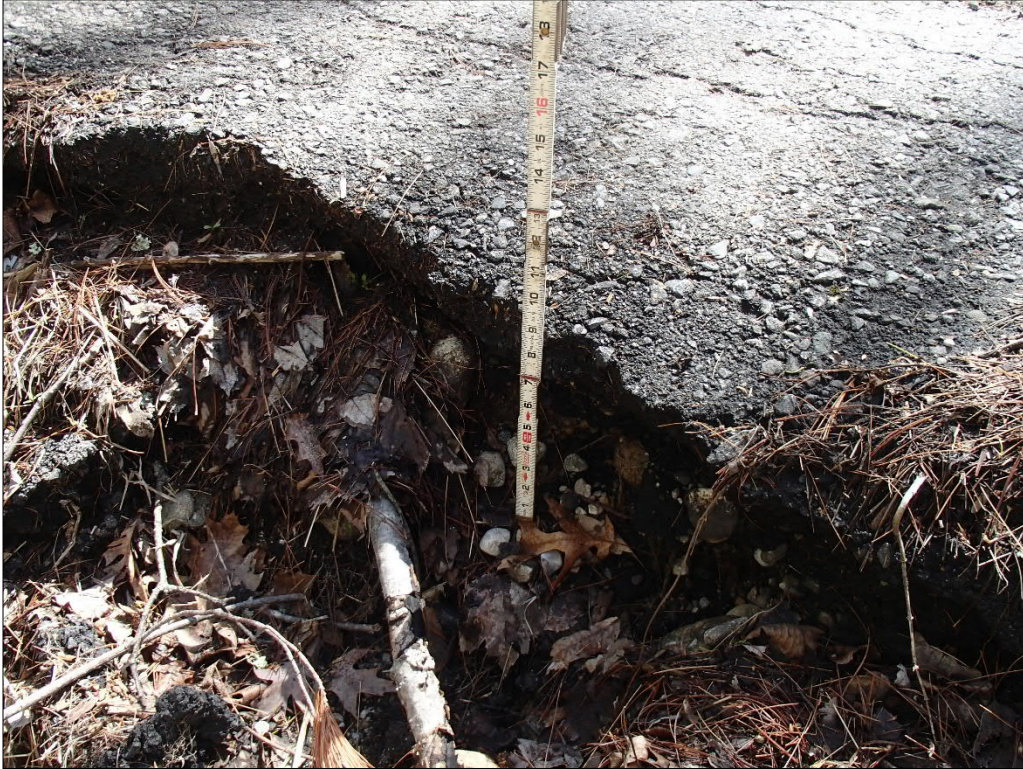
Photo 15 Looking East: Undermining of Pavement near Southwest Wingwall

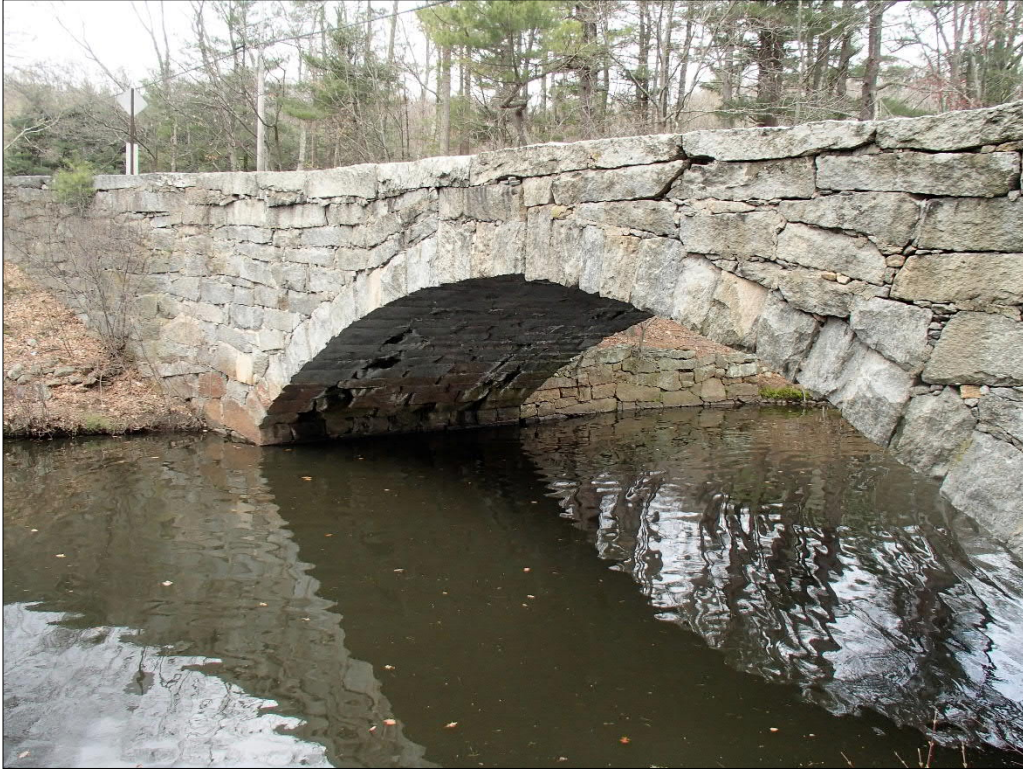
Photo 1 Looking Northwest: South Elevation

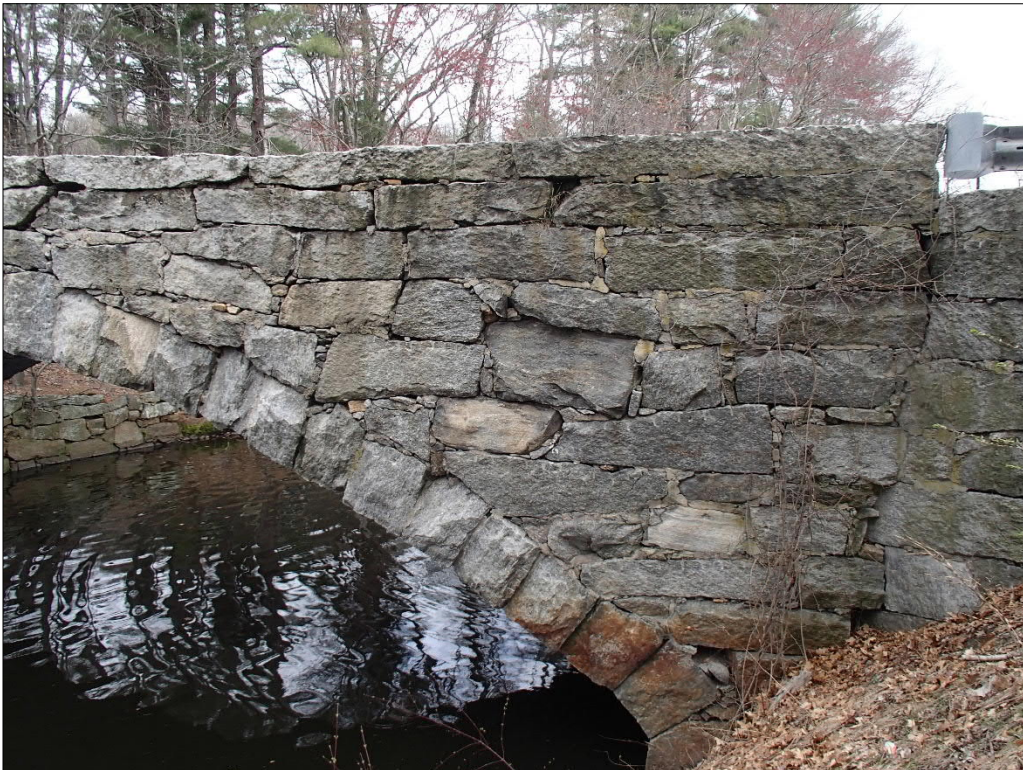
Photo 2 Looking North: Southeast Face

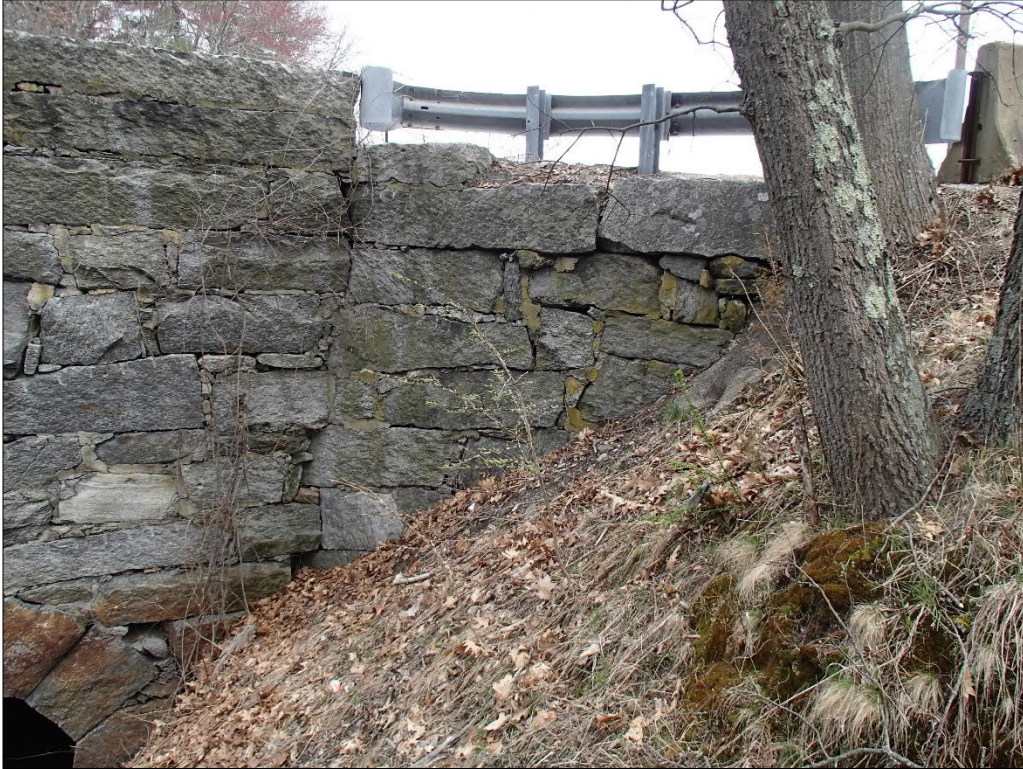
Photo 3 Looking North: Southeast Wingwall

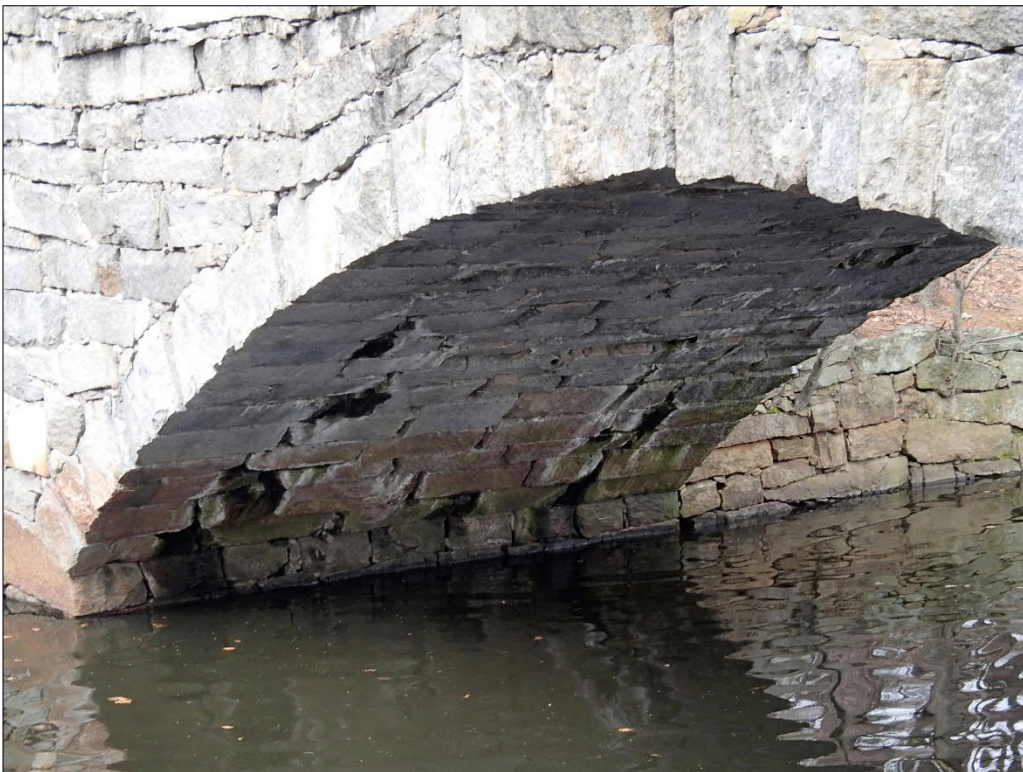
Both abutments are also in fair condition but did exhibit random voids, moderate loss of mortar, and areas of efflorescence (Photos 4 and 5). The east abutment also has a full height crack on the north end and a fractured stone at the center of the abutment. Some scour is present along both abutments, and is continually being monitored.

Photo 4 Looking Northwest: West Arch Abutment

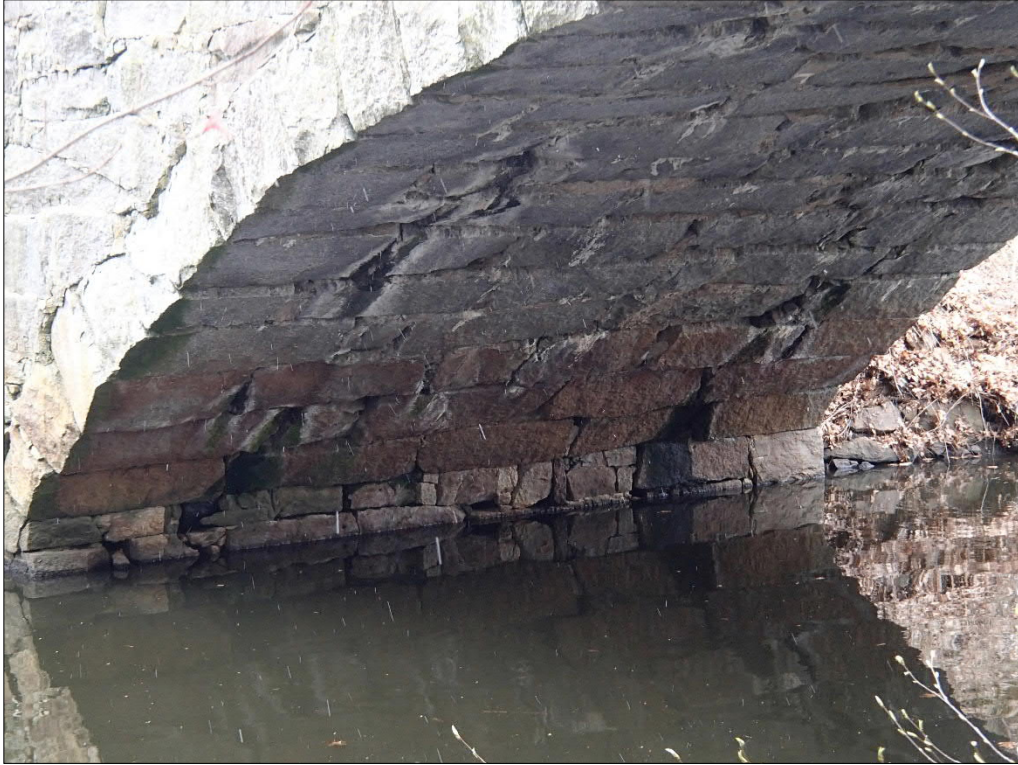
Photo 5 Looking North: Southeast: East Arch Abutment

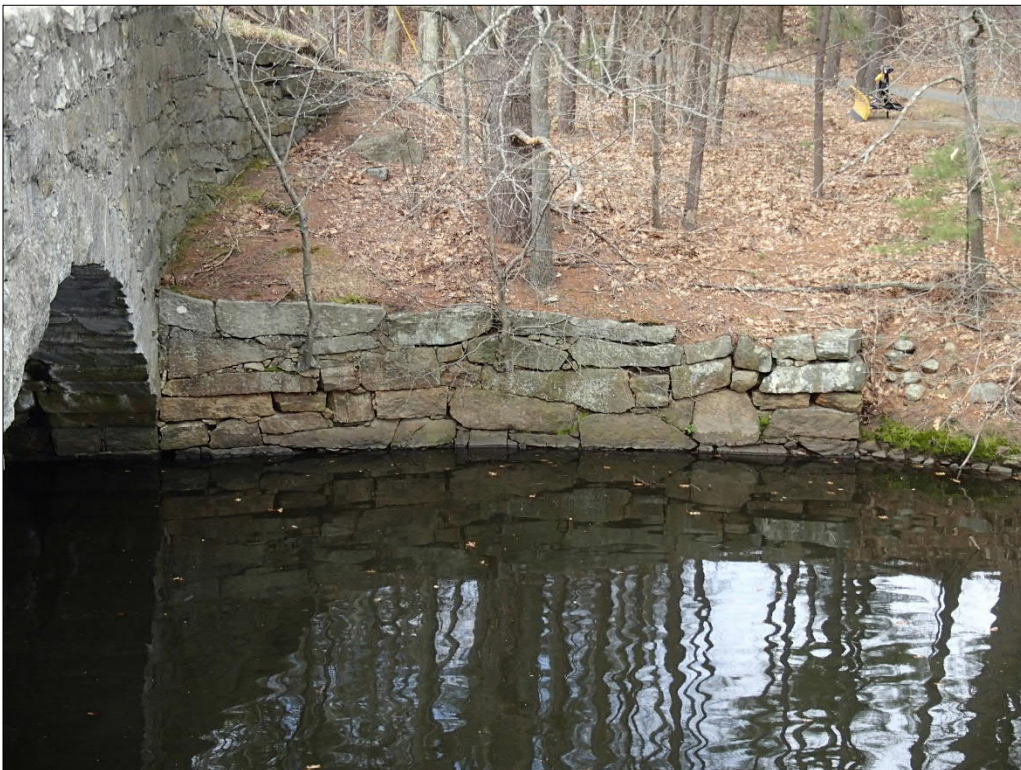
Photo 6 Looking West: Northwest Training Wall

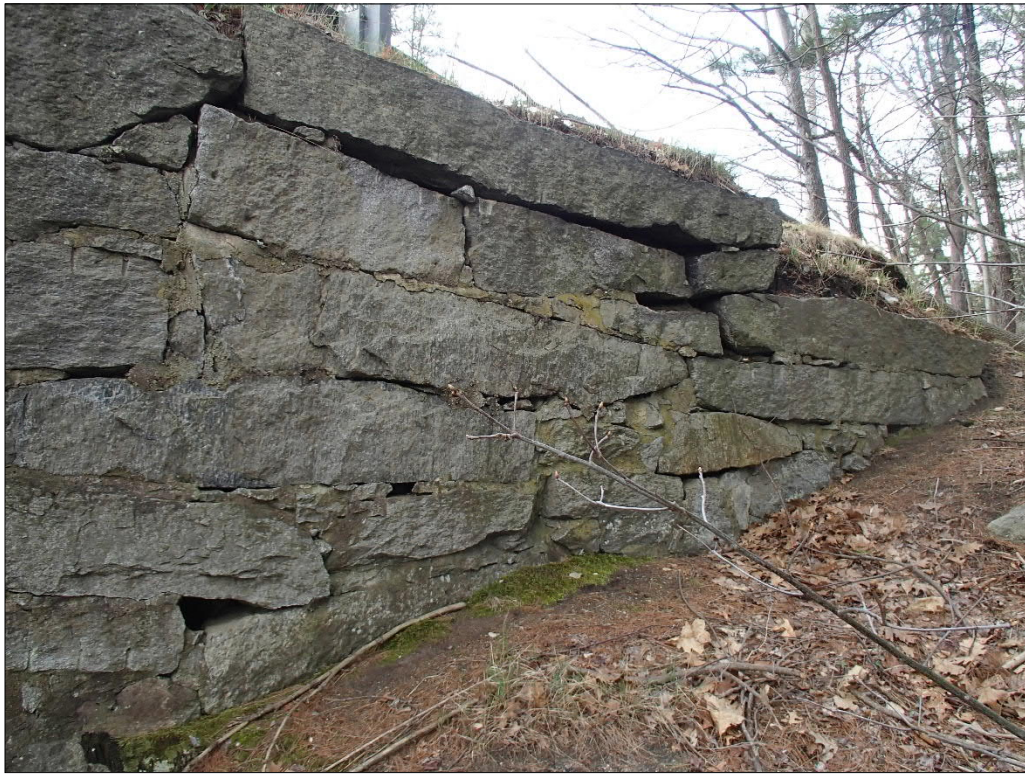
Photo 7 Looking Southwest: Northwest Wingwall

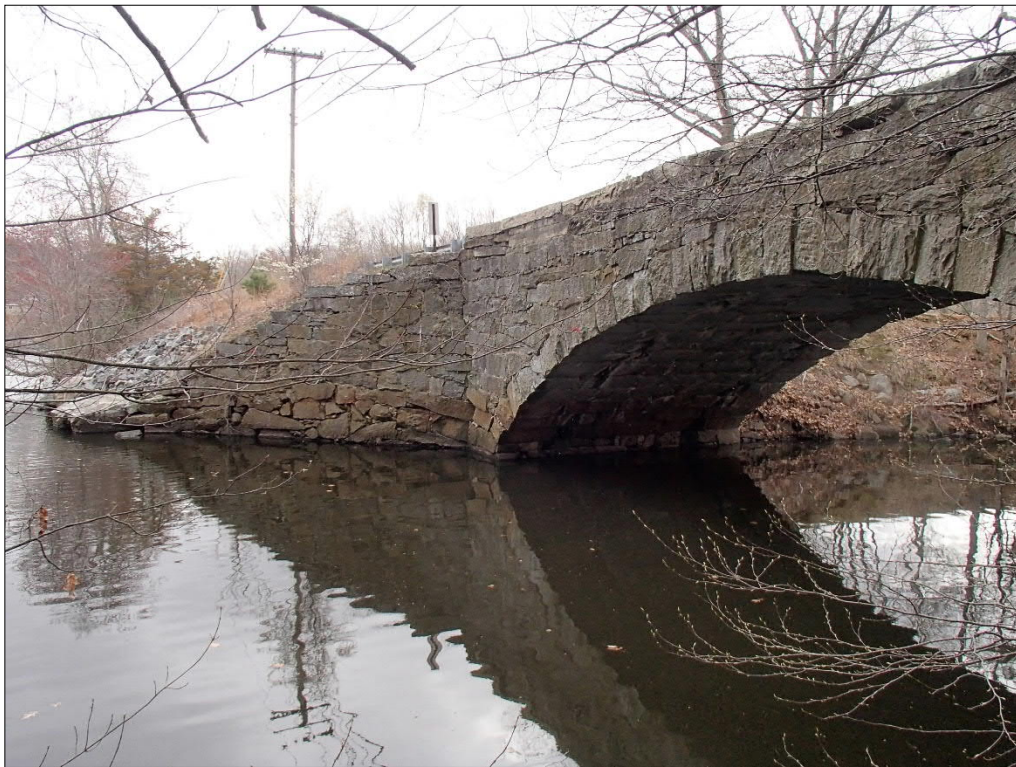
Photo 8 Looking East: North Elevation & Northeast Wingwall

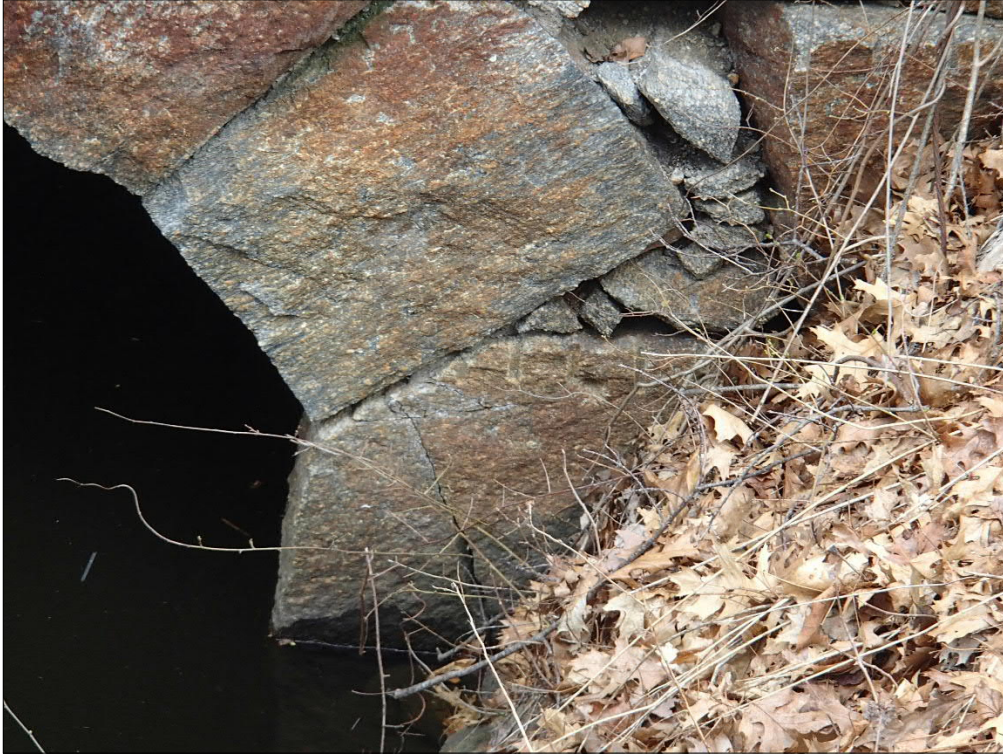
throughout, but there was a crack noted at the southeast arch ring corner (Photo 9). Additionally, there is a coping stone falling off on the north face (Photo 10).

The training walls on the north side of the bridge typically show missing mortar and chinking stones up to 5' above the waterline. The wingwalls on the south side of the bridge have some missing mortar and chinking stones as well but with some vegetation. The southeast wall also has a large 7"x12"x66" deep void where it meets the arch structure (Photo 9).

Photo 9 Looking North: Southeast Arch Bottom Corner

- Replace all loose stones and fill all voids to the stone bridge railing.
- Repair/Seal all cracks to the asphaltic wearing surface over the arch structure.
- Replace all missing and/or loose chinking stones in the stone arch, abutments, spandrel walls, training walls, and wingwalls.
- Repoint all masonry joints to the stone arch, abutments, spandrel walls, training walls, and wingwalls.
- Repair all cracked stones in the stone arch and abutments.
- Fill in any scour holes along both abutments.

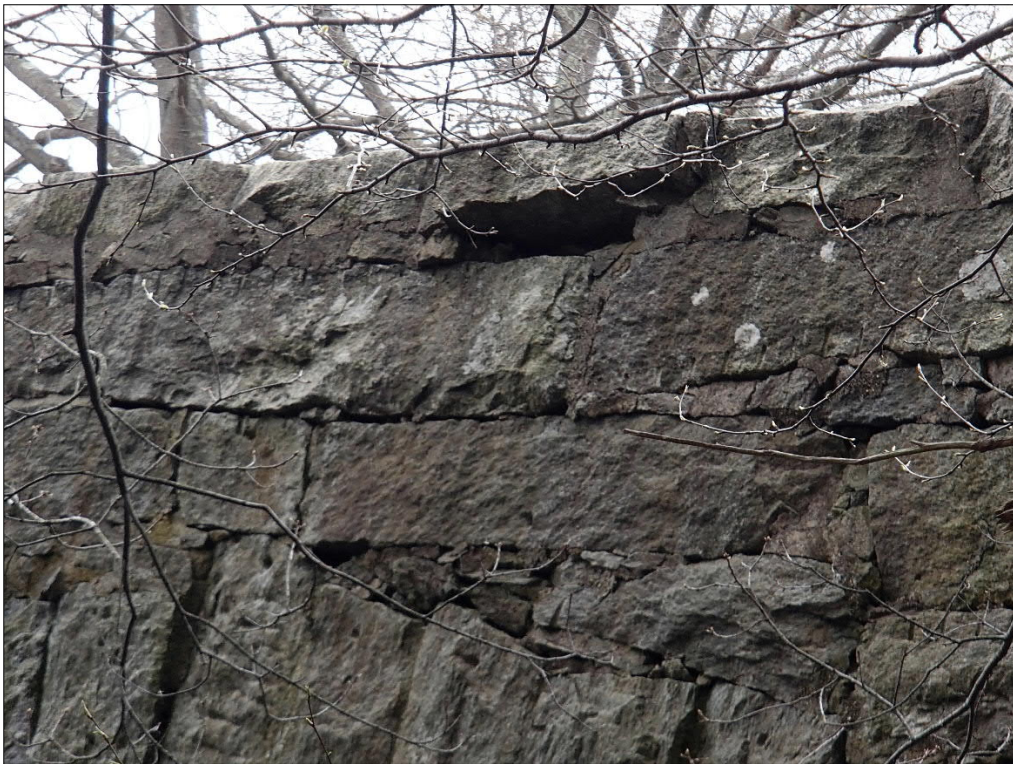
Photo 10 Looking South: North Coping Stone Movement

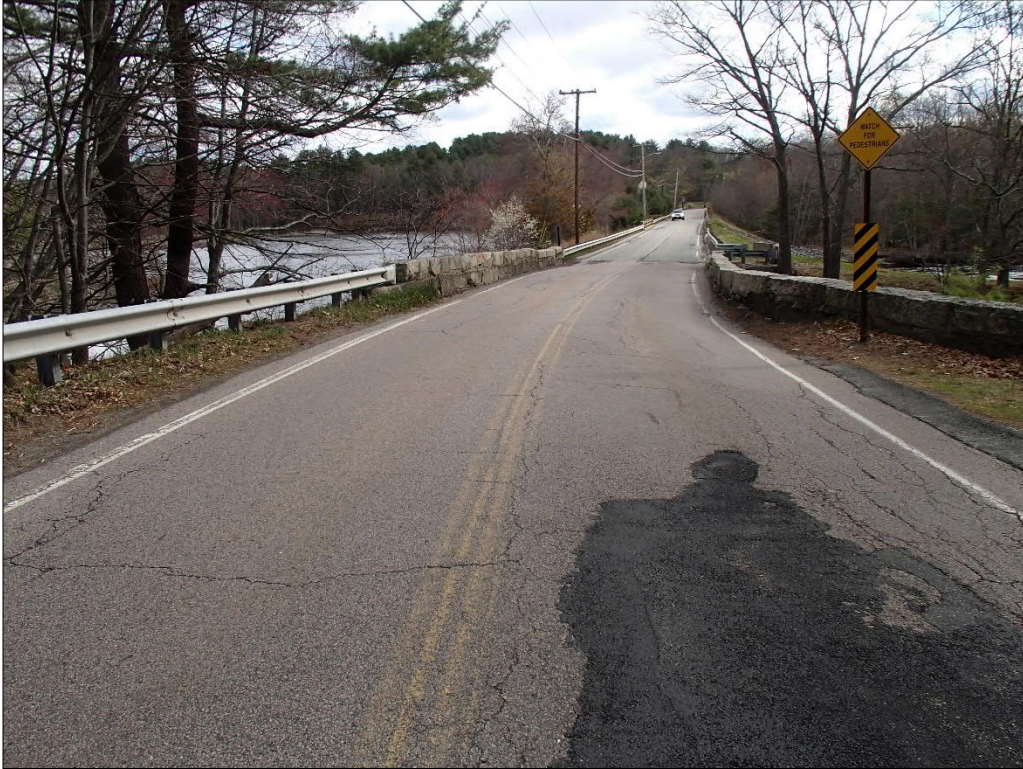
Photo 11 Looking East: West Approach

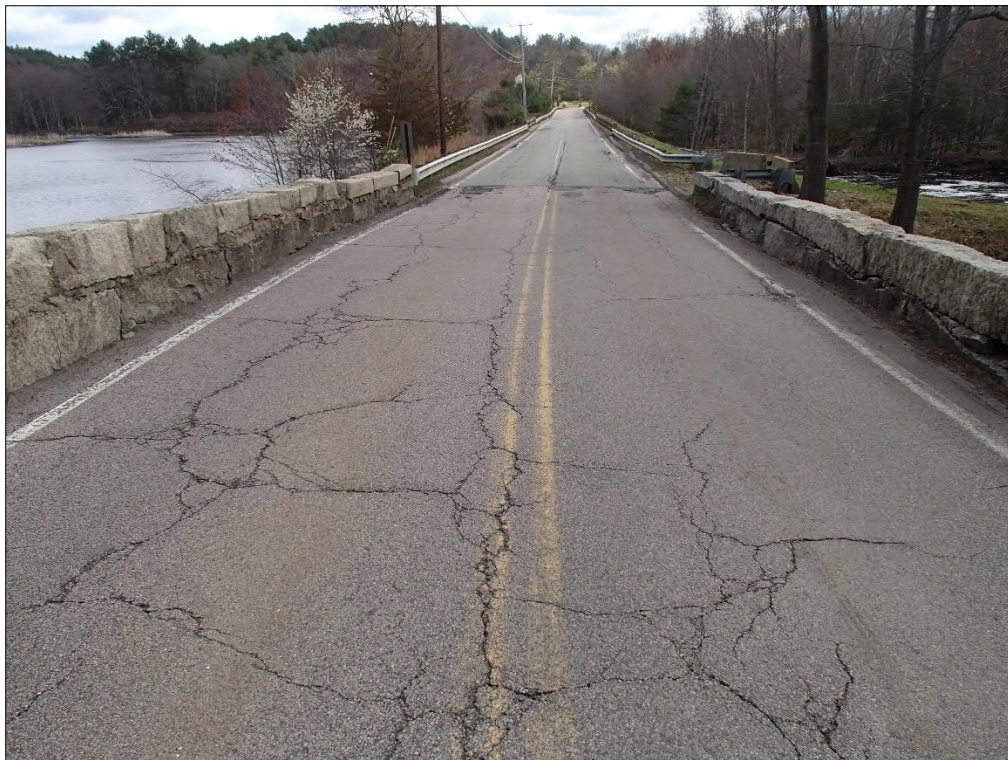
Overall, the roadway is in fair condition with moderate pavement cracking throughout (Photo 12). The west approach has limited visibility. The east approach has an area of pavement patching where it goes over the bridge (Photo 13). The stone bridge railing on the south side has moderate mortar loss with voids and an area of full penetration (Photo 14).

Photo 12 Looking East: Culvert Roadway

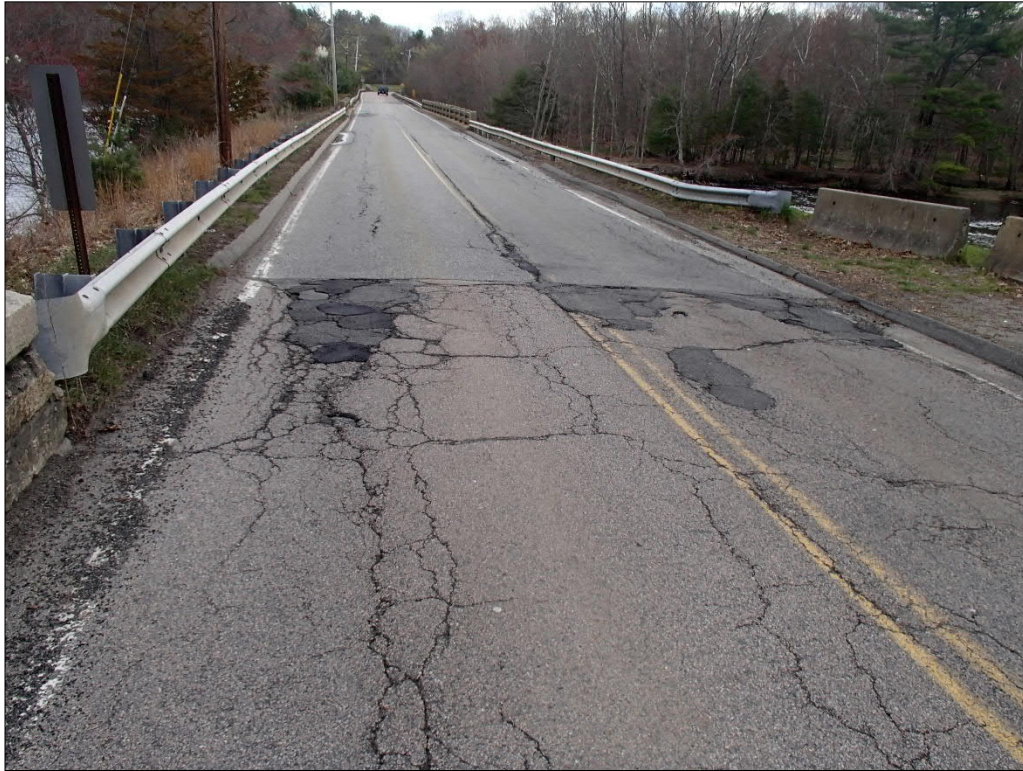
Photo 13 Looking East: Patching Near East Approach

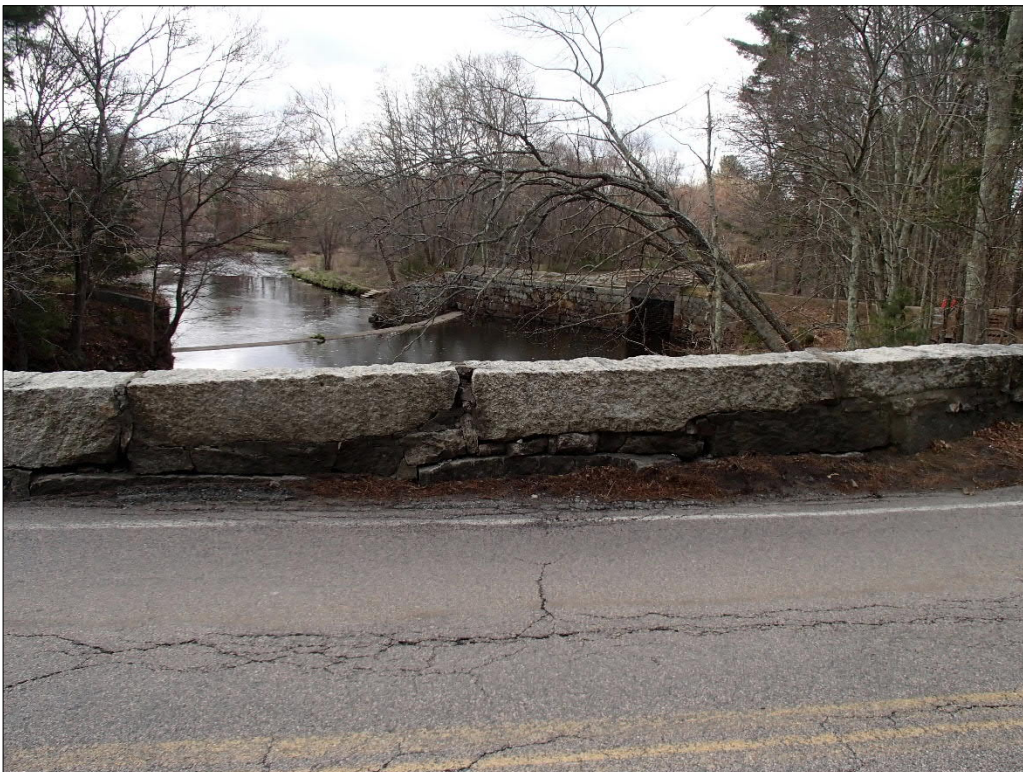
Photo 14 Looking South: South Stone Barrier

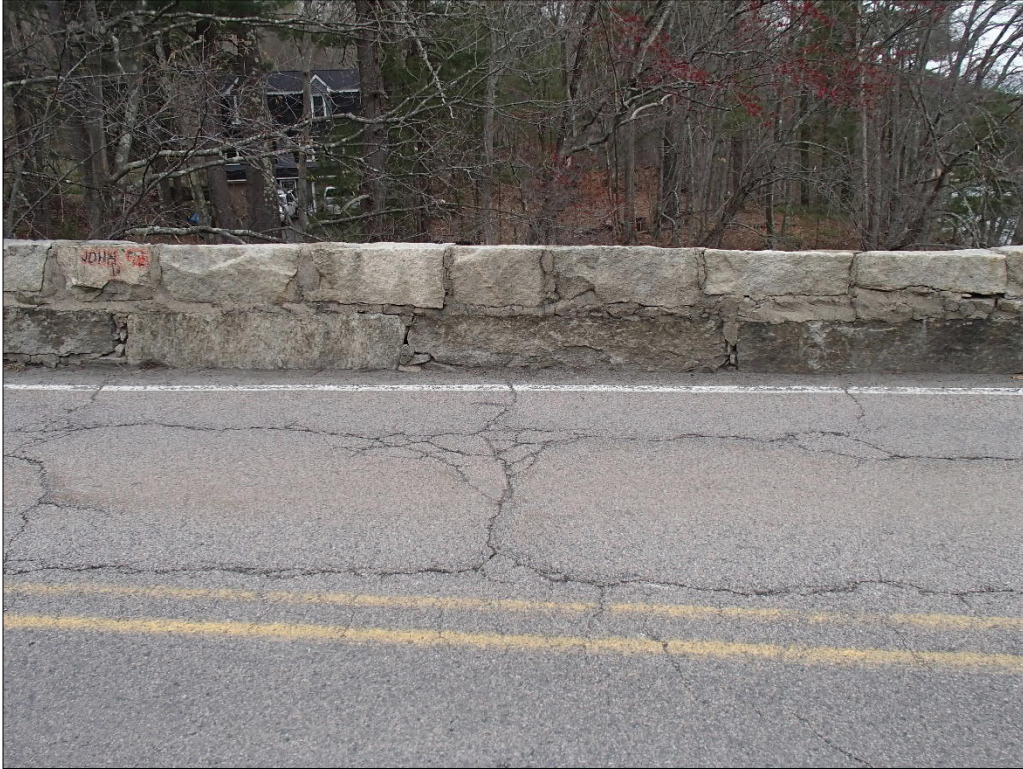
Photo 15 Looking North: North Stone Barrier

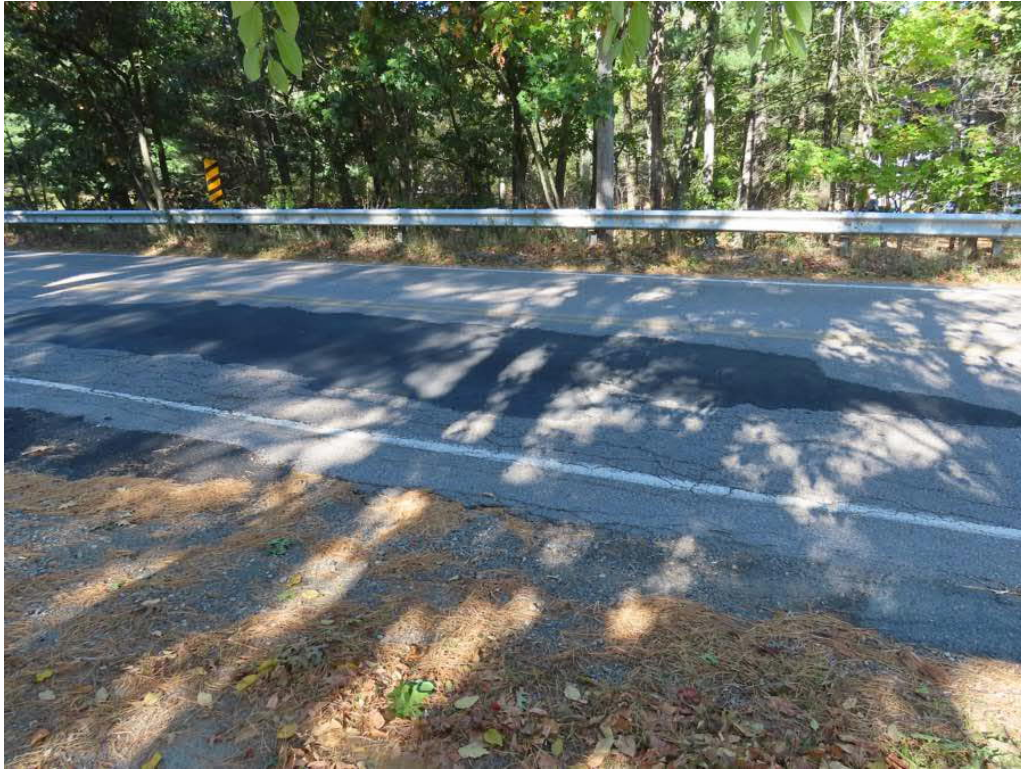
Photo 3: West approach pavement.

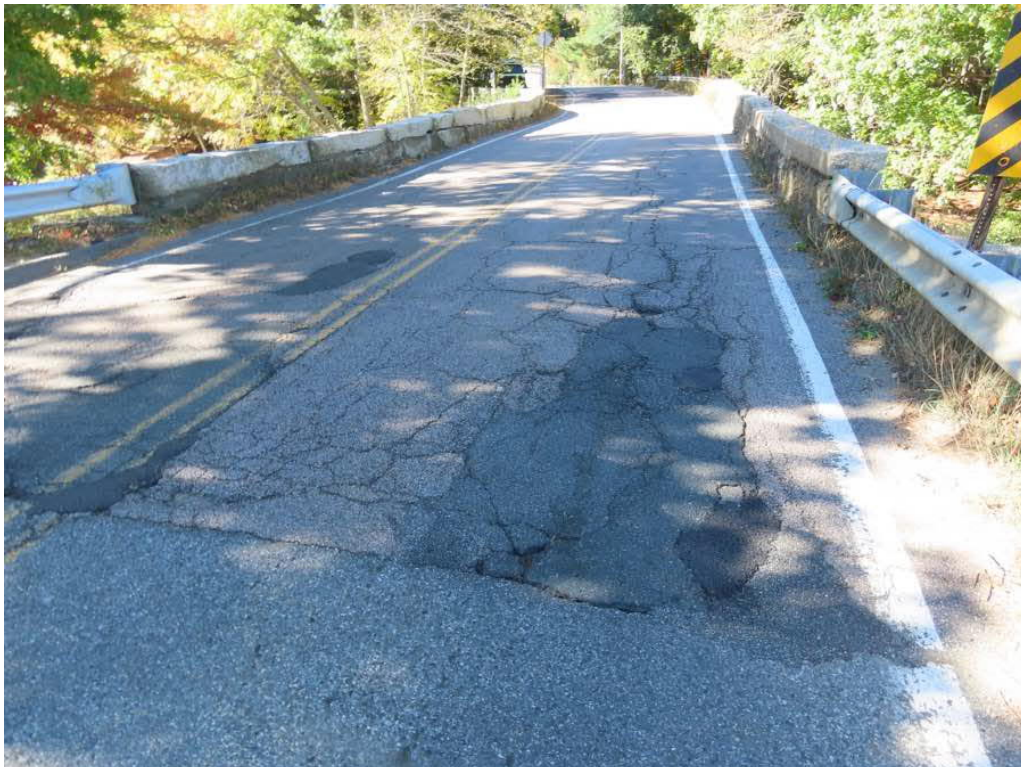
Photo 4: East approach pavement.

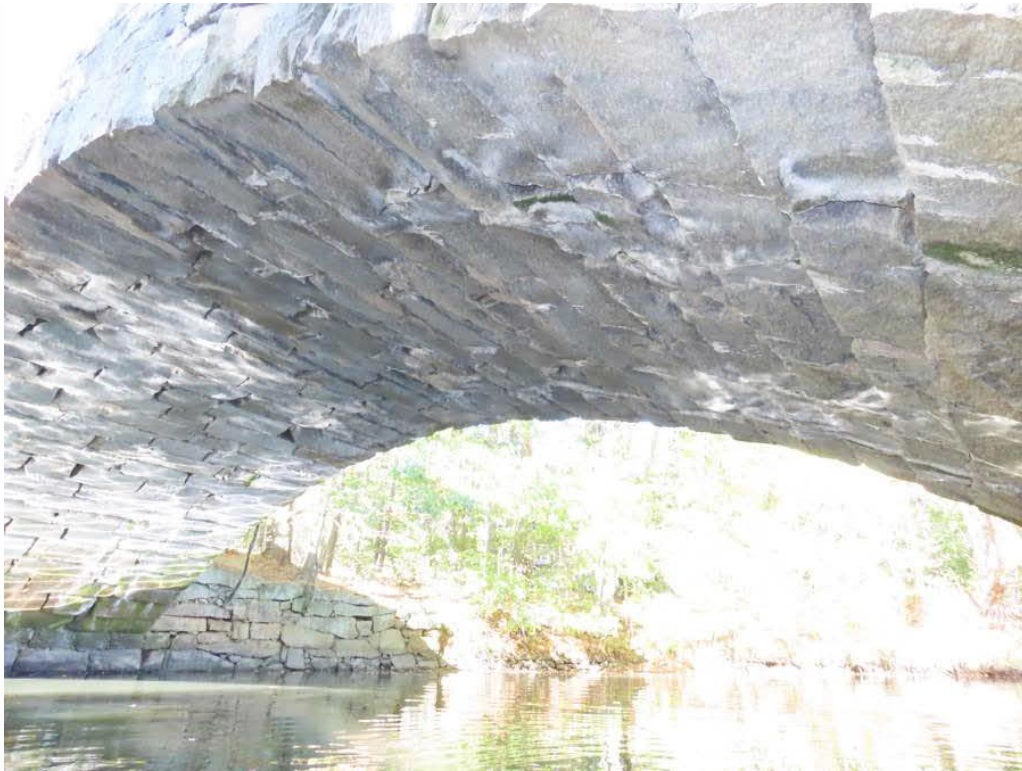
Photo 5: Underside of the arch. View from the Southeast corner.

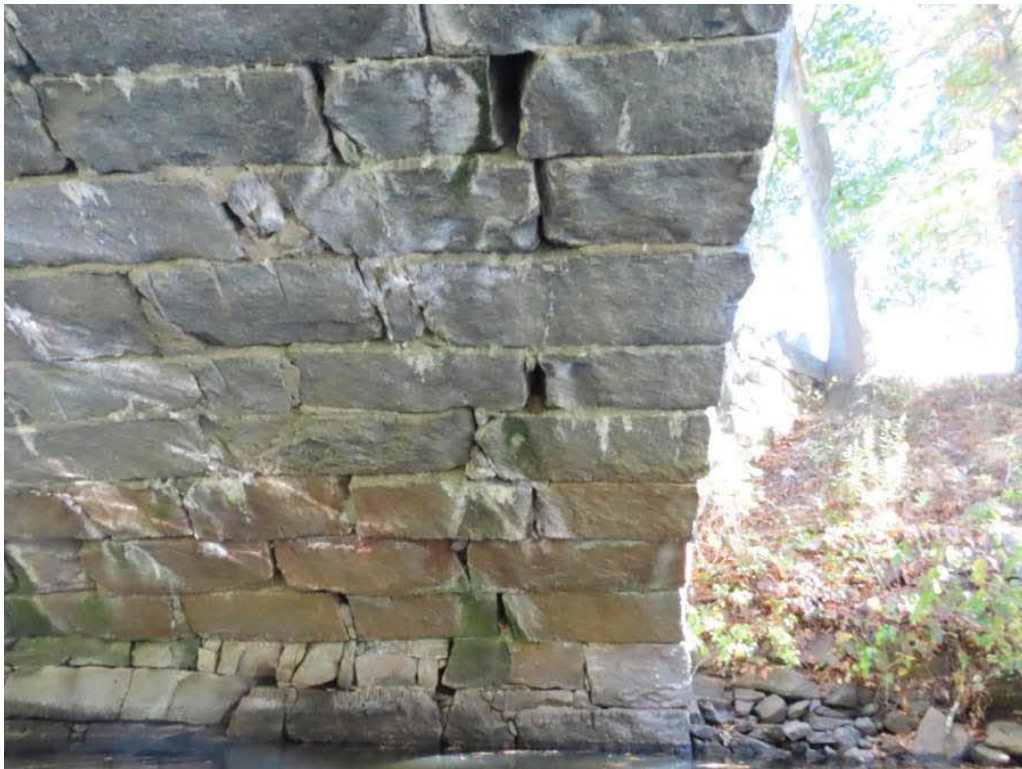
Photo 6: Southeast corner of the arch.

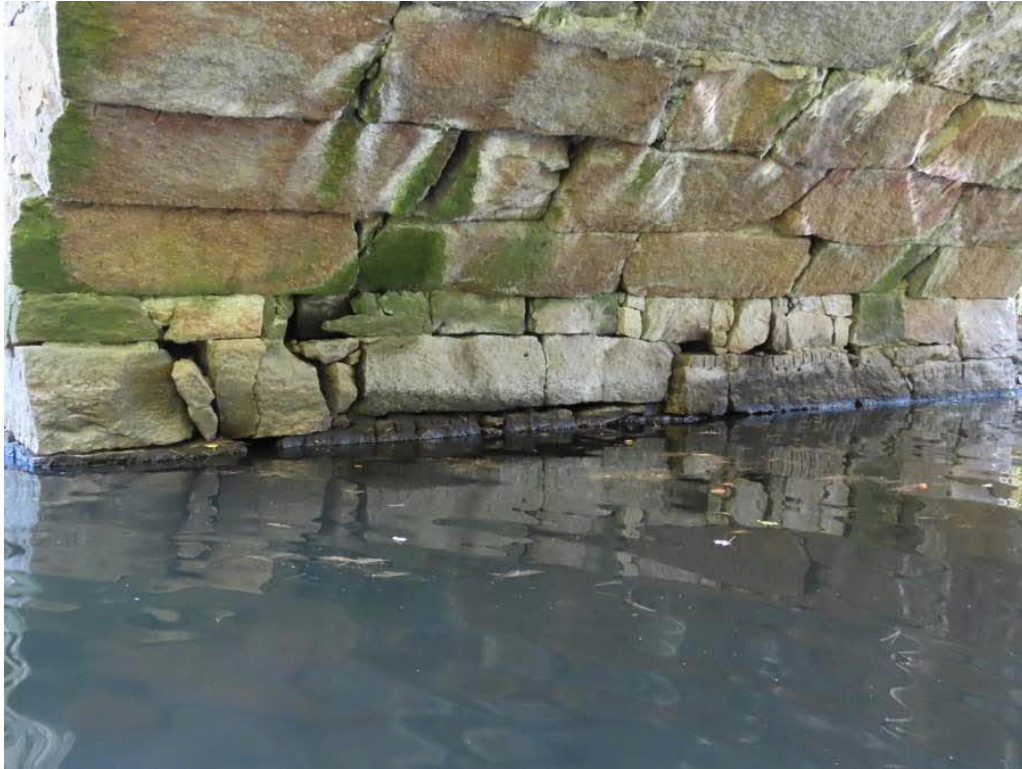
Photo 11: East breastwall.

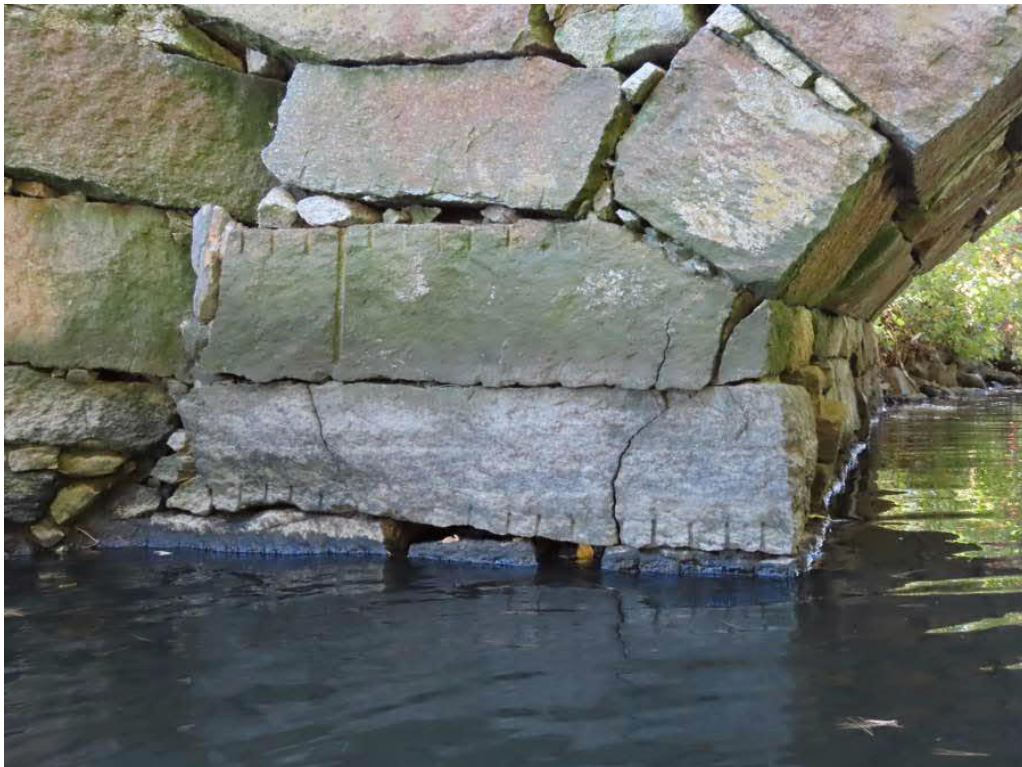
Photo 12: East breastwall North end.

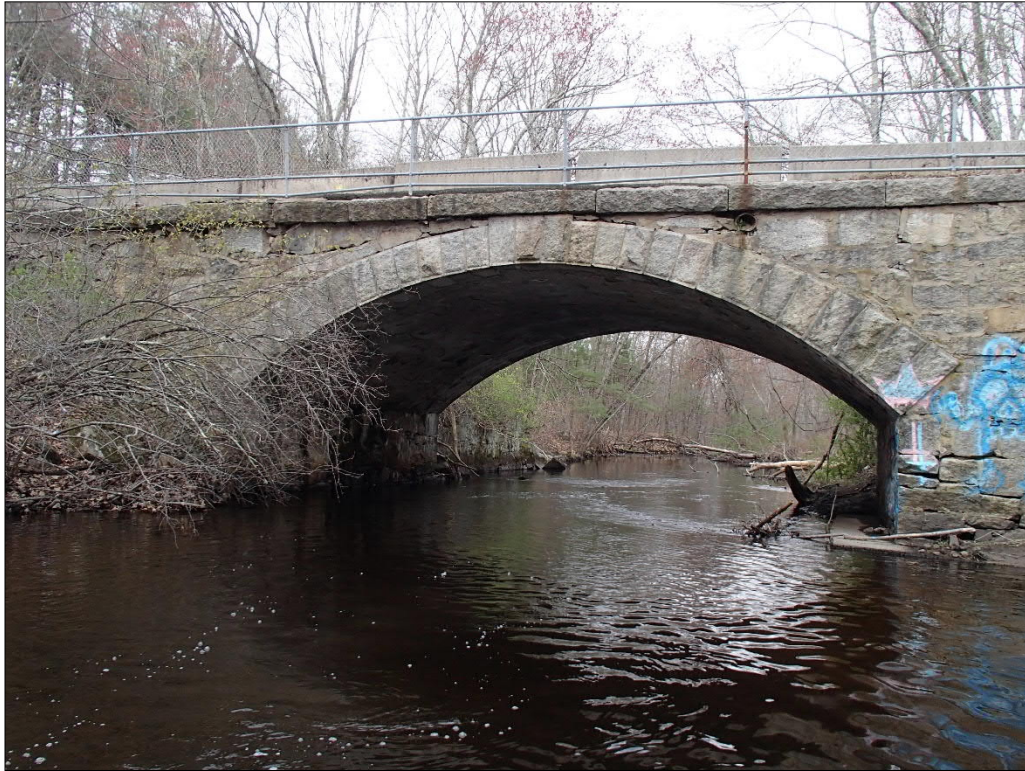
Photo 1 Looking West: East Culvert Elevation

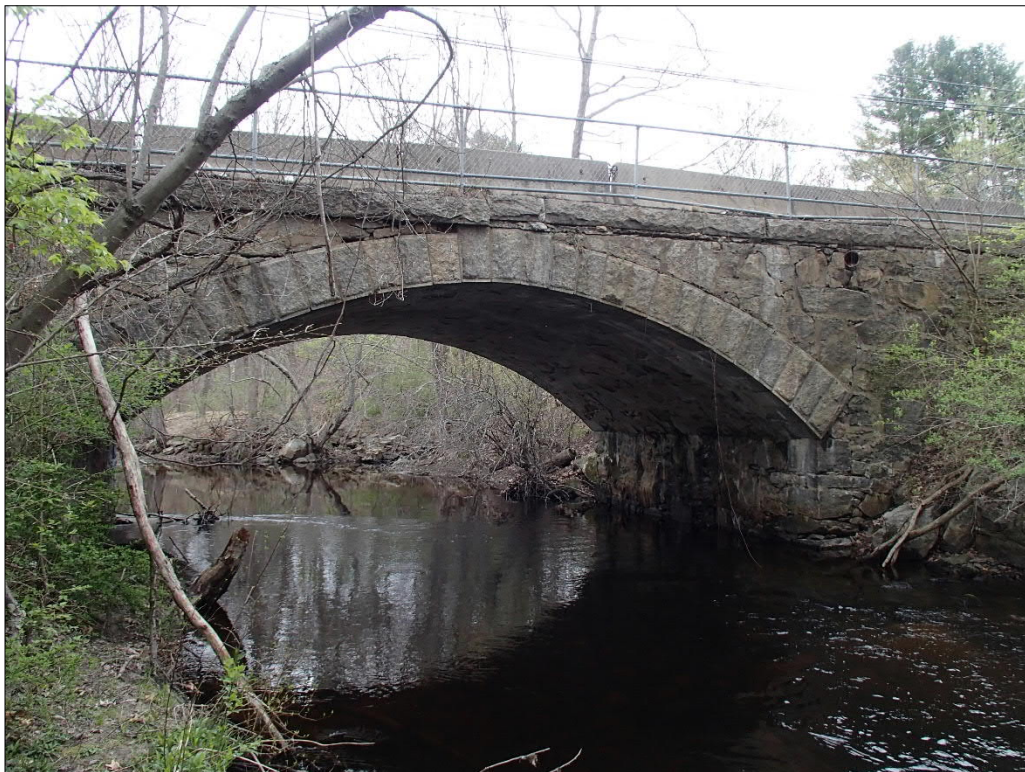
Photo 2 Looking East: West Culvert Elevation

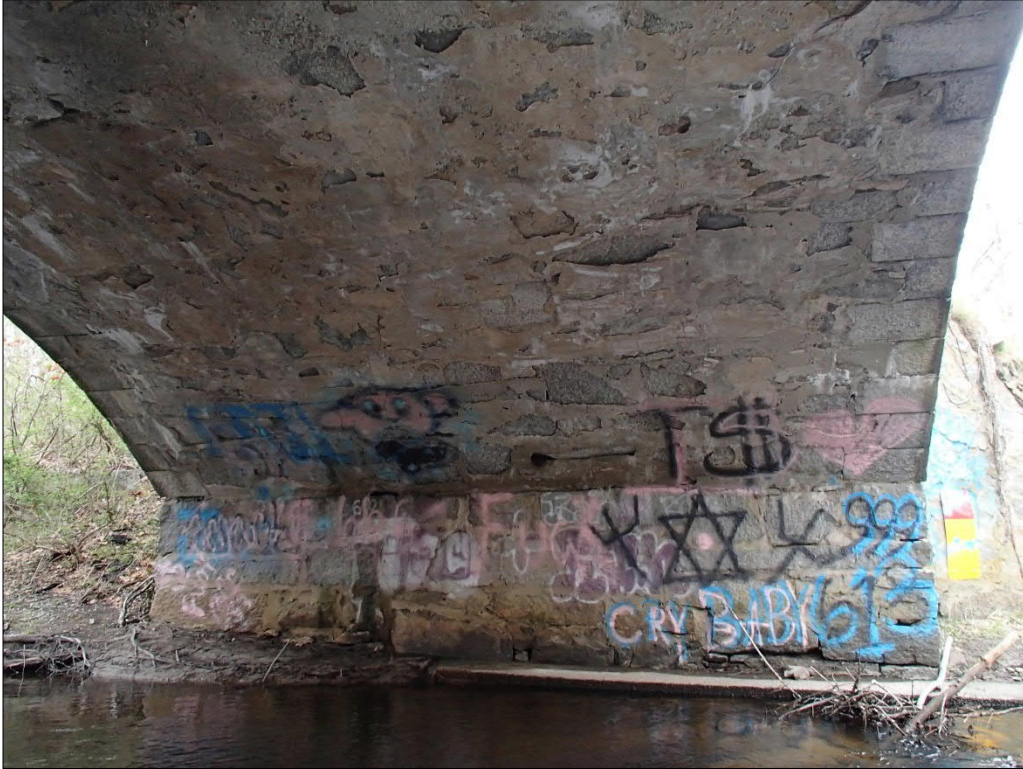
Photo 3 Looking North: North Abutment

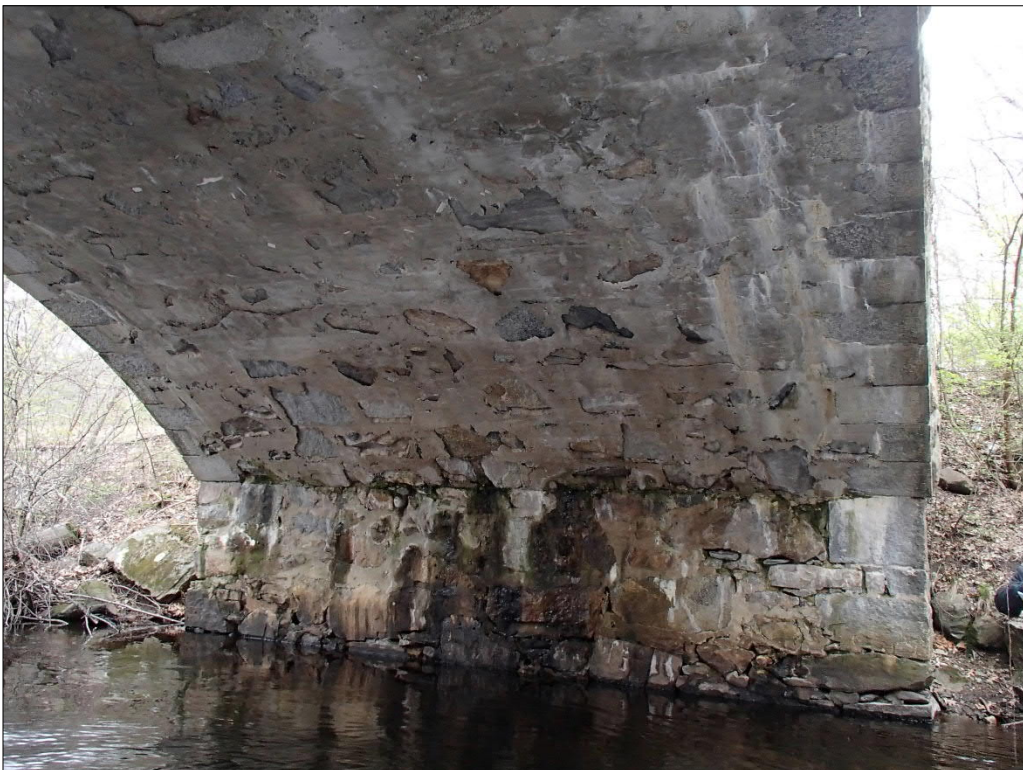
Photo 4 Looking South: South Abutment

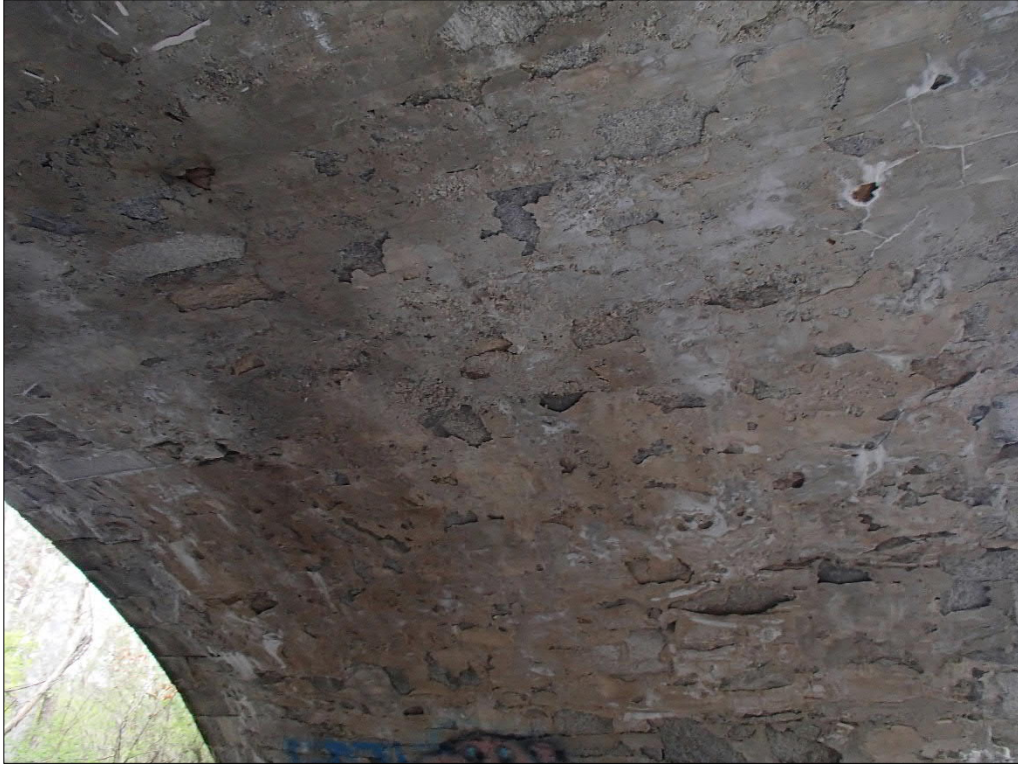
Photo 5 Looking North: North Spandrel Wall
