Uxbridge, Massachusetts
Evaluation Report
Project Number: 7533
June 2021

BRIDGE / CULVERT MANAGEMENT PLAN

Prepared by: BETA GROUP, INC.
Prepared for: Town of Uxbridge

June 2021

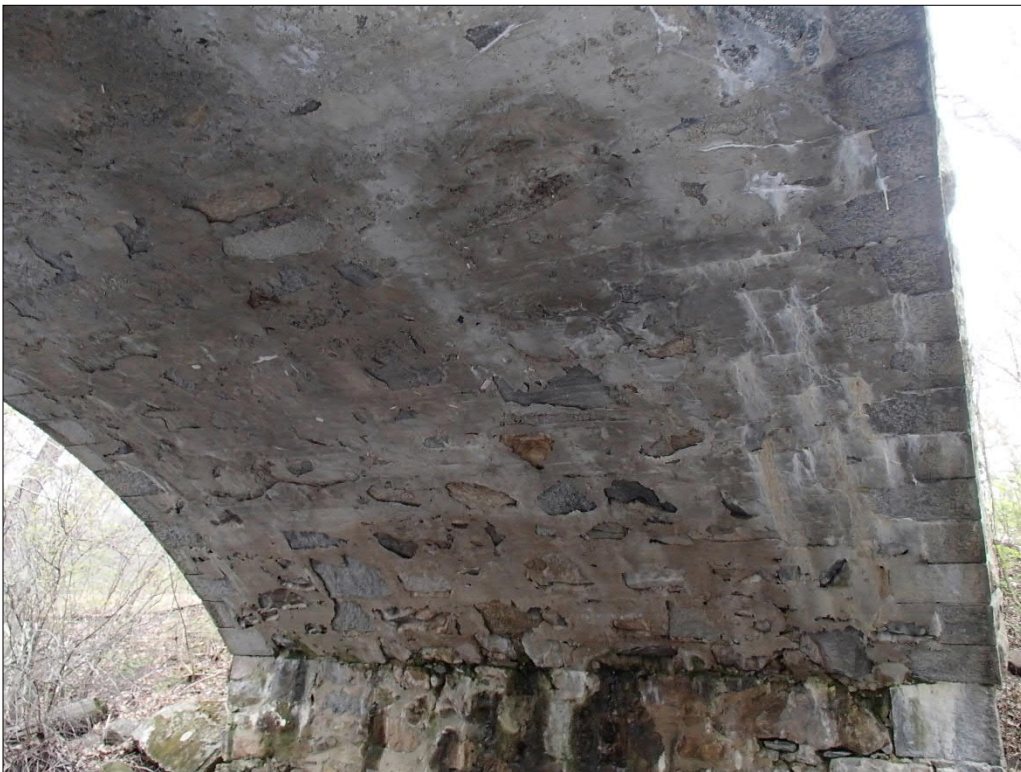
Photo 6 Looking South: South Spandrel Wall

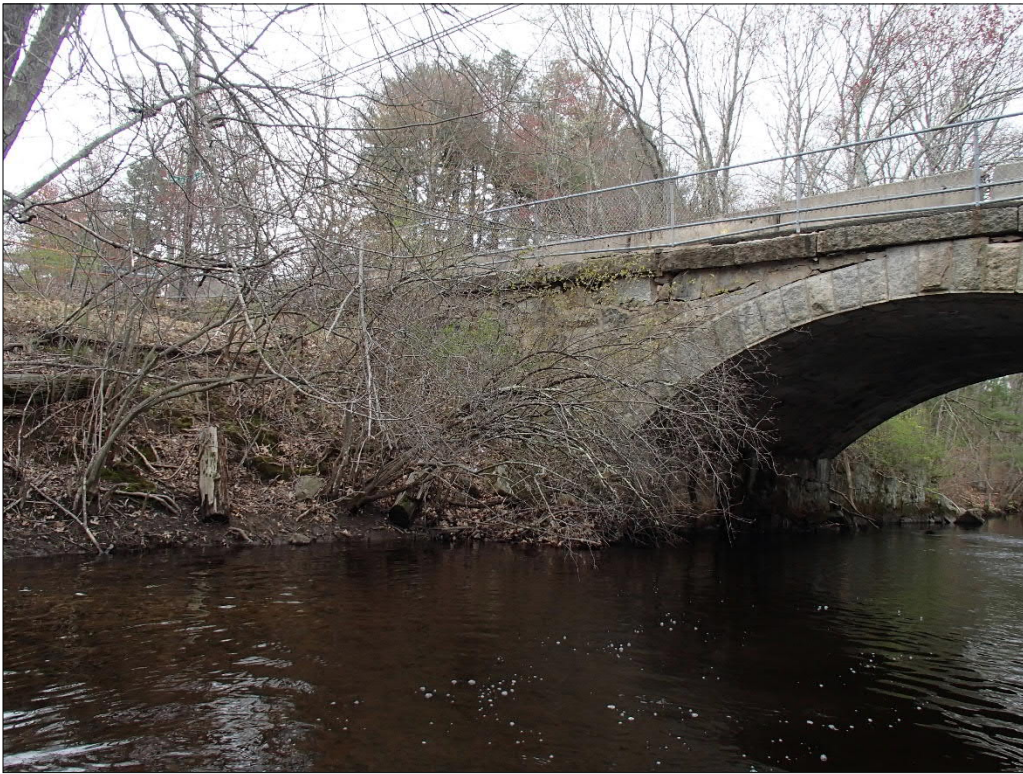
Photo 7 Looking West: Southeast Wingwall

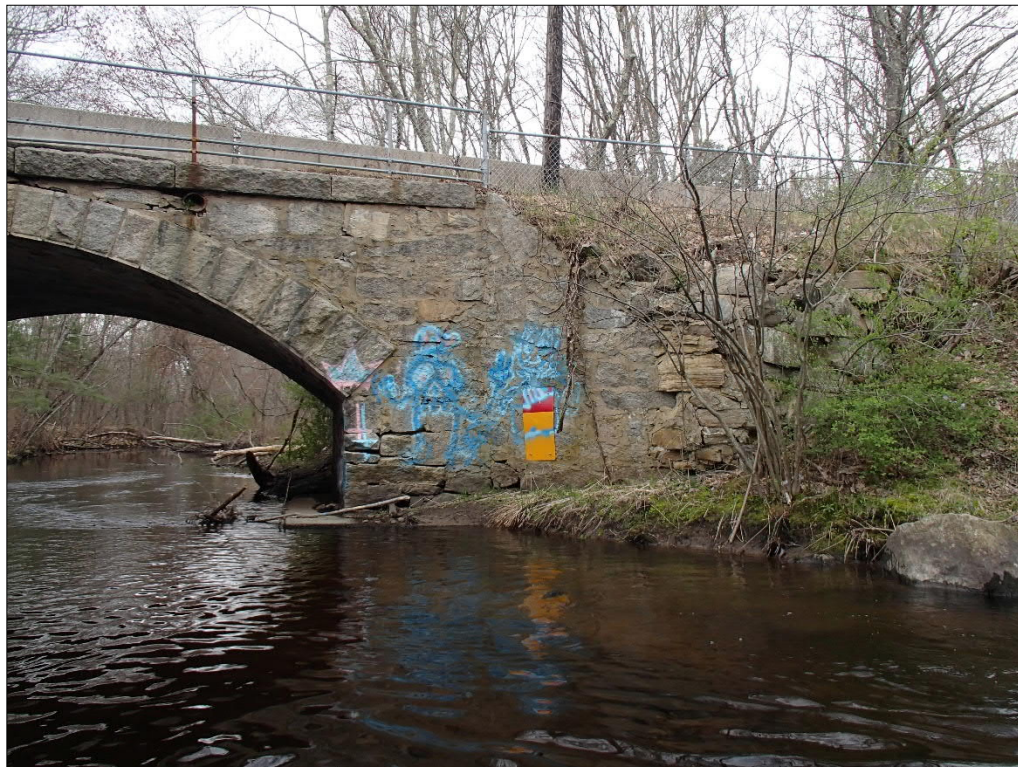
Photo 8 Looking West: Northeast Wingwall

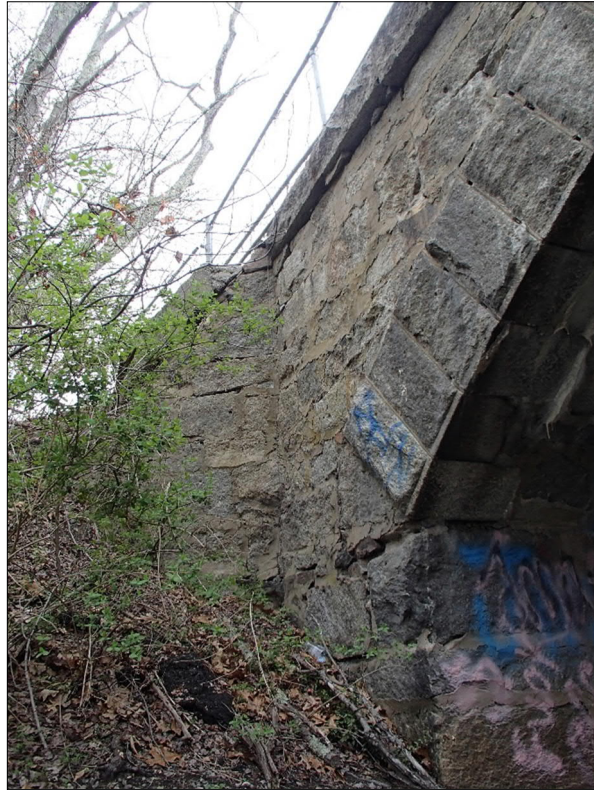
Photo 9 Looking North: Northwest Wingwall

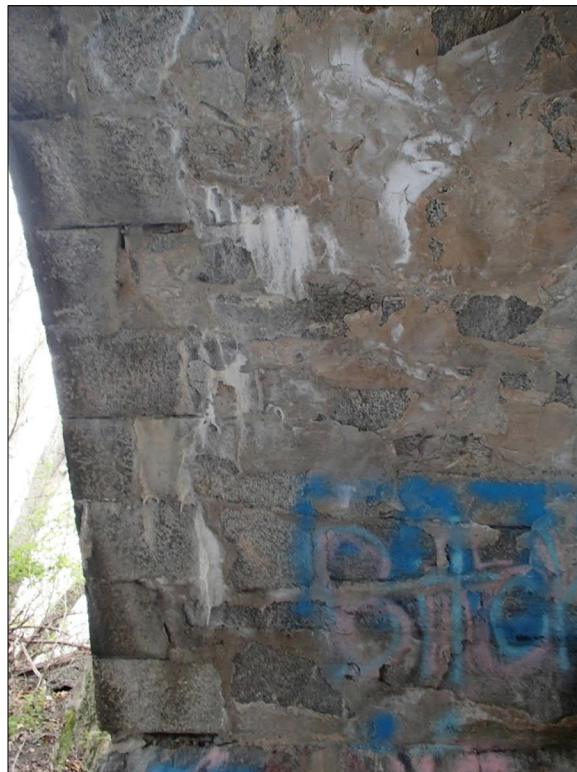
Photo 12 Looking North: Northwest Spandrel Roof

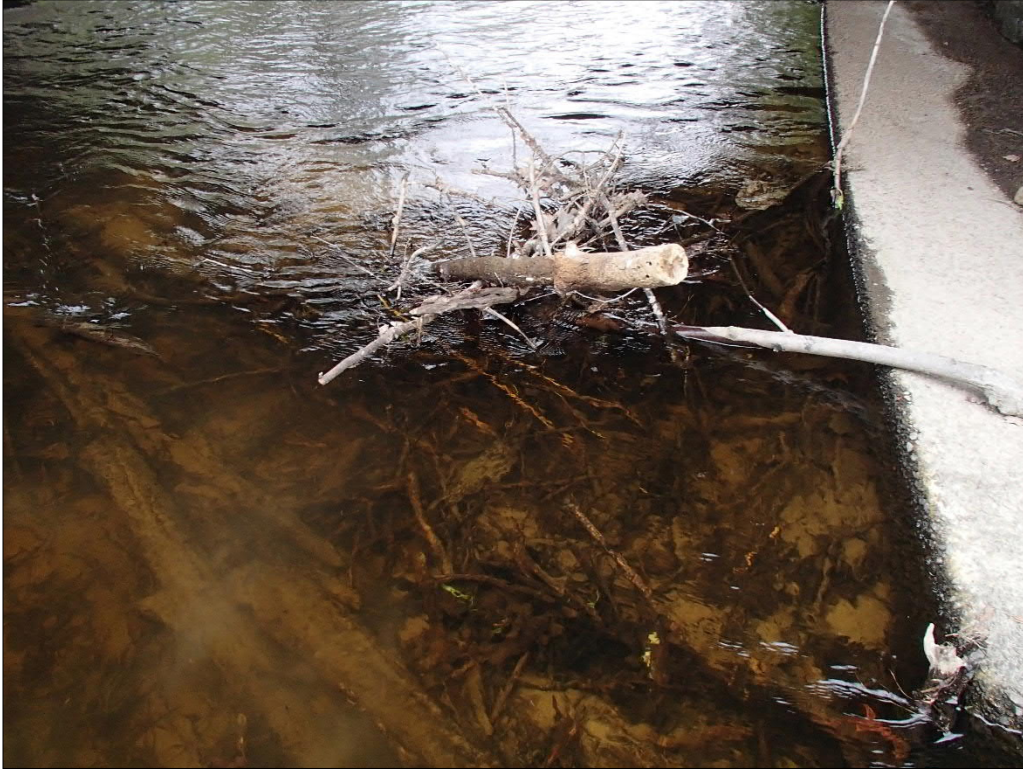
Photo 13 Looking West: Debris in River

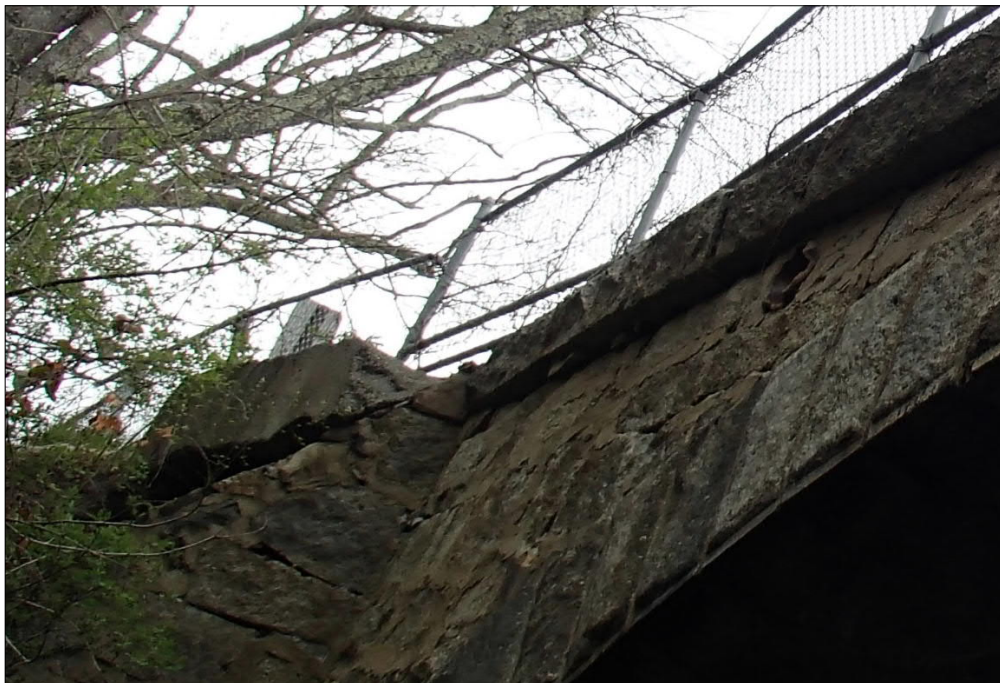
Photo 14 Looking Northeast: Undermining of Slab near Northwest Wall

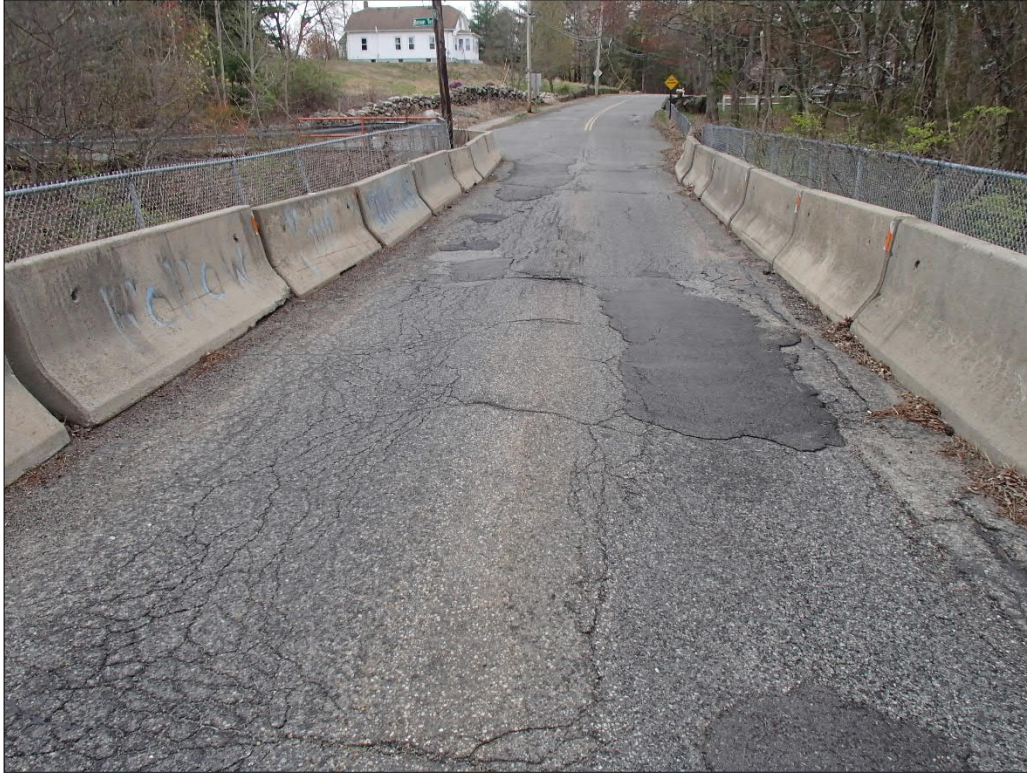
The condition of the roadway is poor, especially over the arch. There is random longitudinal, transverse, and map cracking throughout the pavement. There is moderate heaving and random settlement throughout as well, which is most noticeable around the crown over the culvert. The bridge railing consists of only a chain link fence and is not a crash tested system. In addition, stone displacement at the top of the spandrel wall has compromised the railing base/foundation (Photo 19). The edge of pavement at the east fascia is fragmented, and the roadway appears unstable. Jersey barriers at both curb lines have created a large reduction of lane width and have made both sidewalks inaccessible to pedestrians (Photos 21 and 22). Pedestrian traffic is restricted to sub-standard vehicular travel lanes and poses a severe safety hazard.

Photo 15 Looking South: Pavement over Culvert

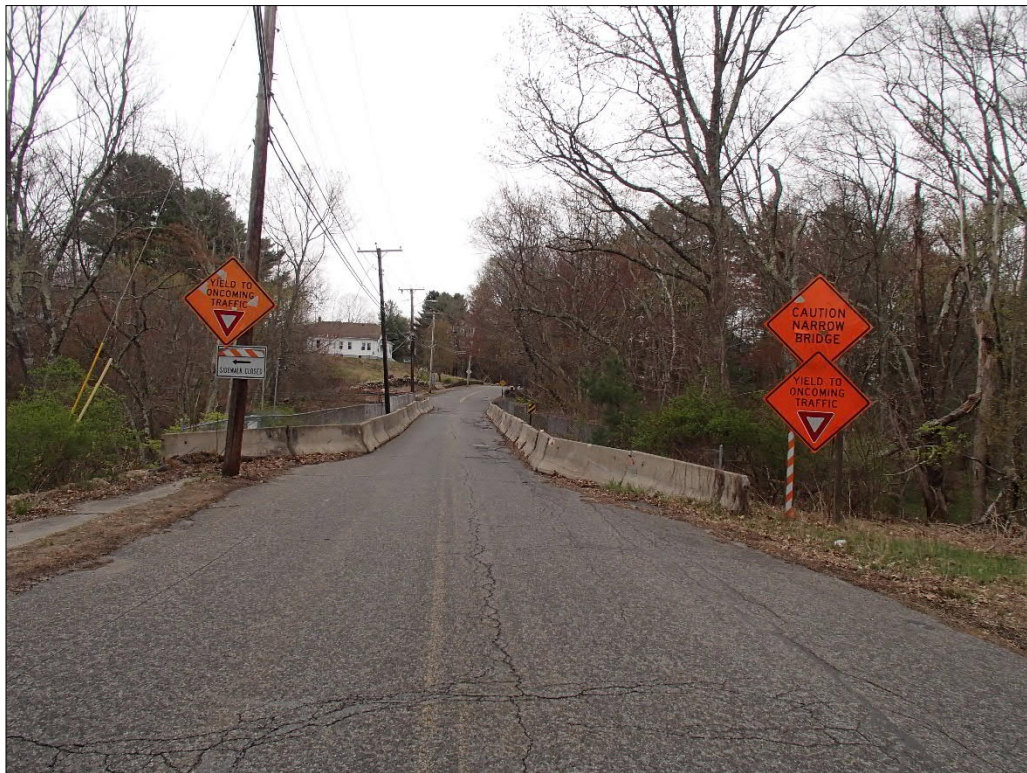
There are several signs posted at this bridge. At both approaches, there are signs that read "Weight Limit 14 Tons", "Yield to Pedestrians", and "Caution Narrow Bridge". Additionally, at the north approach, there are also signs that read "Sidewalk Closed" and "Yield to Oncoming Traffic" (Photos 16 & 17).

Photo 16 Looking South: North Approach

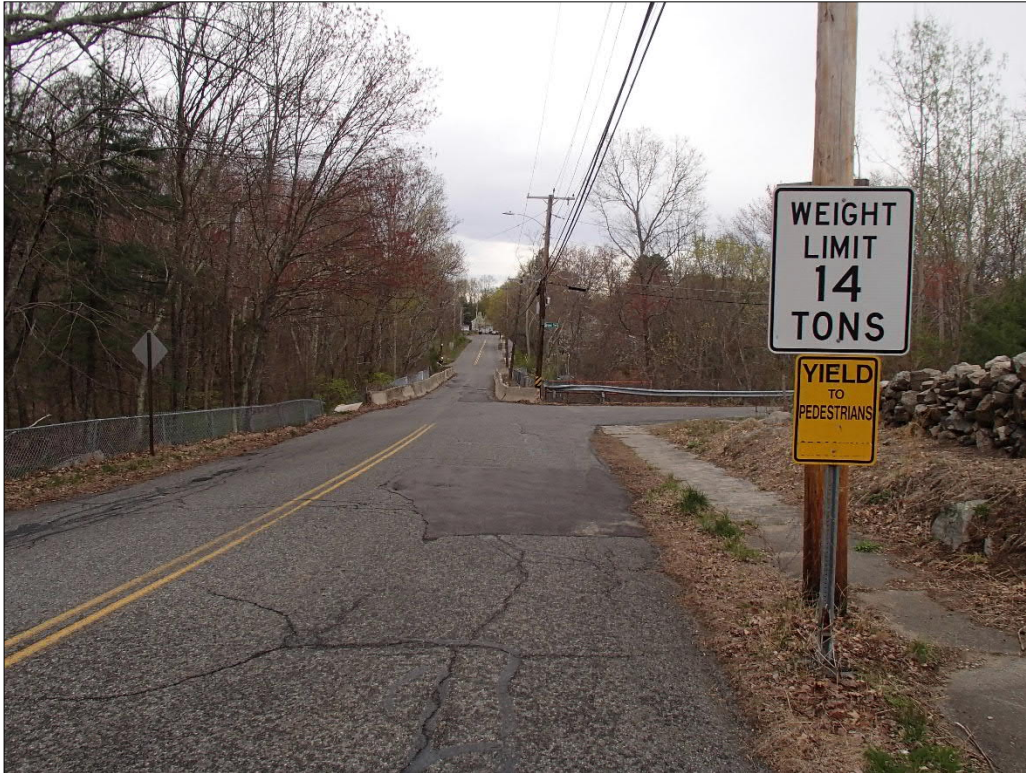
Photo 17 Looking North: South Approach

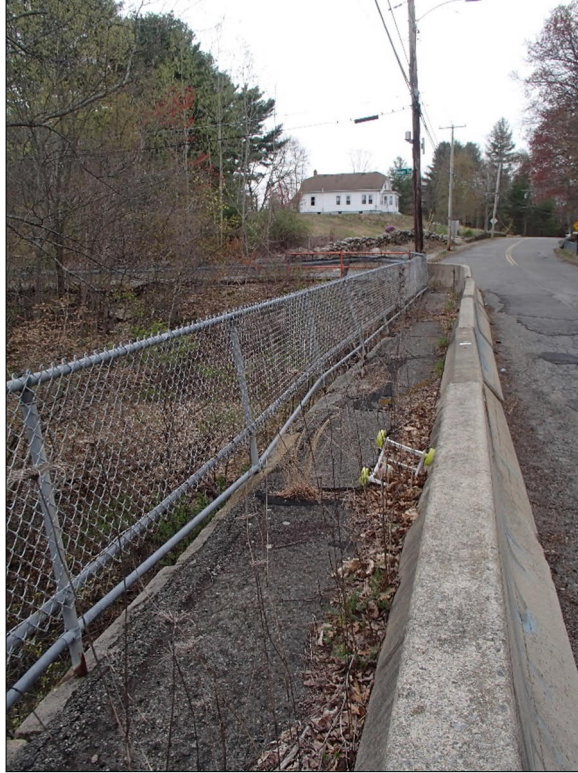
Photo 19 Looking South: East Fence

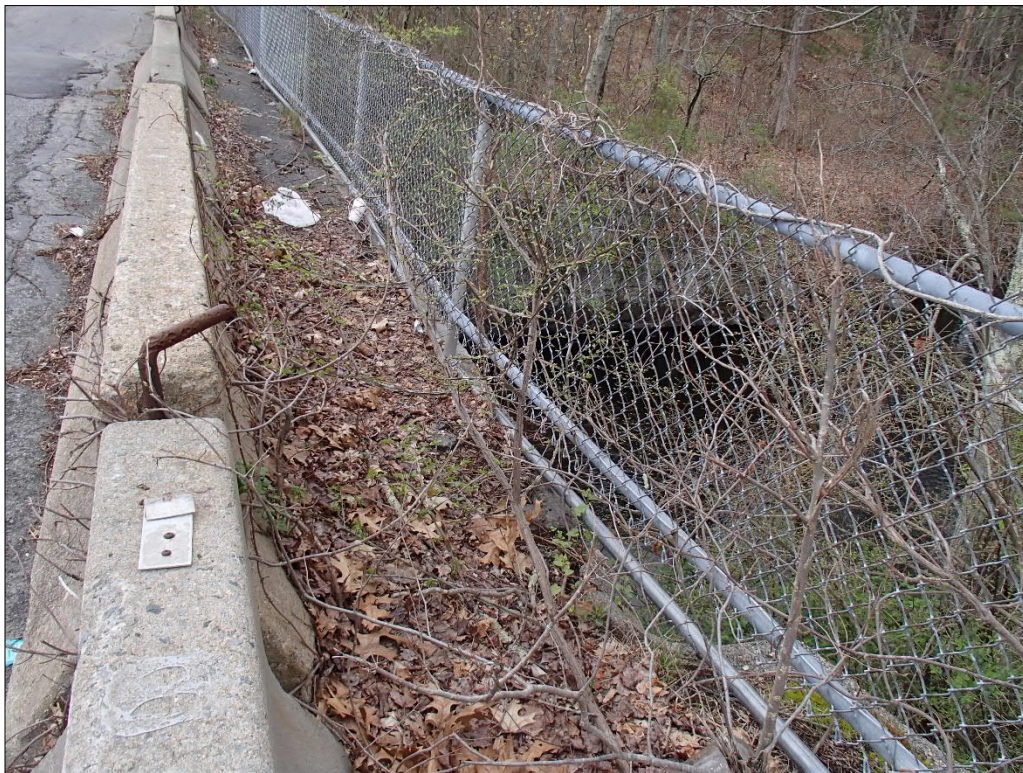
Photo 20 Looking Southwest: West Fence

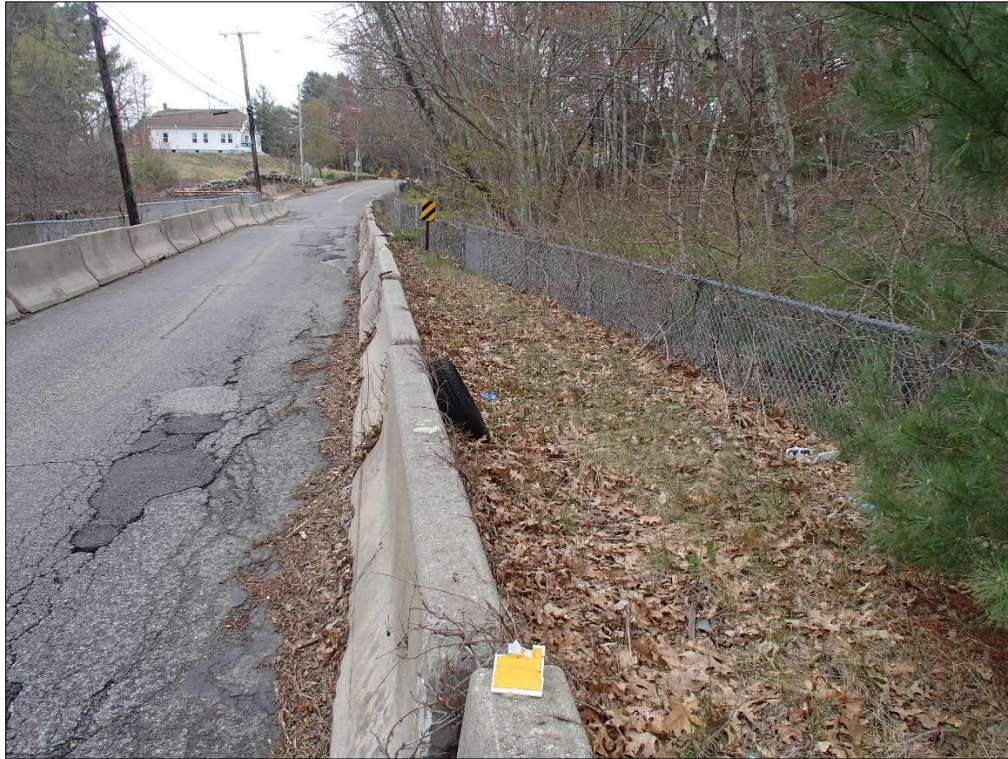
Photo 21 Looking South: West Barriers

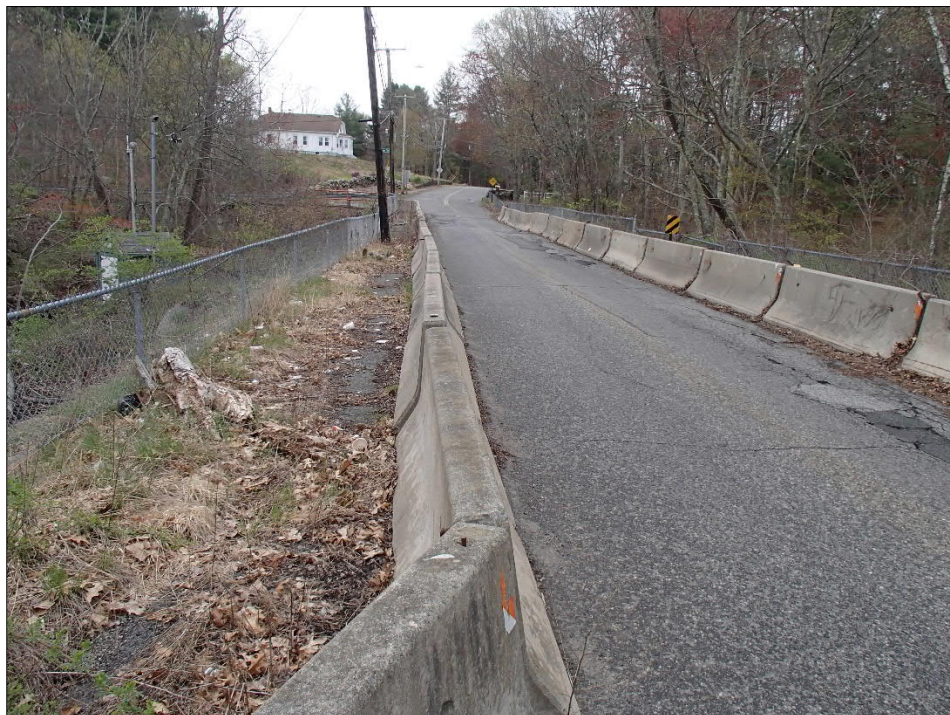
Photo 22 Looking South: East Barriers

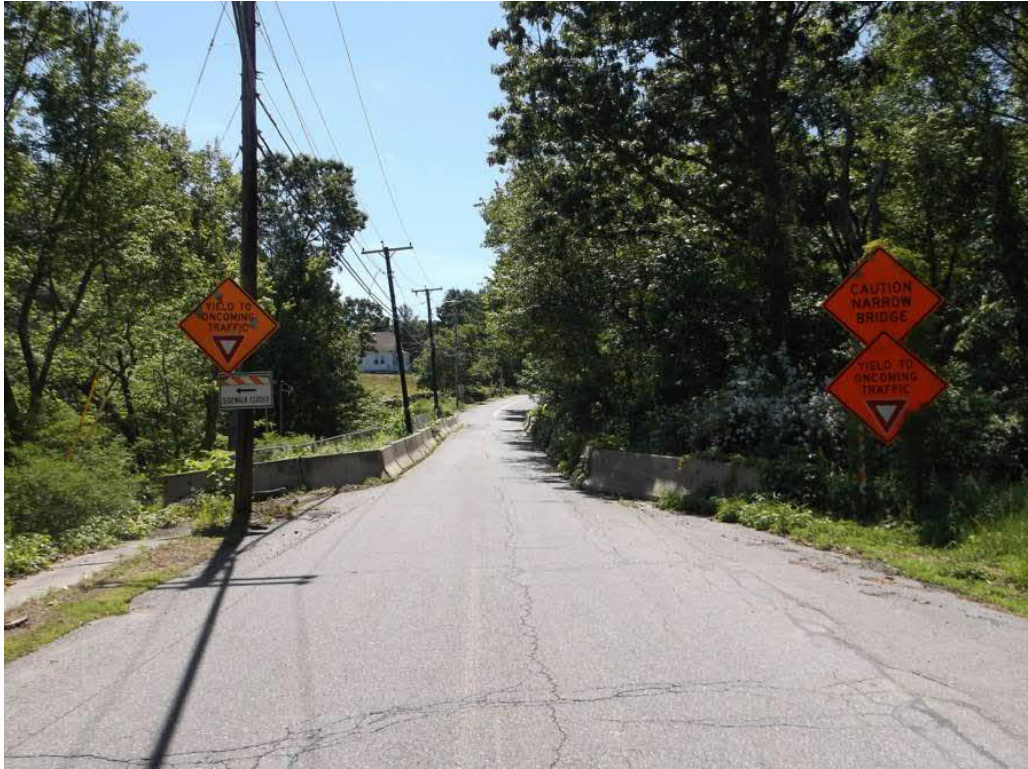
Photo 1: North approach signage.

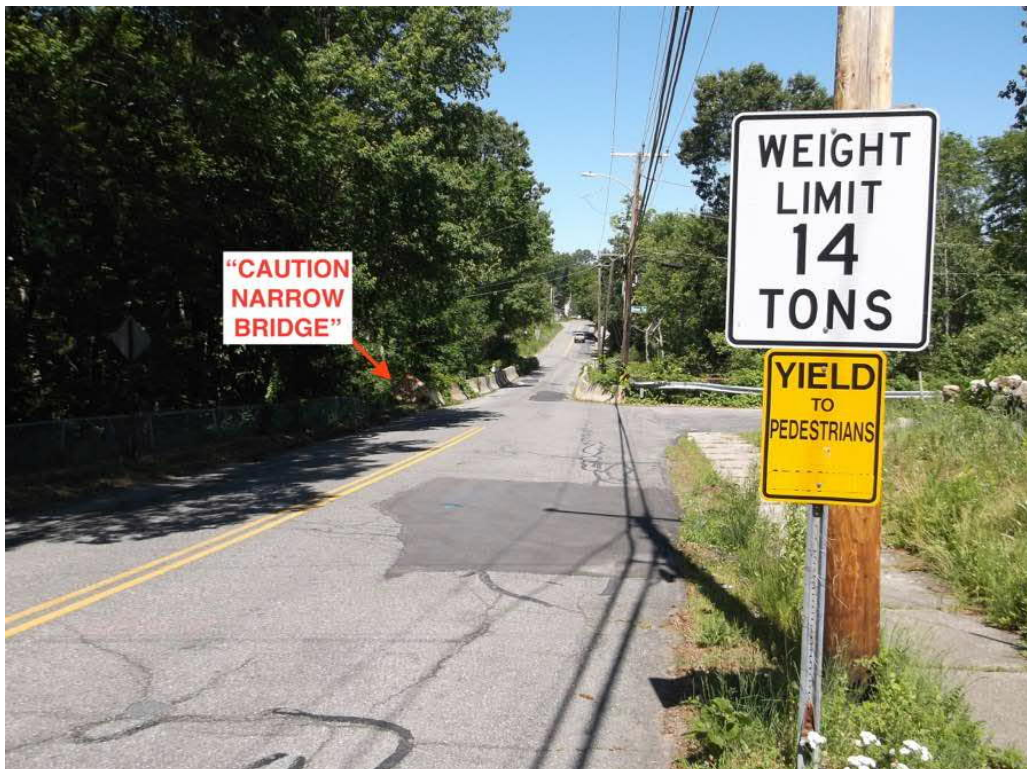
Photo 2: South approach signage.

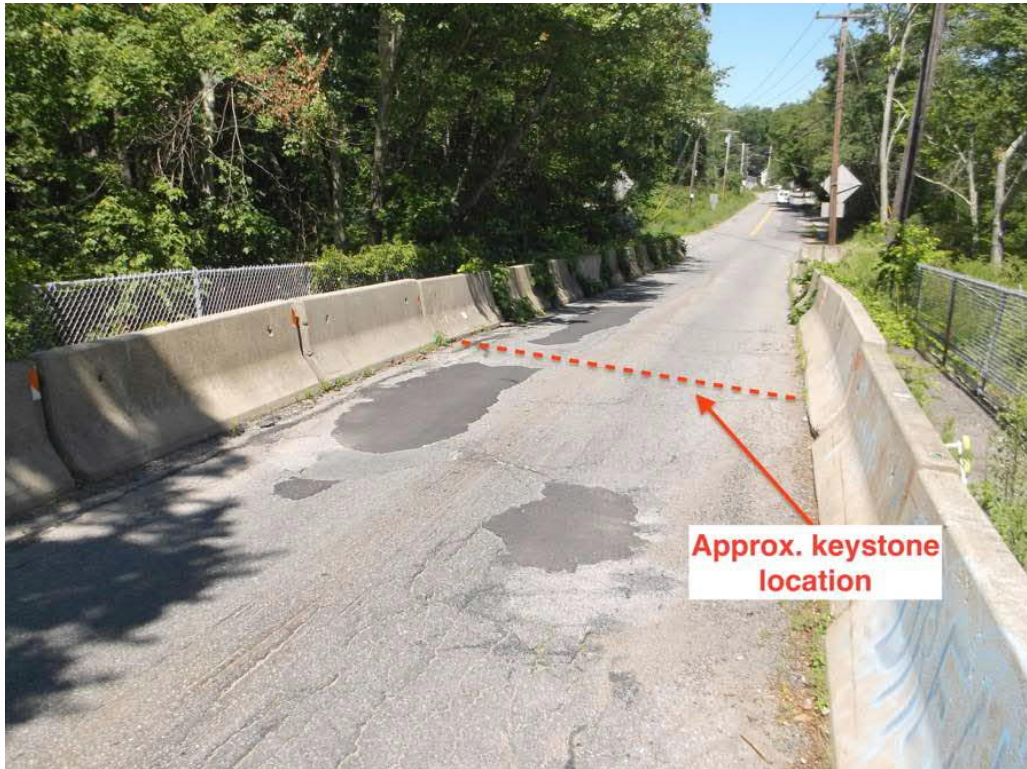
The bituminous concrete wearing surface has heavy transverse, map, and longitudinal cracking throughout, some sealed.

Photo 3: Wearing surface overview, looking Northwest.

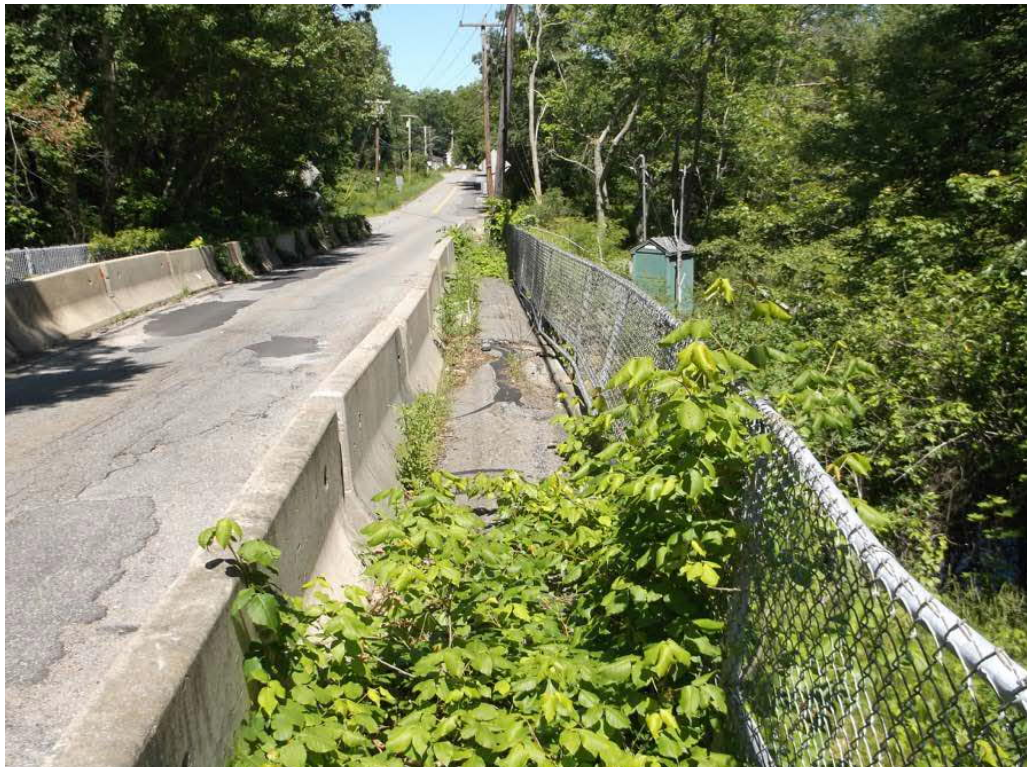
Photo 4: East fence and temporary barrier, looking North.

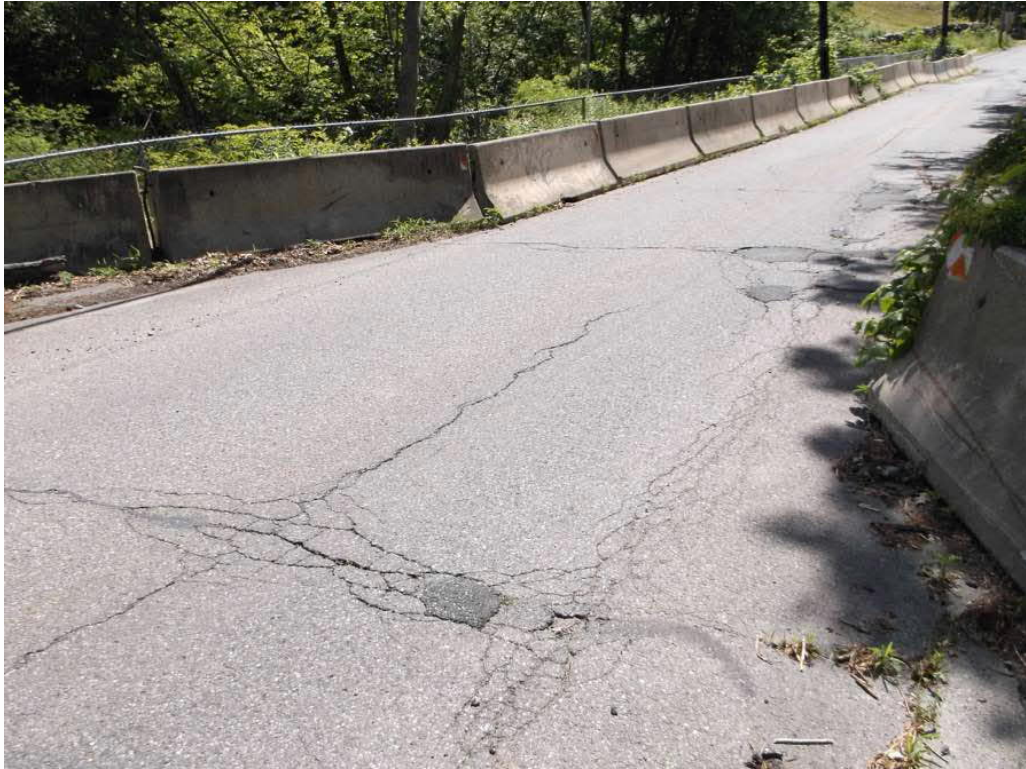
Photo 5: North approach pavement, looking Southeast.

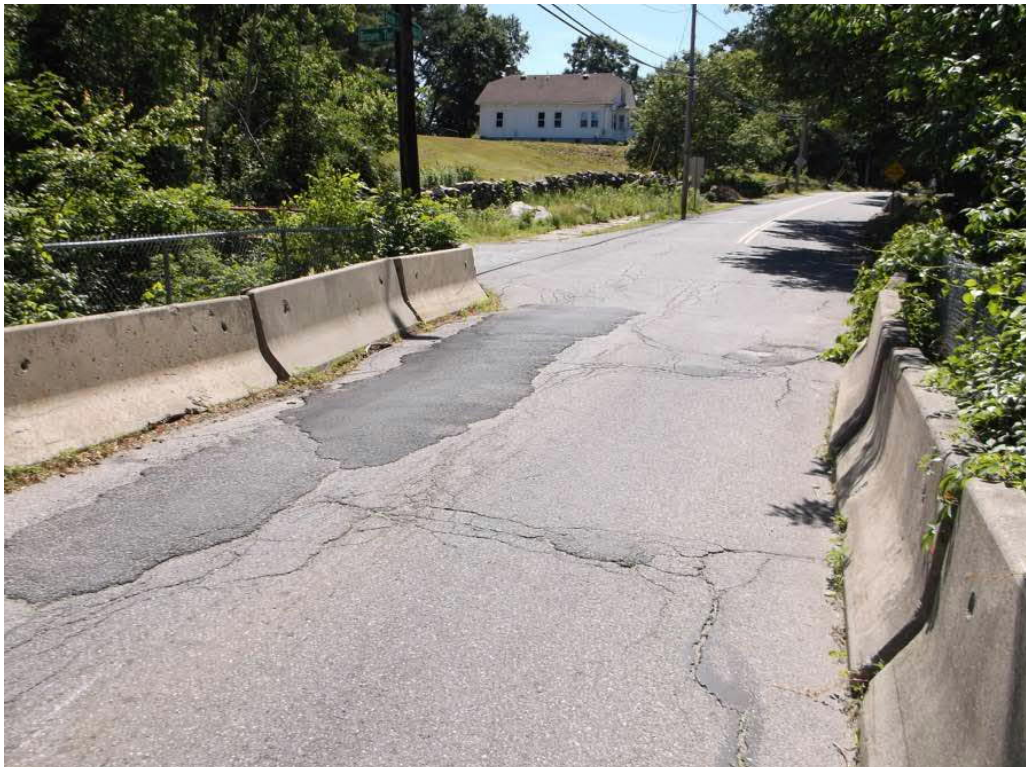
Photo 6: South approach pavement, looking Southeast.

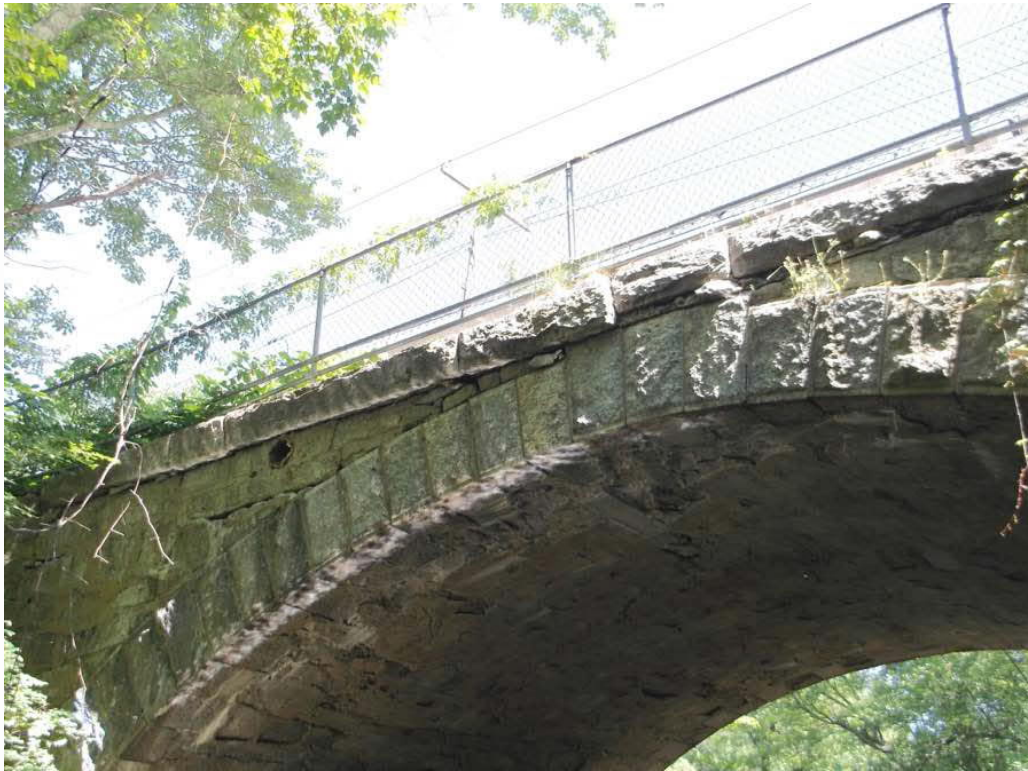
Photo 9: Northwest spandrel wall, looking Northeast.

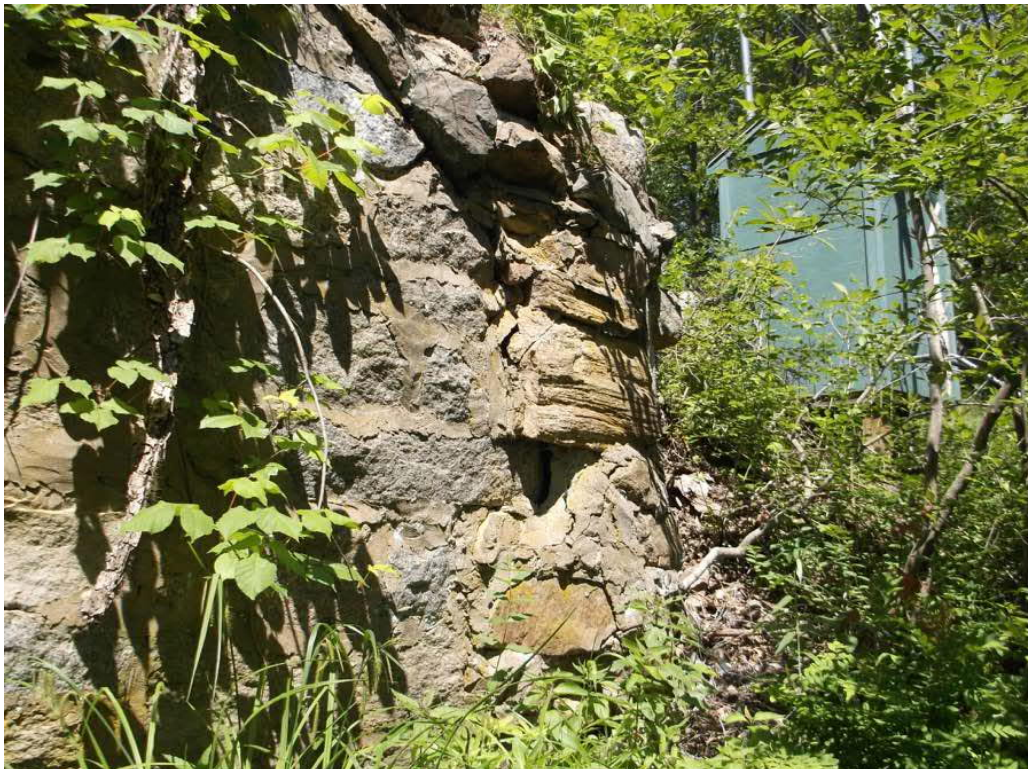
Photo 10: Northeast wingwall displacement, looking North (from channel).

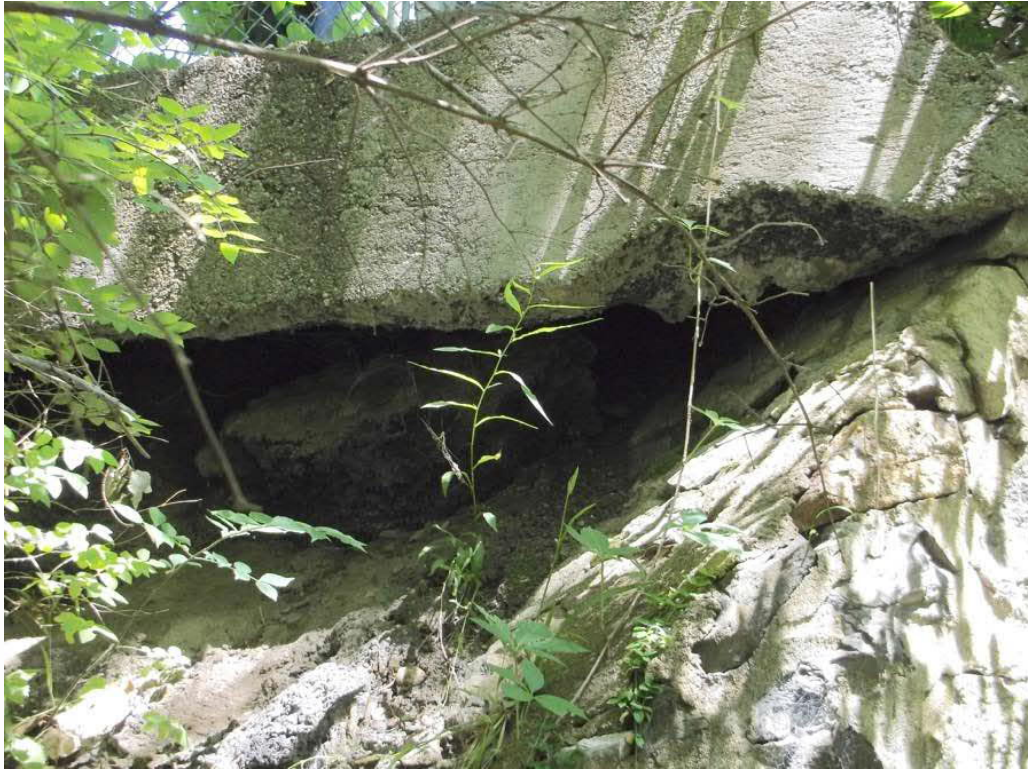
Photo 11: Northwest wingwall cap void (note bituminous chunk).

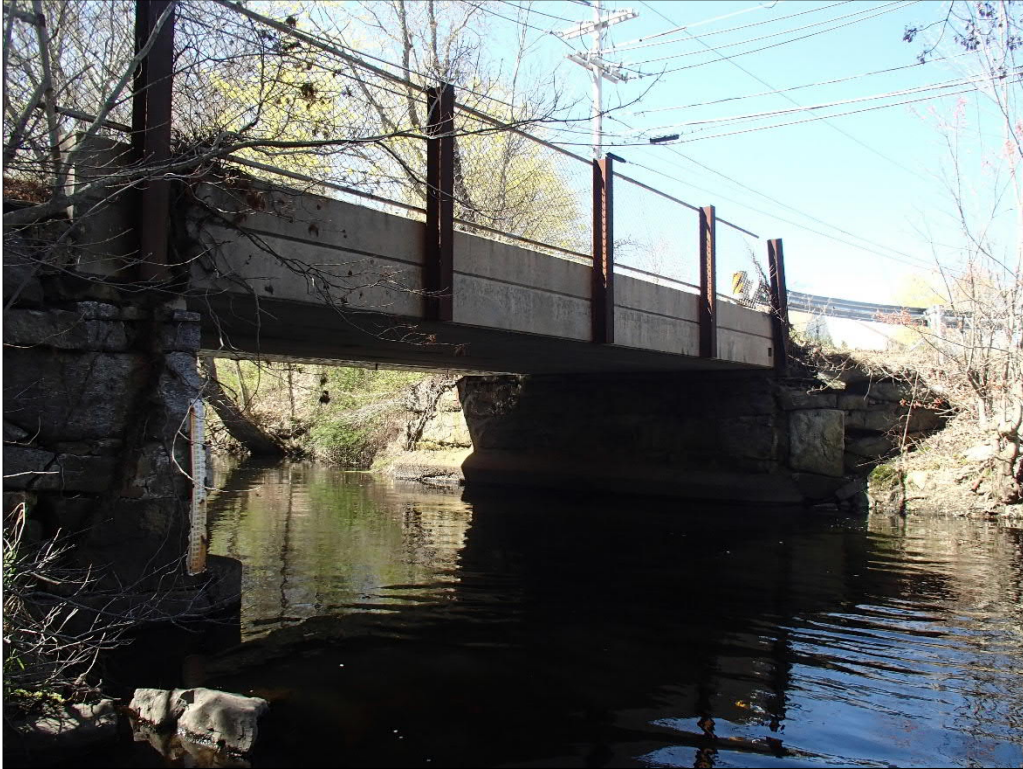
Photo 1 Looking Northeast: South Bridge Elevation

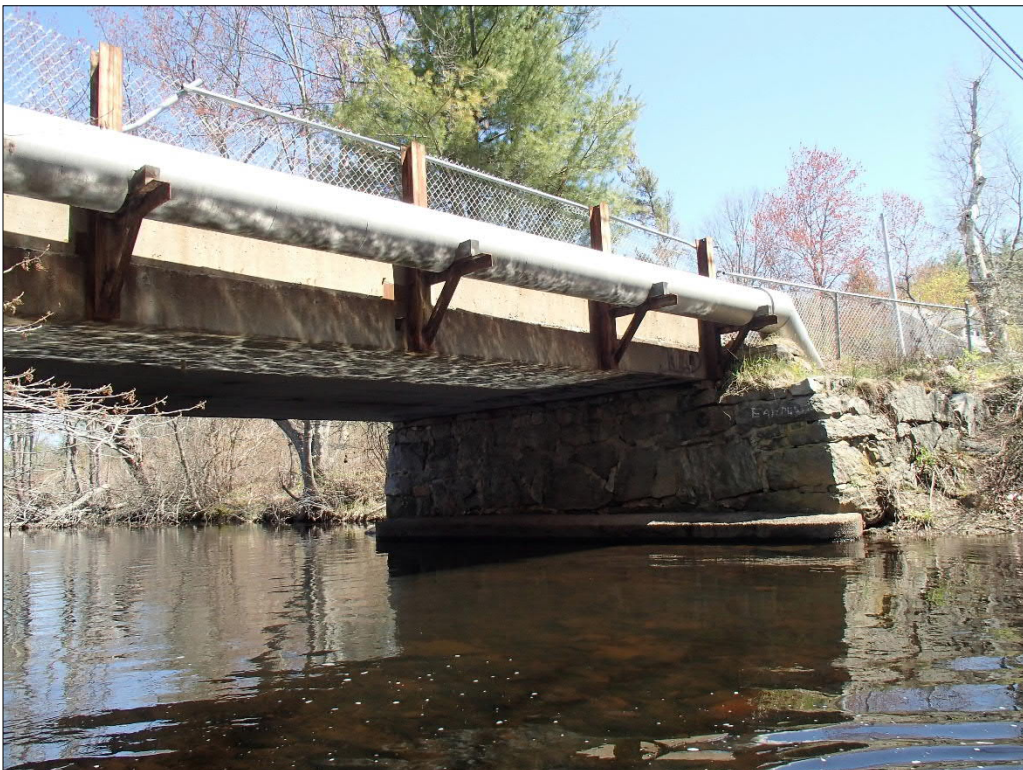
Photo 2 Looking Southwest: North Bridge Elevation

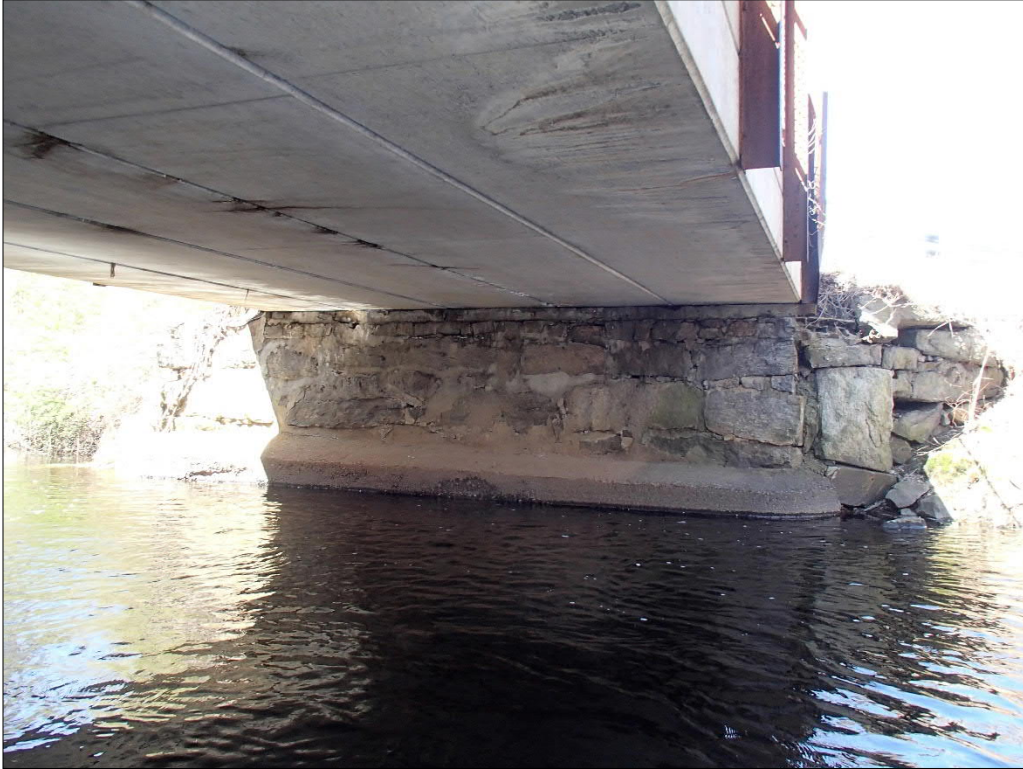
Photo 3 Looking West: West Abutment

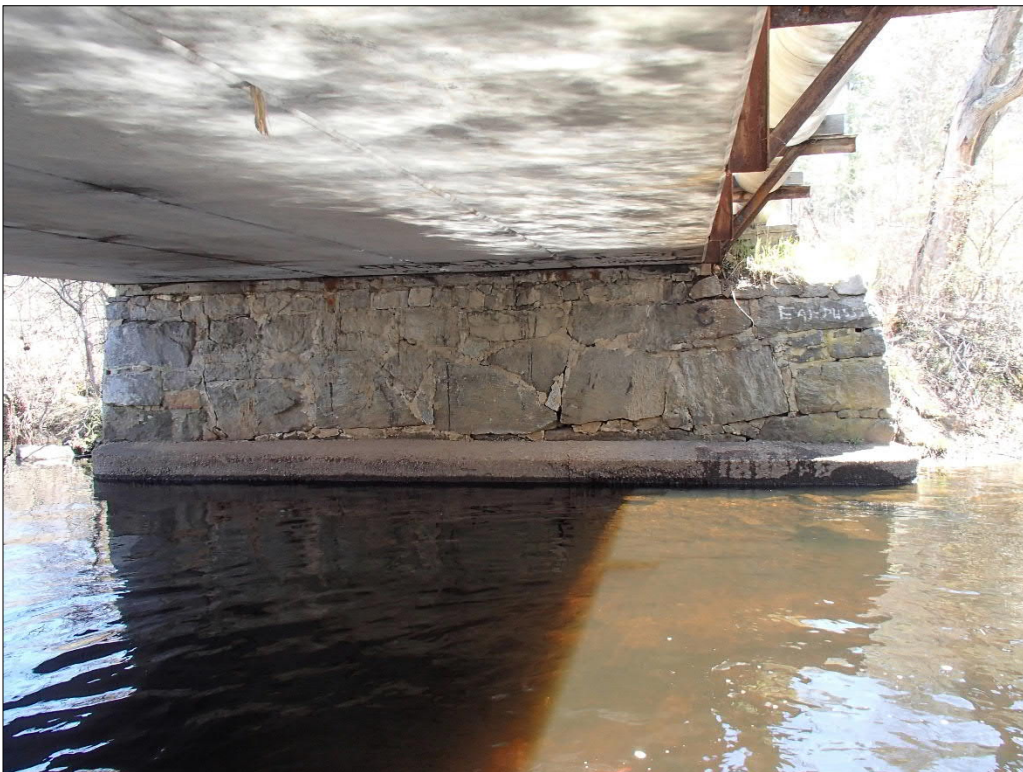
Photo 4 Looking East: East Abutment

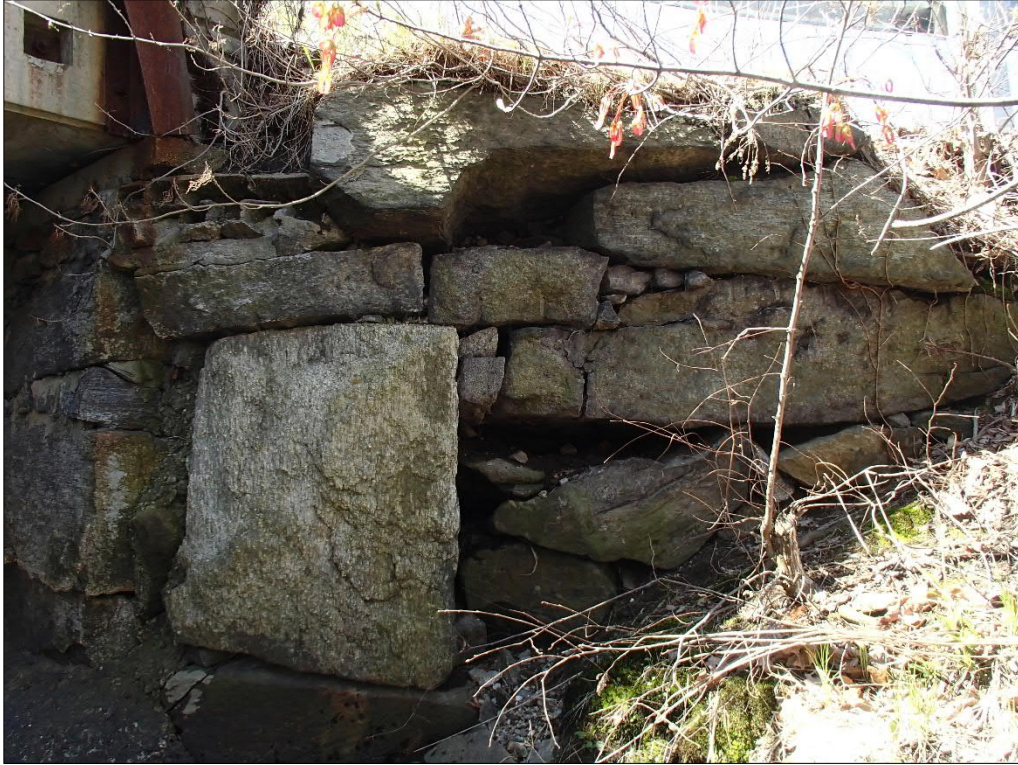
Photo 5 Looking West: Northwest Wingwall

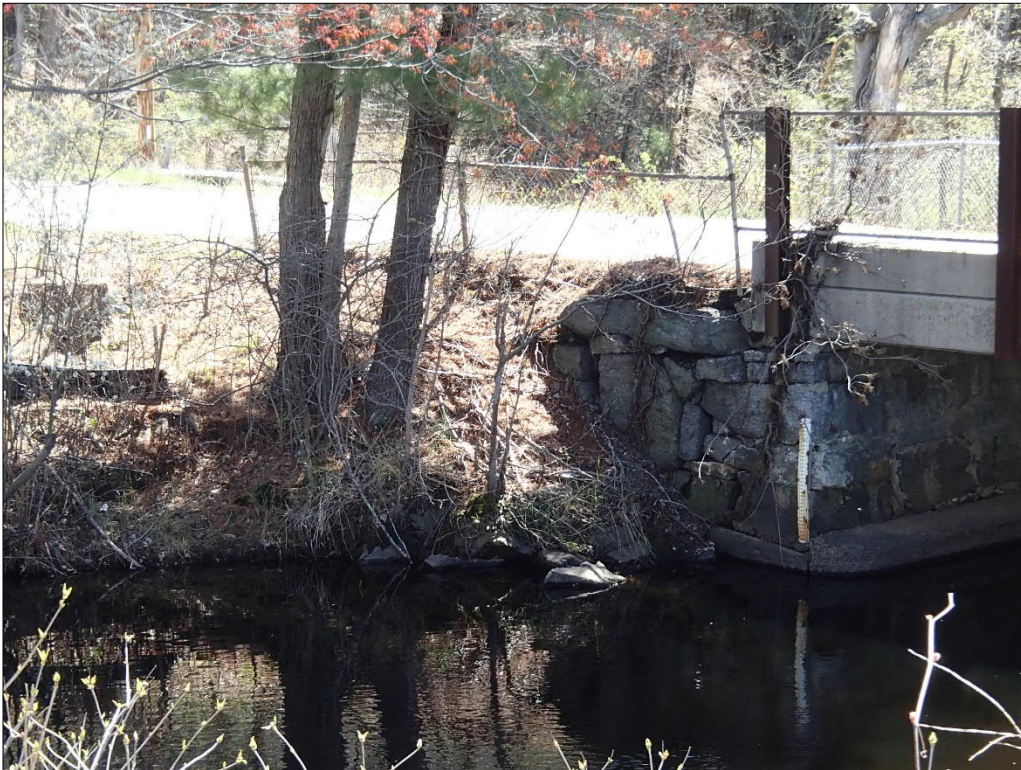
Photo 6 Looking Southeast: Northeast Wingwall

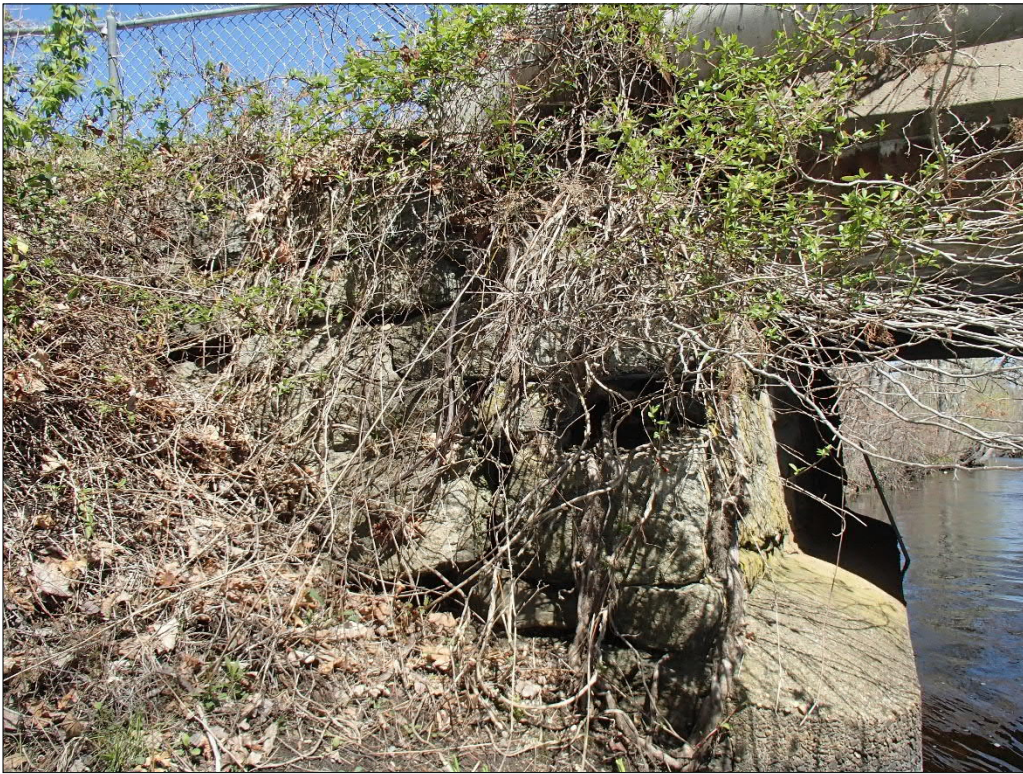
Photo 7 Looking North: Southwest Wingwall
