Uxbridge, Massachusetts
Evaluation Report
Project Number: 7533
June 2021

BRIDGE / CULVERT MANAGEMENT PLAN

Prepared by: BETA GROUP, INC.
Prepared for: Town of Uxbridge

June 2021

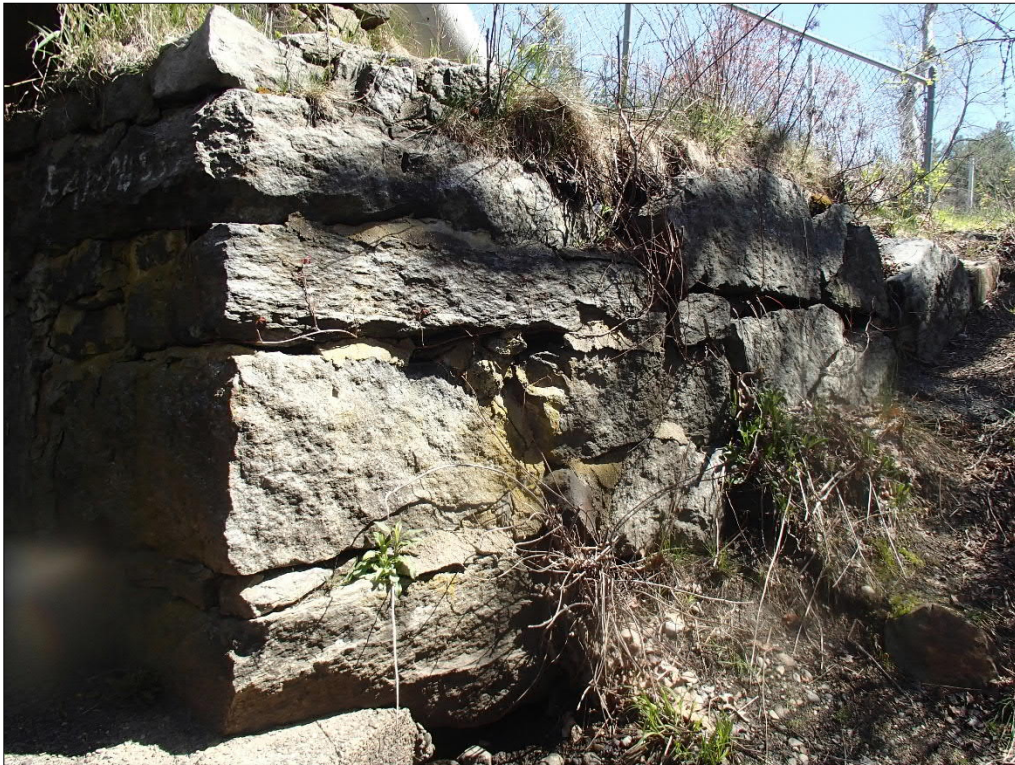
Photo 8 Looking North: Southeast Wingwall

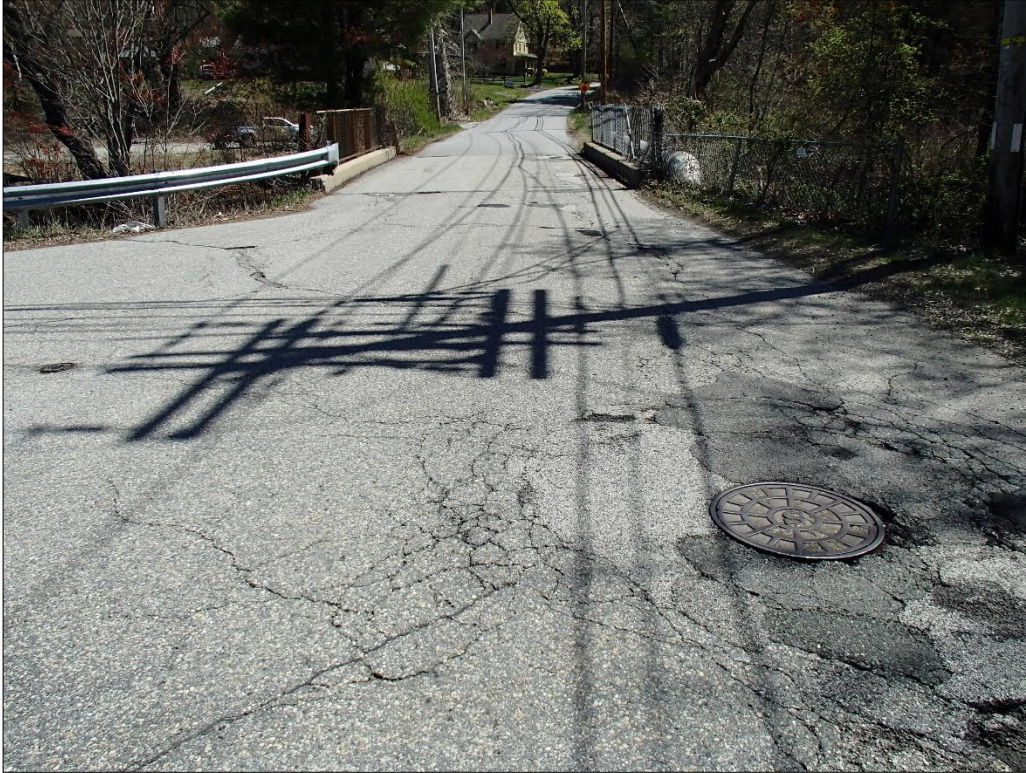
Photo 15 Looking East: West Approach

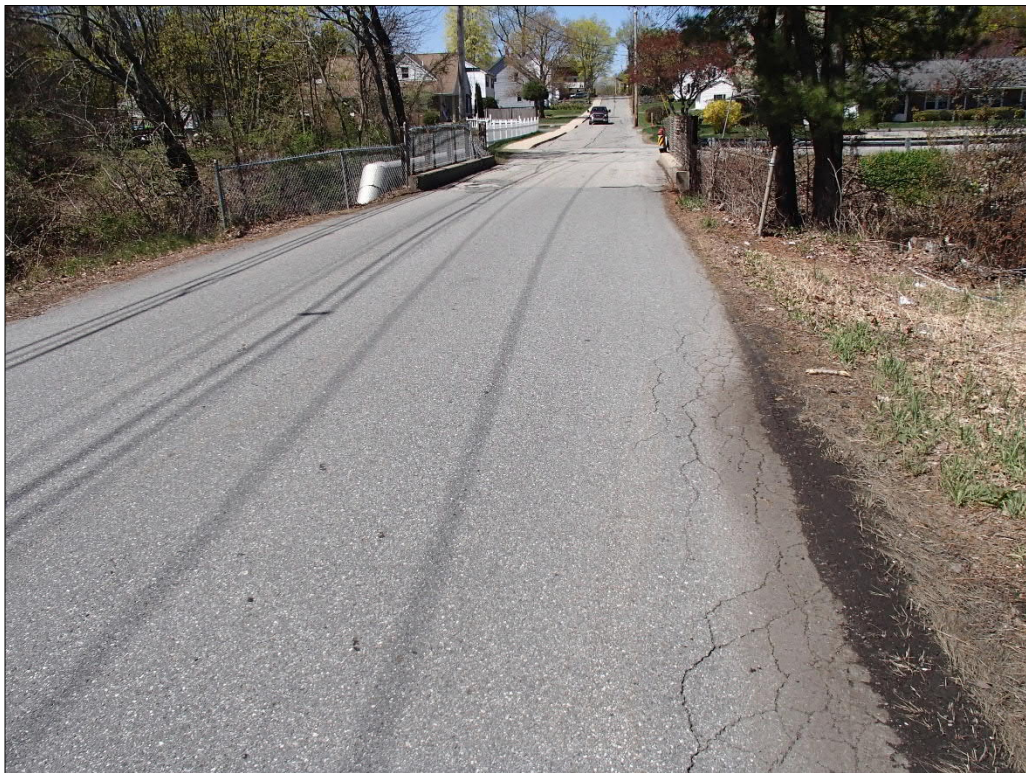
Photo 16 Looking West: East Approach

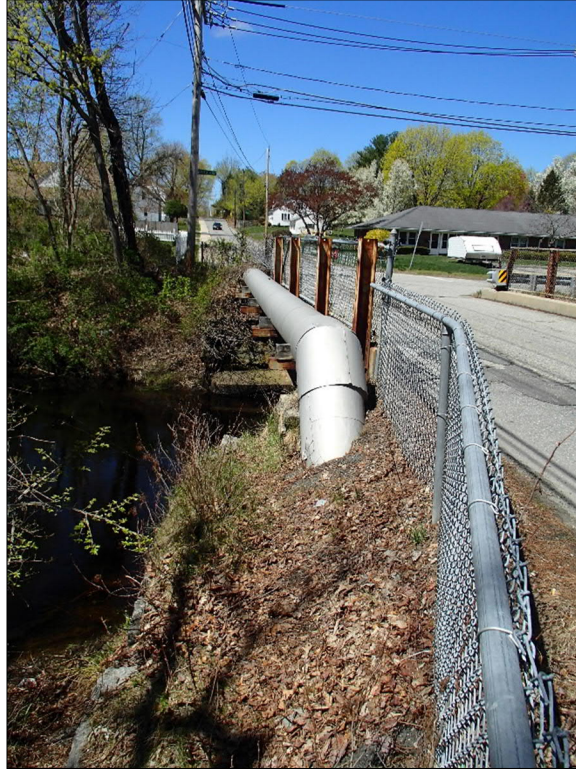
Photo 17 Looking West: South Side Water Line

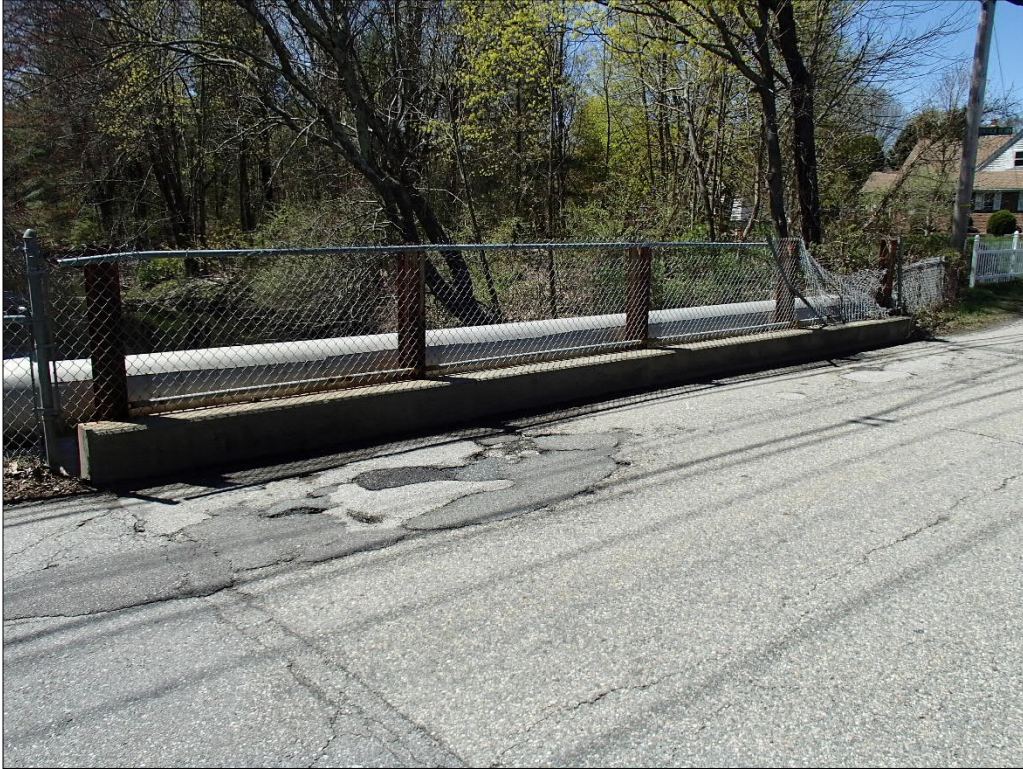
Photo 18 Looking North: North Fence

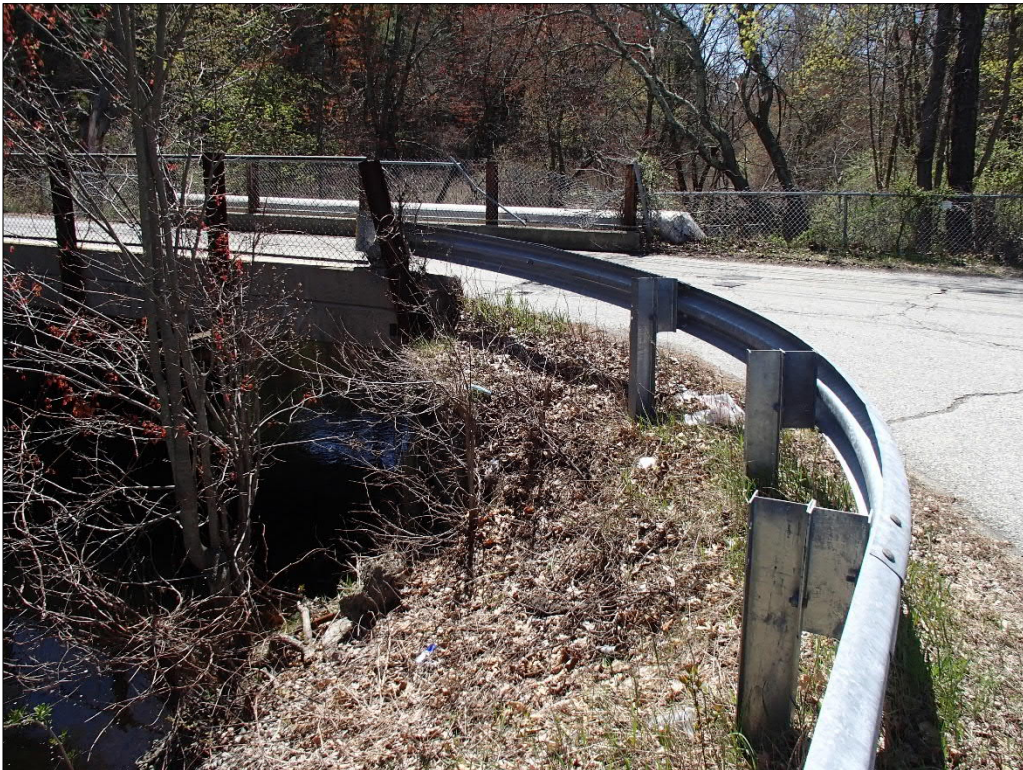
Photo 19 Looking South: South Fence

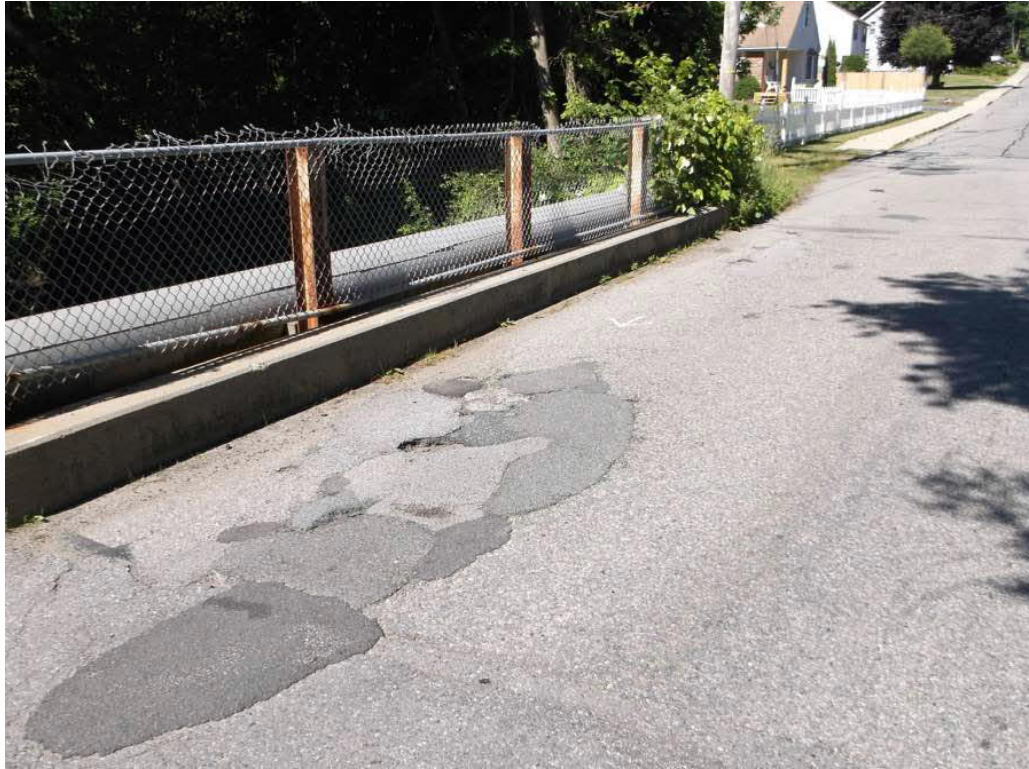
Photo 1: South side of wearing surface, looking Southwest.

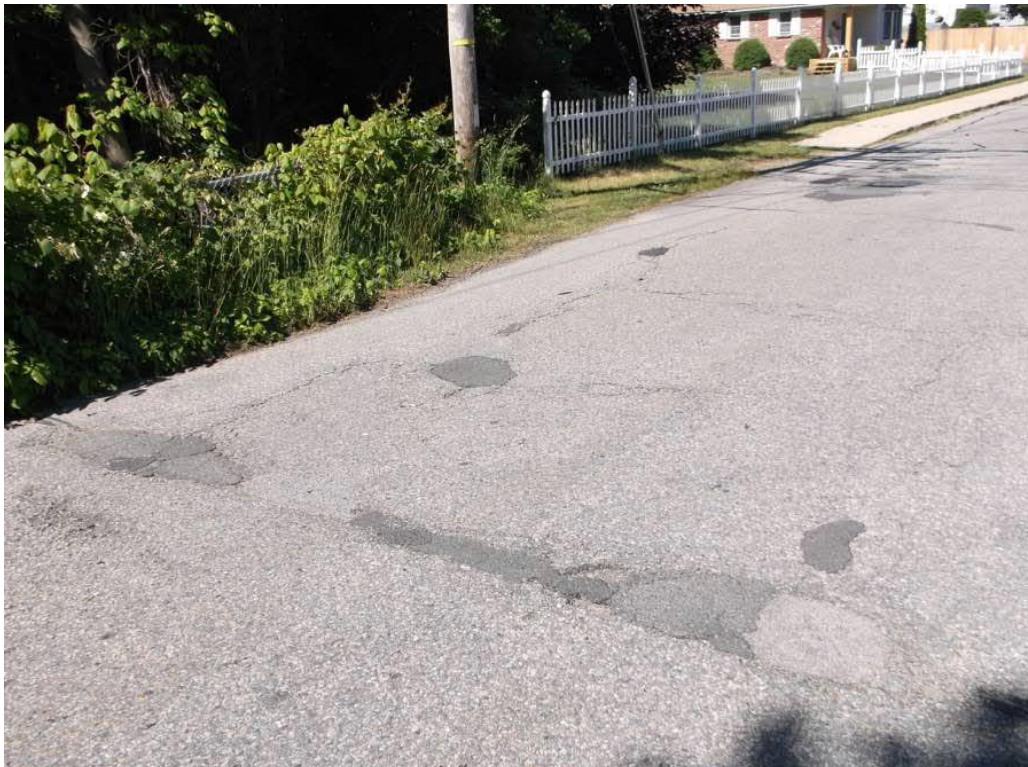
Photo 4: West approach to deck transition, looking Southwest.

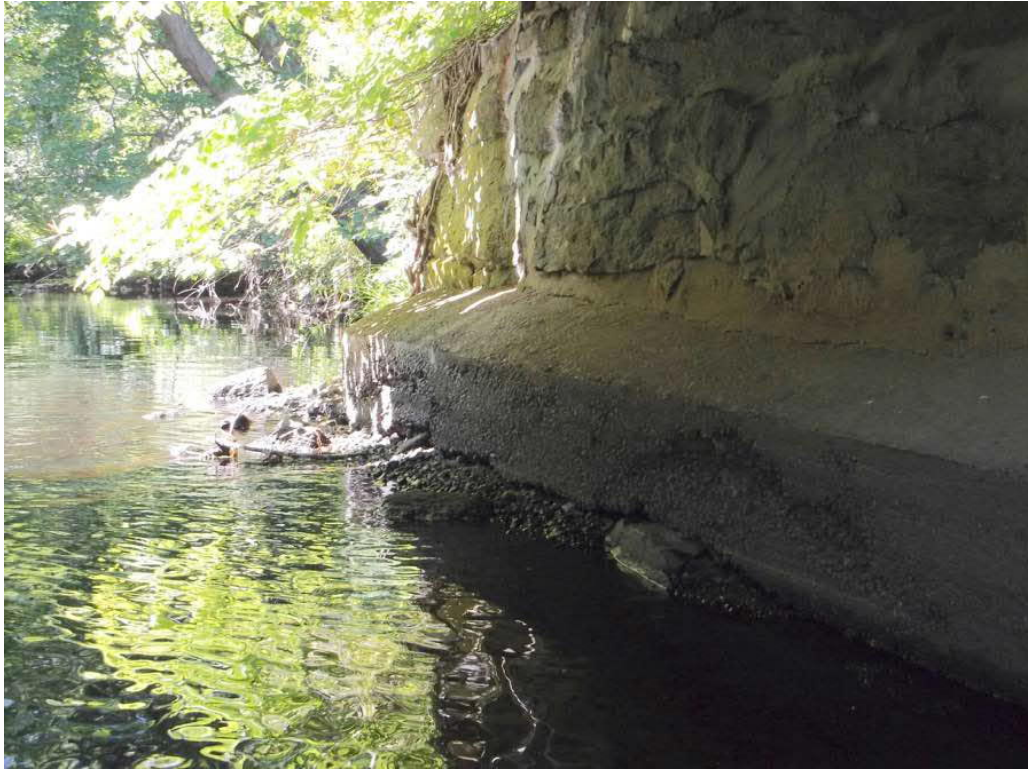
Photo 7: West concrete apron looking Southwest, abrasion and undermining.

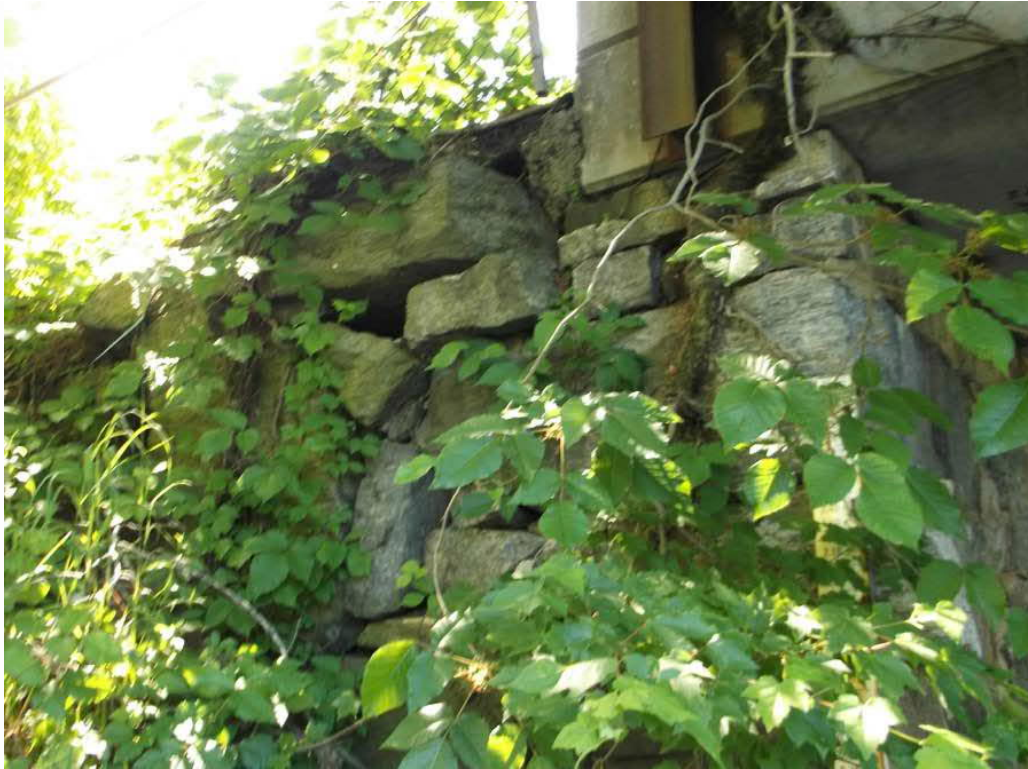
Photo 9: Northeast wingwall, voids and displaced stones.

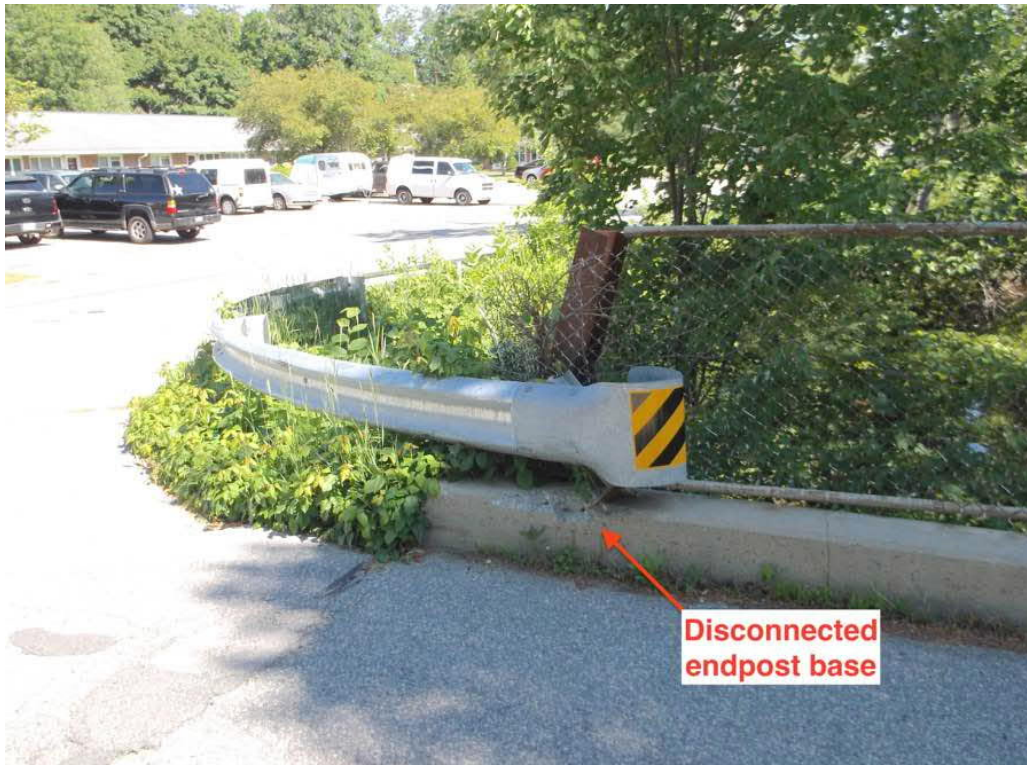
Photo 10: Northwest corner at corner of Patrick Henry St., looking Northwest.
